## MONITORING PROCESS OF THE RE-CONSTRUCTION OF AN ANCIENT STRUCTURE: THE BALUARTE DO CAVALEIRO

Jorge Pinto<sup>1</sup>, Humberto Varum<sup>2</sup>, João Guedes<sup>3</sup> and Anibal Costa<sup>4</sup>

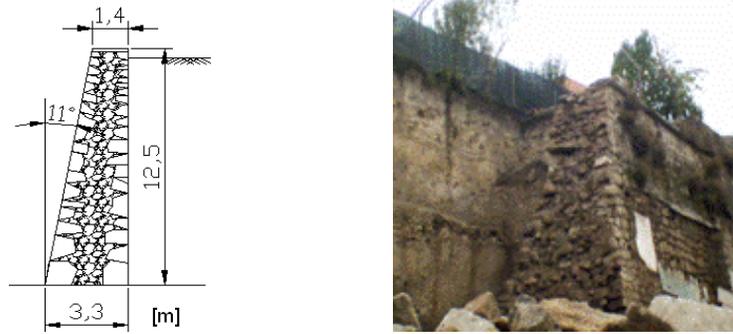
The Baluarte do Cavaleiro is a typical stone masonry wall. The real geometry and dimensions of its cross section is shown in Figure 3. The building technique detail adopted in the construction of the wall that consists of using large granite stone pieces in the inner and the outer faces and filling the gap between them using small and irregularly shaped granite stone pieces is also illustrated in Figure 3.

Figure 3. Cross-section of the Baluarte do Cavaleiro wall (December 2005)

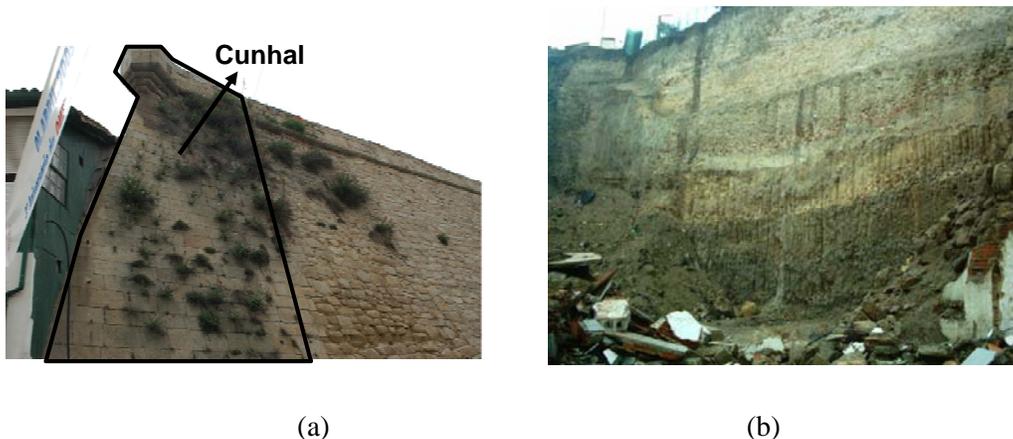
Figure 4. a) *Cunhal* that connects the SE and SW walls; b) Soil profile supported by the wall (December 2005)

Figure 4(b) shows the soil that has been supported by the wall (December 2005). This soil has the following constitution: 1.0 m thick organic soil as the first layer; 11.5 m thick of embankment type of soil as the second layer. This soil is extremely consolidated because it allowed an almost vertical cut, Figure 4(b). Exploration drilling tests were done in the downstream side of the SE wall in order to identify the foundation soil. The results of these tests concluded that the foundation soil has the following typology (see Figure 5): the first layer is a 1.0 m thick of silt; the second layer is a 2.0 m thick of thin sand; the third layer goes down to until the bedrock and is formed by saturated sand which varies in terms of granulometry from thin to thick. The bedrock depth is around 5.4 m near the *cunhal* that connects the SE and SW walls (test S1), 10.8 m in the middle span of the SE wall (test S2) and 7.4 m near the *cunhal* that connects the SE and NE walls (test S3).

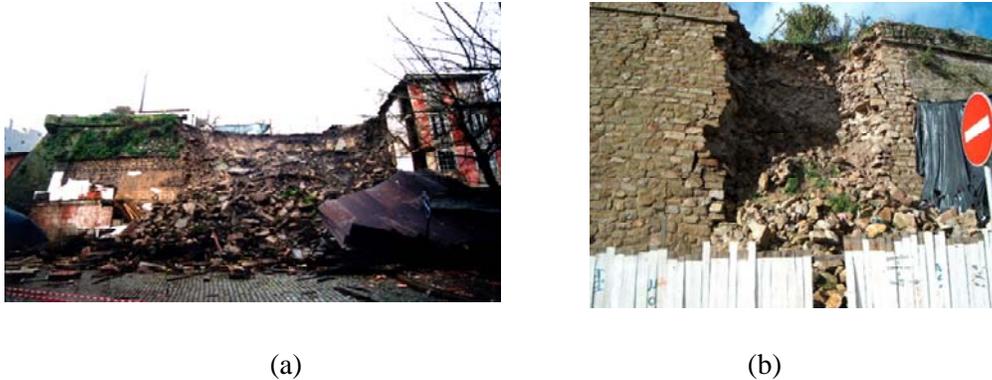
The first collapse culminated in the loss of a substantial part of SE wall and also in the loss of some of the attached building, Figure 7(a). From this figure and from Figure 3 it is noticeable that parts (related to the contact area of wall and attached buildings) of the outer face of this wall had cement coat and in the other ones there was vegetation. These facts prove that the wall did not have a regular maintenance process and had faced changes in its original drainage system. Some structural instability signals gave evidence of occurrence of the first collapse. These signals were an impressive crack that was formed in the top of the soil that was supported by the SE wall and a significant slope of the front façade of the buildings that collapsed.

After the first collapse, the SE wall was rebuilt and this reconstruction process took about 1 year to finalise. The attached buildings that had suffered partial or total collapse were completely demolished, Figure 7(a). Just after the conclusion of the above reconstruction process (April 2002), the SE wall faced the second collapse which resulted in a smaller scale of destruction, Figure 7(b). This situation required another reconstruction process of the SE wall of the Baluarte do Cavaleiro that ended in February 2007. The monitoring process described in this work is related to this last reconstruction process.

Figure 7. Scale of destruction of the SE wall of the Baluarte do Cavaleiro after the two collapses: a) First collapse (March 2001); b) Second collapse (April 2002)

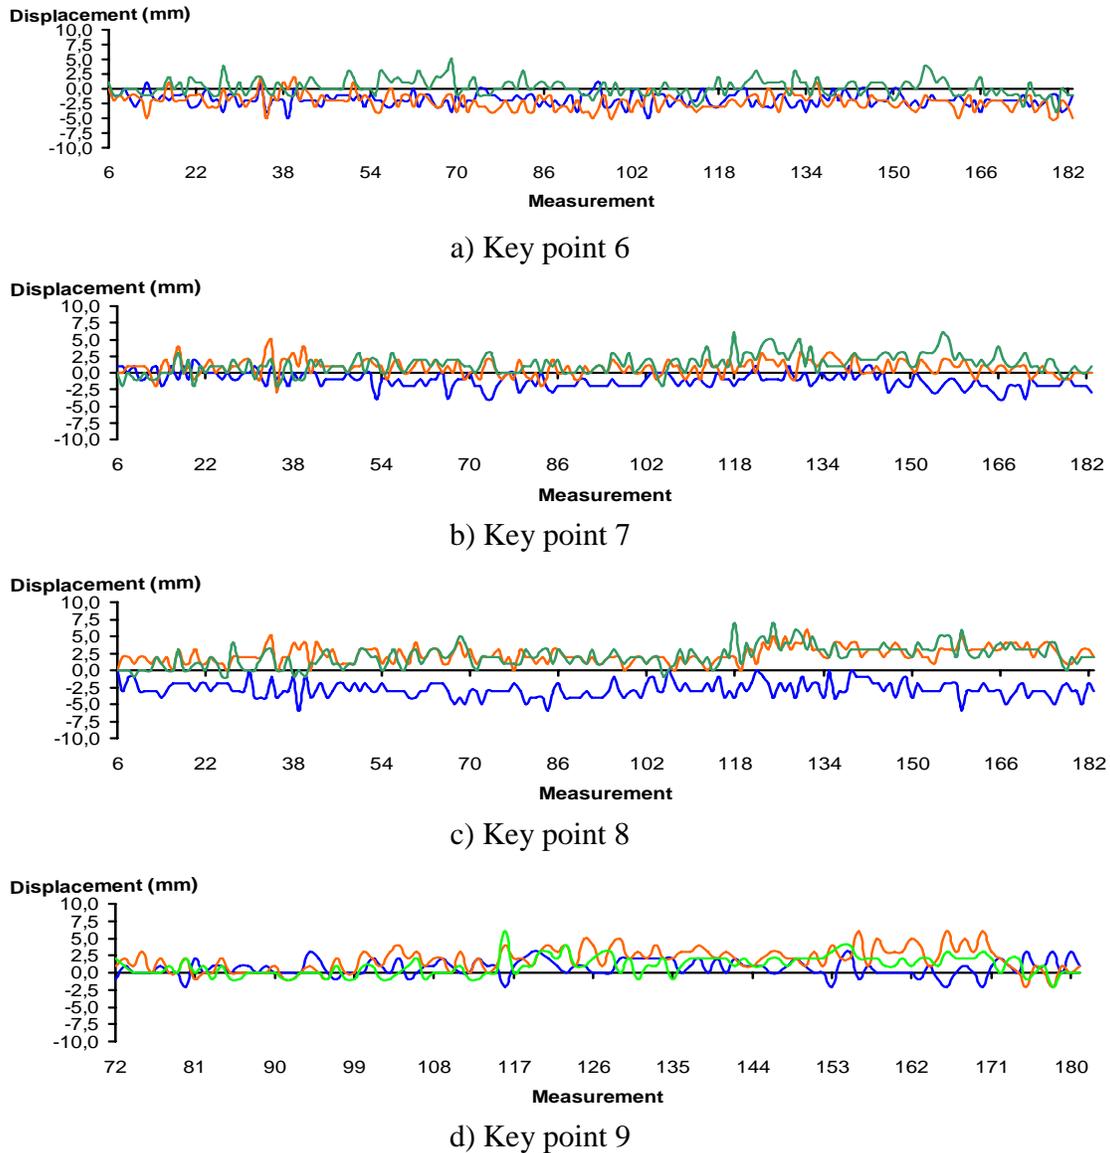
The displacement components evolution of the key-points of the NE wall (6, 7, 8 and 9) throughout the reconstruction process of the SE wall is shown in Figure 11. None of these points had an increasing displacement evolution. In fact, the evolution was an oscillatory function type, having in general maximum values less than 6.0 mm in terms of absolute value. The average value of the displacement components of these key points was in general less than 2.0 mm. Only the perpendicular displacement component of the key point 8 showed an average value of 2.7 mm. In fact, if the error associated to the surveying process was taken into account in the quantification of the coordinates of the key-points then the above displacement values could be assumed as being smaller. This error is a function of: (1) the instrument accuracy, which can be quantified using the expression presented next; (2) the precision of the measurement, associated to a human error; (3) the temperature correction.

According to the technical specifications of the used surveying instrument (Nikon 2007), its accuracy can be measured using the expression  $\pm(3+3\text{ppm}\times D)$  mm, in which:  $D$  is the distance (in km) from the surveying instrument to the reflector. Thus, the key-points of the NE wall had no expressive displacements during the reconstruction process of the SE wall, these displacements were mainly related to the normal behaviour of the NE wall as being a stone masonry wall structure. We may conclude that the tasks related to the reconstruction process did not affect the stability of the NE wall. In fact, as it was stated before, the key-point 8 was the one that had shown a higher value of displacement and, at the same time, it was the most far away from the rebuilding area, Figure 8(b).

Figure 11. Displacement evolution of the key points of the NE wall (6, 7, 8 and 9)

Figure 11(d) only includes the displacement evolution of the key-point 9 from the 72<sup>nd</sup> measurement because the reflector (that materialised this key-point) fell down in December of 2005. It was only possible to define one key-point (key-point 37) in the SW wall of the wall because the attached buildings did not allow sticking other reflectors on this wall. This key-point was located approximately at the half length of this wall, Figure 8-d), and consequently a bit far from the zone affected by the demolition/reconstruction of the SE wall. The displacement evolution of the key-point 37 is illustrated in Figure 12 where we can realise that there was no significant displacement of this point throughout the reconstruction process of the SE wall. This

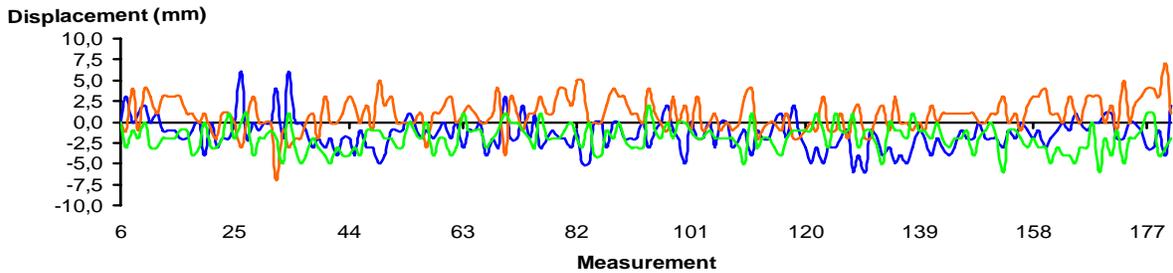
evolution was not increasing type and the displacement component that had shown higher average value (equal to 1.8 mm) was the vertical one.

Figure 12. Displacement evolution of the key point 37 that was defined in the SW wall

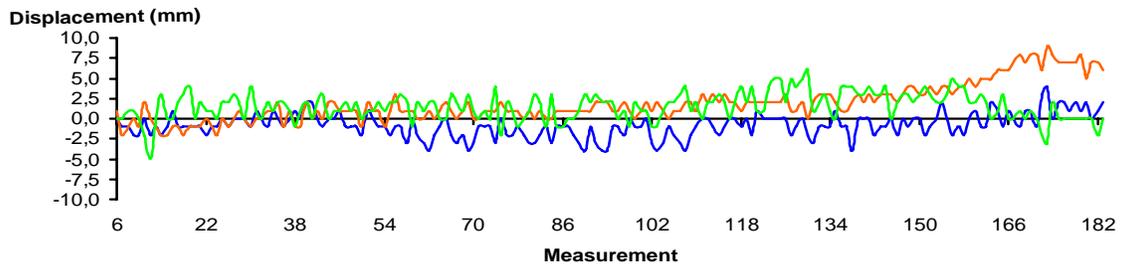
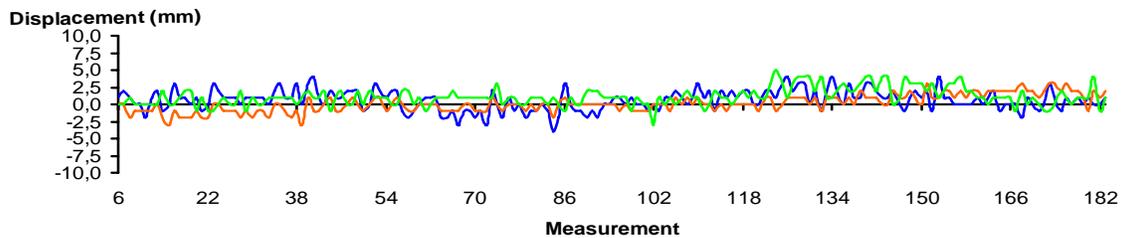
The key-points 12 and 13, Figure 8(c), were defined to monitor the cunhal that connects the SW and SE walls. Their displacement evolution is shown in Figure 13. In this case, there was not a generalised increasing trend on the component displacement of these key-points either; the average value of these components was less than 2.0 mm. These facts indicate that this structural element was not affected by the reconstruction process of the SE wall.

Figure 13. Displacement evolution of the key points 12 and 13 related to the cunhal that connects the SE and SW walls

However, it is noticed in Figure 13(a) that the parallel displacement component of the key-point 12 had suffered an increasing evolution between the measurements 141 and 167 (September and December 2006). This behaviour was related to the fact that this key-point had been defined in a piece of stone of the top course of stone (Figure 14) and this piece of stone had suffered movements resulting from the working process. This parallel displacement component evolution had stabilised from the measurement 167.

This is an example of an instability signal detected through the proposed monitoring process in this work. In this particular case, it was possible to detect an instability signal (increasing evolution of a displacement component of a key point), to identify its cause (movement of a piece of stone resulted from the working process), to evaluate the scale of that instability signal (circumscribed to a piece of stone, the visual inspection did not find significant movements in the area surrounding that piece of stone, the key point 13 (near the key point 12) did not have an increasing displacement evolution during that period of time), to decide if the planned working process should continue (the working tasks related to the reconstruction process had run as planned because the instability signal did not give evidence indicating risk of collapse of the cunhal or other construction).

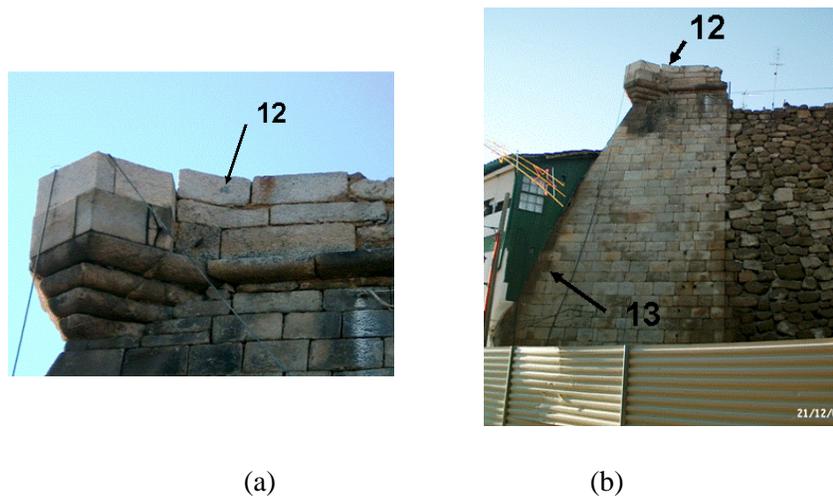
Figure 14. Key point 12: a) Location of the key point 12; b) Location of the key points and 13

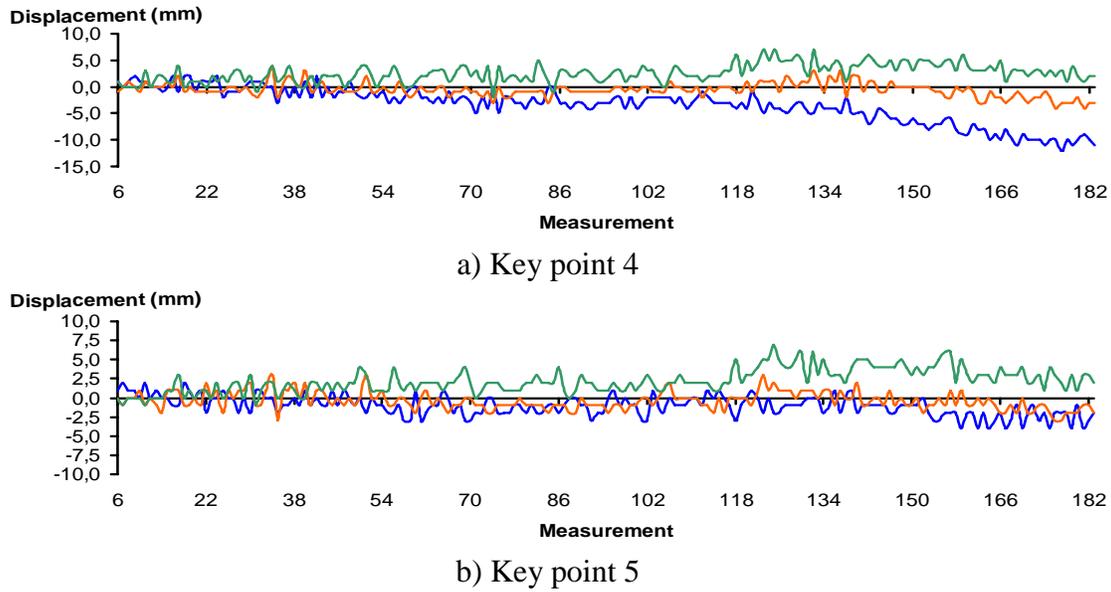
A similar situation had happened for the cunhal that connects the SE and NE walls for which the related key points were 4 and 5, Figure 8(b). The displacement component evolution of these key points is described in Figure 15 where we can notice that until the 116<sup>th</sup> measurement (June 2006) there were not expressive value of displacement. However, from this measurement, the vertical component of displacement of both key points had increased which indicates that these key points went up. This evolution had inverted from the 158<sup>th</sup> measurement (November 2006) and the vertical component of displacement evolution converged to 0 mm, Figure 15.

Figure 15. Displacement evolution of the key points 4 and 5 related to the cunhal that connects the SE and NE walls

Through Figure 10, it is possible to realize that the 116<sup>th</sup> measurement was done when the demolition of the SE wall was taking place and, more precisely, this demolition task (Task 1, Figure 10) was taking place next to the cunhais. Simultaneously, the work task related to the excavation for the execution of the drainage system (Task 2, Figure 10) was also in progress by that time. Based upon these facts, the ascendant displacement of the key points 4 and 5 may be related to the above work tasks. As the reconstruction process was progressing (after the 116<sup>th</sup> measurement) the key points 4 and 5 had shown a displacement components evolution trend similar to the initial one (before the 116<sup>th</sup> measurement).

The key points 12 and 13 also had shown a similar displacement evolution trend, Figure 14, as the one described for the key points 4 and 5 being though less expressive. Figure 15 also shows that the key-point 4 of the NE wall had had an increasing evolution of the perpendicular displacement component that started from the 138<sup>th</sup> measurement. By the time in which the 138<sup>th</sup> measurement was done the reconstruction process of the SE wall was in progress. Since the values of this displacement component were negative, the piece of stone on which the reflector (that materialized the key point 4) was glued had moved in the direction of the embankment.

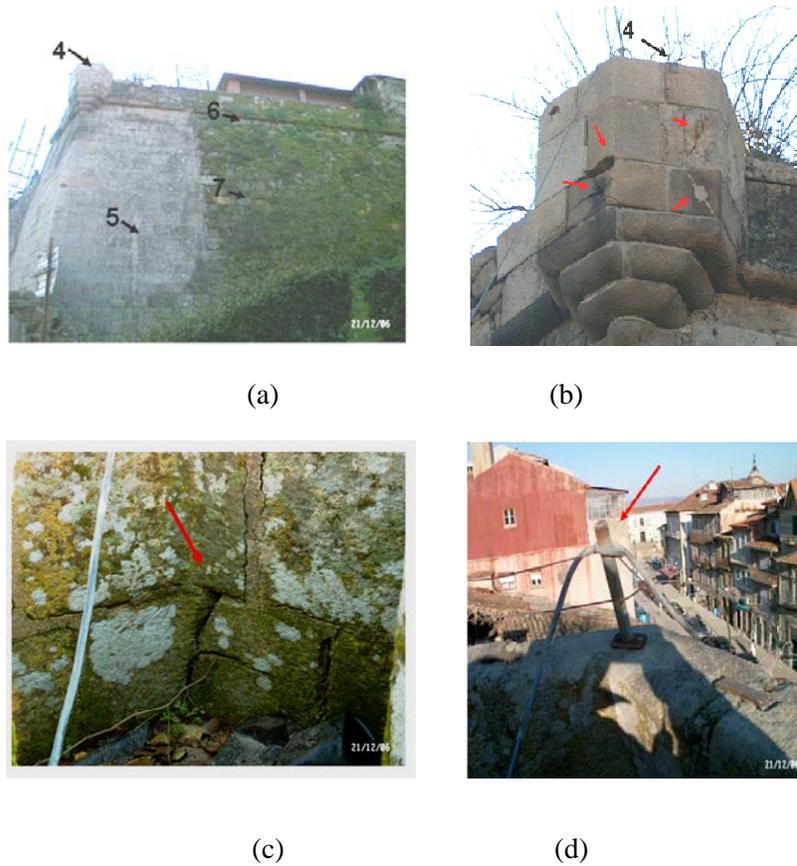
Figure 16. Key point 4: Some pathologies existing around the key point 4 and resulted from the working tasks related to the reconstruction process: a) Location of the key points 4, 5, 6 and 7; b) Existing pathologies surrounding the key point 4; c) Existing pathologies surrounding the key point 4; d) Existing steel bar next to the key point 4

As it was described for the key-point 12, the cause of the above displacement evolution of key point 4 was related to the working task that was in progress by the time in which the measurement 138<sup>th</sup> was taken. Figures 16(b) and 16(c) illustrate that some pieces of stone located near the key point 4 had cracks. Meanwhile, Figure 16(d) shows the existence of a steel bar fixed to the wall and also near the key point 4. This steel bar had been under an action, resulted from the working tasks of the reconstruction process, which resulted in a permanent deformed shape of this bar in the direction of the embankment.

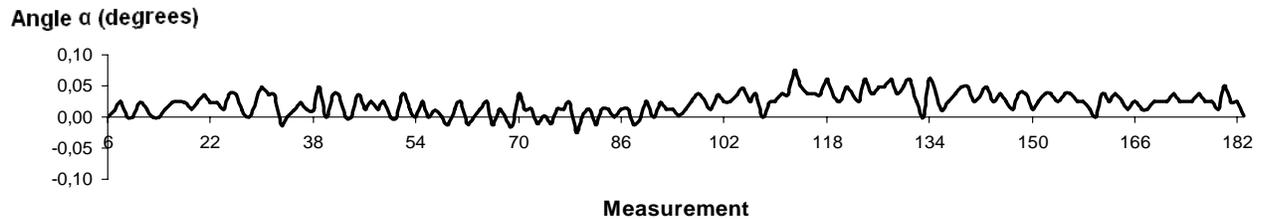
This is another example case that validates the applicability of the adopted monitoring process described in this work. At the same time, graphs that describe the evolution of the angle  $\alpha$  throughout the reconstruction process of the SE wall of the Baluarte do Cavaleiro were also defined in order to control the verticality of the constructions under the monitoring process. Figure 17 illustrates, as an example, the evolution of  $\alpha$  for the alignment defined by the key-points 6 and 7 related to the NE wall. As it can be seen, the area of the wall surrounding this

alignment had kept the same slope (i.e.  $\alpha$  remained almost constant) throughout the reconstruction process and this is another indication that the reconstruction process did not affect the stability of the NE wall.

Figure 17. Evolution of  $\alpha$  for the alignment defined by the key points 6 and 7 of the NE wall

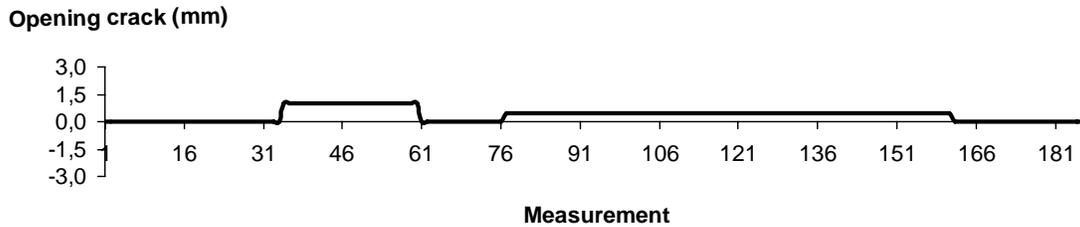
The opening crack evolution was studied during the reconstruction process. Those cracks did not have an expressive opening crack evolution. In general, the quantified opening crack evolution was the expected and resulted from the normal temperature changing through the year. Figure 18 illustrates the opening crack evolution graph of the crack D-1-36 (i.e. localized in the building D (Figures 8(a) and 8(d)), in the 1<sup>st</sup> floor and is the 36<sup>th</sup> pathology identified in that building) as an example. As it can be noticed from Figure 18, the crack opening evolution at this point is almost constant having the maximum value of 1.0 mm. This small oscillation of values was related to the normal temperature variation during the year even taking into account that all the cracks that were controlled were inside of a building.

Figure 18. Opening crack evolution of the crack D-1-36
