Analysis of the Fracture of a Turbine Blade

A.R. Shourangiz Haghighi¹, S.Rahmanian¹, A. Shamsabadi^{2,*}, A. zare³, I. Zare²

Received 18 February 2016; accepted 5 April 2016

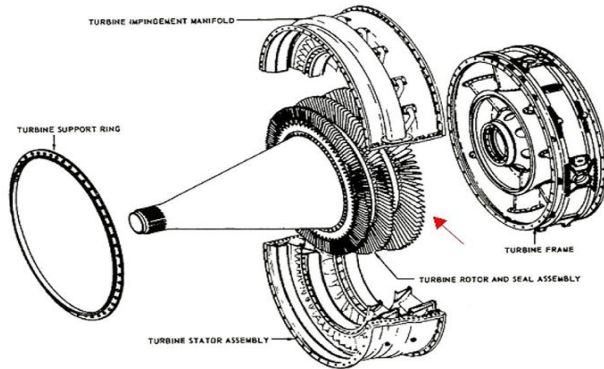
During the in-field research, we found that several blades were damaged without fracture and merely one blade was fractured that was installed on the third stage rotor of the turbine as can be seen in Fig. 1. The blade was fractured at about the 6 cm distance from the hub of the blade. And it did not seem to have suffered any damages by any foreign objects because there were no damage on the compressor segment and the first and second stage of the turbine [12, 44].

Fig.1 Schematic illustration of the turbine section of the turbojet engine [11, 12]. Note: The arrow indicates the location of the blade failure.

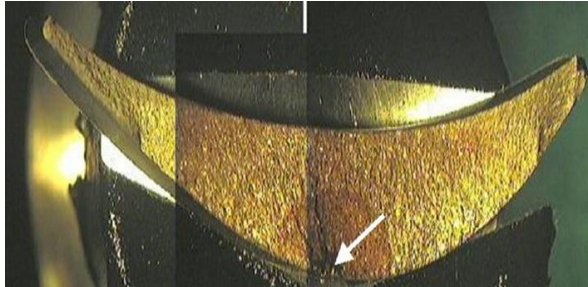
The origin of fatigue is so clear and at the convex area of airfoil (see Fig.6). The figure also clearly demonstrates that the blade fractured rapidly after the progress of the fatigue crack up to 72% of the cross section area.

Fig.6
Overview of the fractured surface and the crack initiation site by stereoscope.

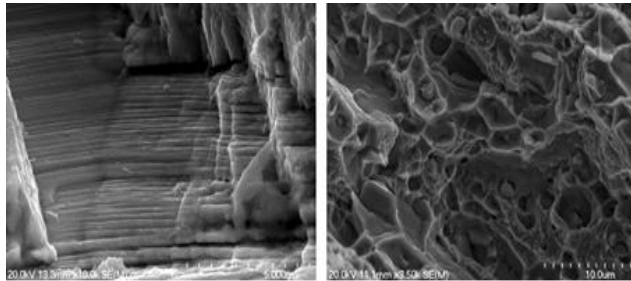
In order to examine the fractured surface in detail FE-SEM was used. As presented in Fig. 7, tiny striations and dimples are present. As the striations are frequently observed on the fatigue-cracked surface and dimples on

Fig.7
FE-SEM inspection of fractured blade: (a) striations and (b) dimples.

The instant-fractured surface as well, we can strongly conclude that blade had an experience of high cycle fatigue (HCF) from the small striations. HCF failures are unusual in the rotating part of turbine engine, unless some FOD initiates by the ingested debris or a manufacturing fault is present [31, 47].

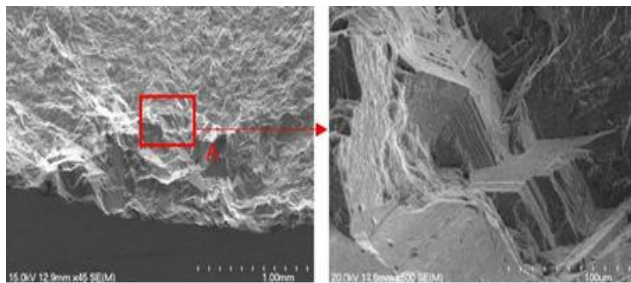
The FE-SEM fractograph of the crack initiation site, as presented in Fig. 8, shows a feature of the cleavage-like fracture. Generally, cleavage-like fracture is often observed on high-cycle, low stress fracture but unusual in low-cycle, high stress fatigue [22, 31, 32]. In stage II (region B) fatigue, crack marks such as fatigue striations may be appeared.

Fig.8
FE-SEM fractographs of a fractured blade: (a) overview of the crack initiation site and (b) cleavage-like fracture (magnified region A).

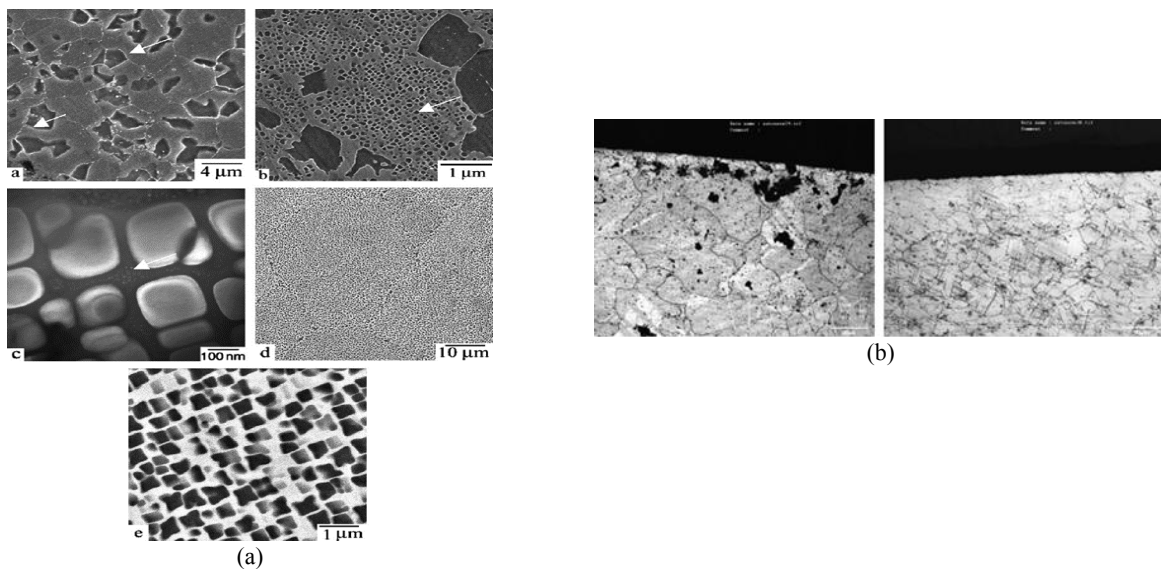
Fig.10

The microstructures of the blade fractured and the normal blade, as presented in Figs. 10(a), 10(b), are taken from a confocal laser scanning microscopy. It is shown clearly that different sizes of shape, black colored, are concentrated on the edge of blade where the fatigue crack initiated. Also, the grain size of the failed blade is larger than that of the normal blade and the grain has a distribution of various sizes. The microstructure shown in Fig. 8(a) usually appears in the part that is treated by the improper manufacturing process.

a) Microstructure of subsolvus and supersolvus processed. b) Microstructure of blade: (a) fractured blade and (b) normal blade.

1. Increase the radius of the lower slot of the serration fitting.
2. Change the dimensional tolerance of the dovetail-rim area of the turbine to unload the critical zone of the 3rd lower slot of the disc.
3. Proper manufacturing process (i.e., appropriate heat treatment)

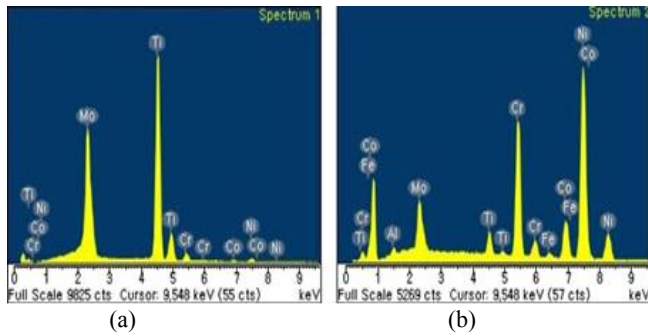
Using a FE-SEM, EDX analysis in this area has performed and indicated that lumps are composed largely of Ti and Mo as presented in Fig.11(a). The analysis of the normal part, also, shows that its component is consistent with the base material and matches well with its compositions as indicated in Fig.11(b). So it is reasonable to assume that the components of Ti and Mo were formed into segregation at the voids by the unknown reason and then the segregations of Ti and Mo were removed leaving the voids behind during the polishing process. Due to the stress concentration on the segregations near the blade surface, crack is initiated. And this crack begins to progress, then results in an instant-fracture of the overall section.

Fig.11 Micro-chemical analysis of different location by EDX: (a) segregation area and (b) normal area.

Also, the origins of internal fatigue in some materials were attributed to the presence of inclusions [36]. Boyd-Lee showed that crack initiation occurred either within mode II slip bands or within brittle Titanium carbides in the Ni-base super-alloys. Also, he showed that the latter is much easier than the former [37,38]. At the fractured blade, crack initiated at the subsurface or close the surface because of the segregation showing that Ti and Mo segregations act like inclusions.
