Evaluation of Damage Problems in the Water Pump Components of an Air Compressor Cooling System: a Case Study

Abstract

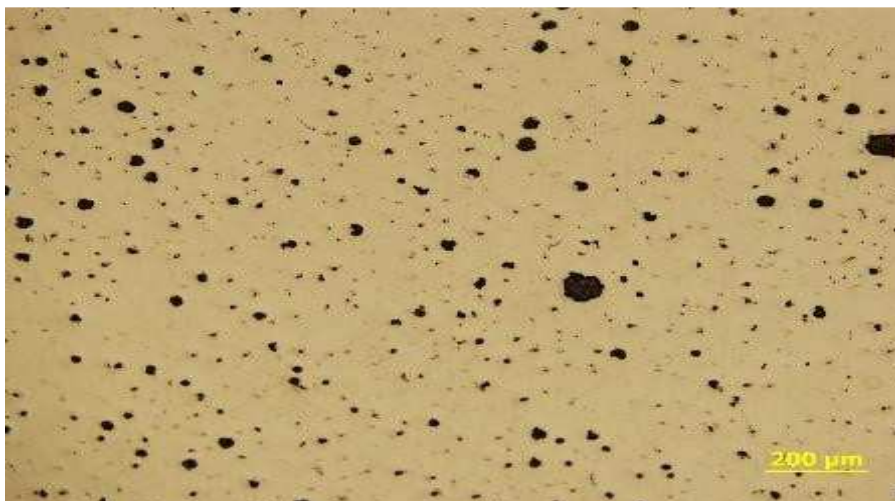
Examination of microstructure of metallographic samples showed that the pump casing has a uniform distribution of spherical graphite (Figure 2) and the pump impeller has a random distribution of graphite sheets in the field of ferrite – pearlite.(Figure 3, 4)

Figure2. Spherical graphite with almost uniform distribution of the sample metallographic taken from the pump body

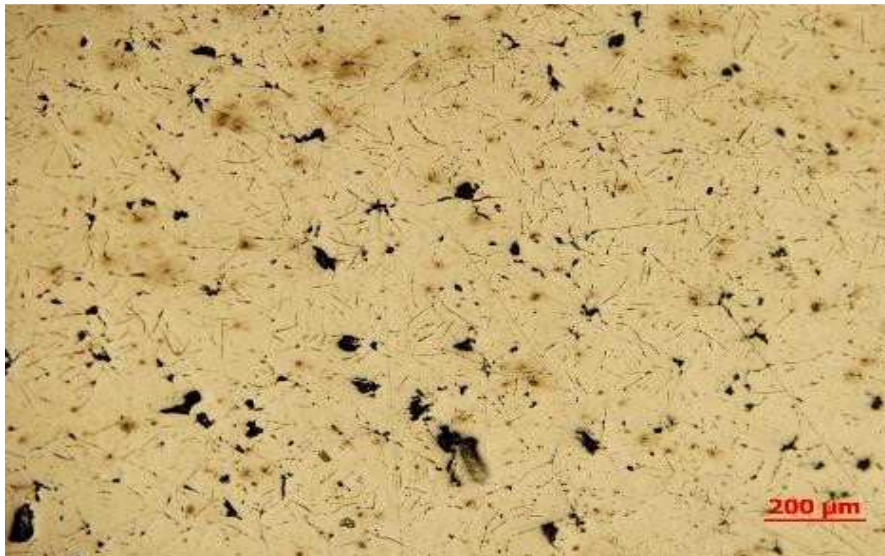
Figure3. Graphite of sheets representing grey cast iron used in the polished sample pump impeller

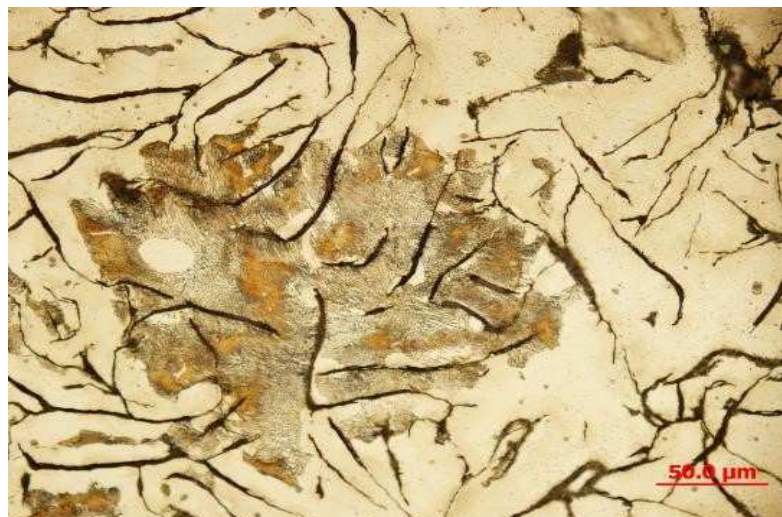
Figure4. Graphite sheets in sample ferrite-perlite structure taken from the pump impeller (affectation picral affectation)

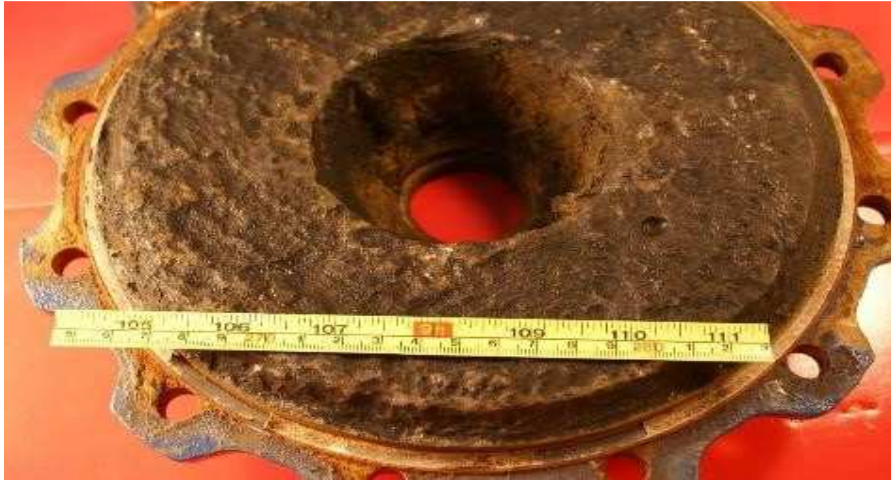
In some parts of the microstructure, porosity of the casting process also is observed to a limited extent. Severe corrosion along with thickness reduction is evident in some of the interior components of the pump.

In addition to reducing the thickness, sediment accumulation and corrosion products on the components are visible as shown in Figure. 5.

Figure5. Damage and the formation of deposits on the inner cover of the pump

The presence of corrosive factors such as chlorine ions in water used in the air compressor of the cooling system in which chemical analysis of the sediment and corrosion products also uncovers the role of these factors can be considered. It seems that in this regard, focusing more on quality of used water and adapting its characteristics to the conditions in manufacturer's instructions will be necessary.

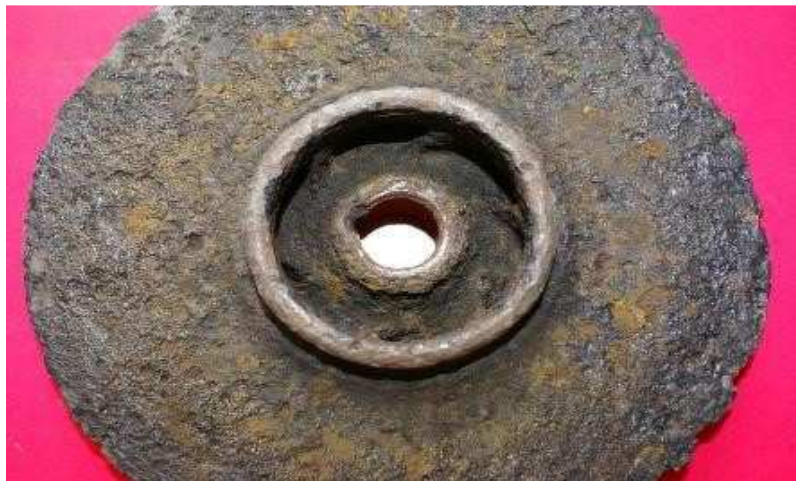
The damaged pump impeller is coated by black, brittle, fragile, and quite porous deposition. (Figure6)

Figure6. Corrosion and destruction of water pump impeller of the cooling system air compressor

According to studies, particularly considering the results of structural evaluation and chemical decomposing of the sediment, the type of impeller damage is graphite corrosion. Graphite corrosion is categorized as selective corrosion.

A solution that is often used to prevent corrosions such as graphite corrosion is proposed to replace the alloy. It is essential that the phenomena and damages such as selective separation occur due to specific metallurgical structure of some alloys. Therefore, by changing the conditions of this type of alloy, such damages will reduce probably. For example, replacing gray cast iron with other white cast iron reduces the risk of this phenomenon strongly. However, in terms of reducing, it is discussed with regard to significant corrosion in other system components. It is very important to conduct these strategies more carefully.

The white cast iron is very hard machining alloy and if this alloy be used, the cost of pump gets high. In general, white cast iron is used when erosion is important. But, when the corrosion is important, the alloy such as stainless steel is usually used (such as AISI 410, 420).

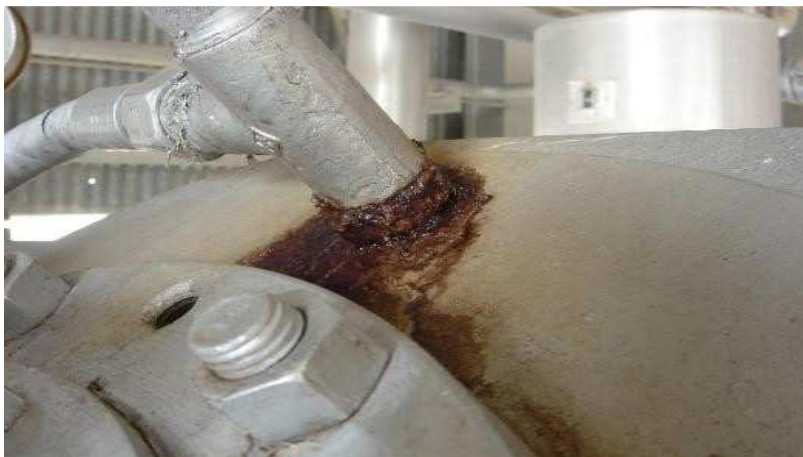
Due to the fact that cooling system alloy tubes are made of stainless steel, therefor corrosion in the pipes has to be seen significantly. Most fractures are gathering at the junction of the plain carbon where steel coating is used as shown in Figure 7.

Figure7. Corrosion at the junction of cooling water system to the compressor

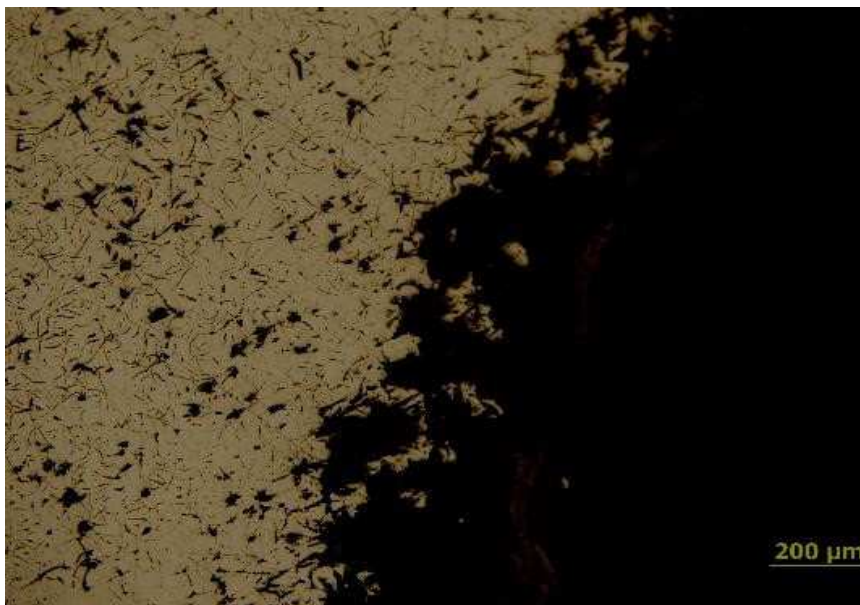
As shown in Figure.8, the collapse of the graphite cast iron grids and formation of black and porous layer and also formation of corrosion products that in some areas include up to half of the thickness of the sample is evident.

Figure8. Separation of cast iron from iron and leaving the black graphite layers on the surfaces of the pump impeller, when polishing the sample

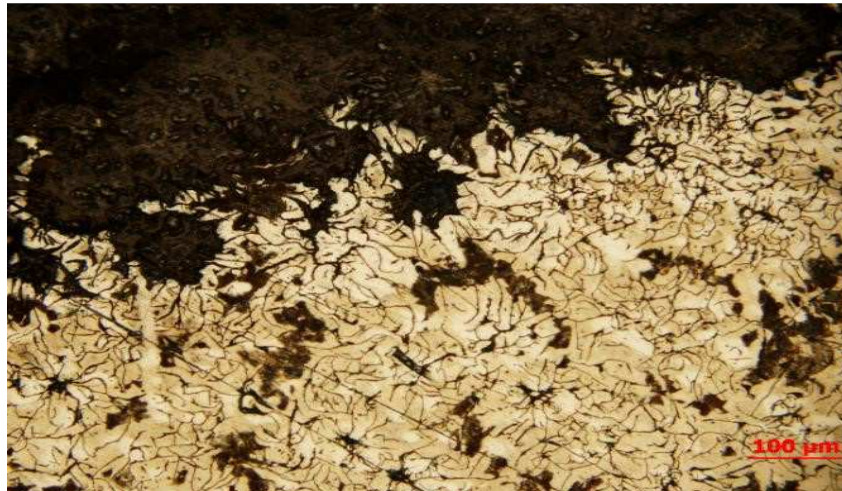
By focusing on the corrosion areas and enlarging in microscopic examination, exacerbated corrosion in the contact Ferrite- pearlite and graphite-free complex network of rail network Graphite or iron sulfide remain detectable impurities. In metallographic samples taken from the

Figure9. Iron-free areas because of graphite corrosion

At the surfaces of the pump impeller, the intensification of corrosion at the contact point of the graphite with the ferrite – perlite network is discernable marked places.
