# Lifelines Performance of the Mw 8.8 Offshore BIOBÍO, Chile Earthquake

Alex K. Tang\*

## Abstract

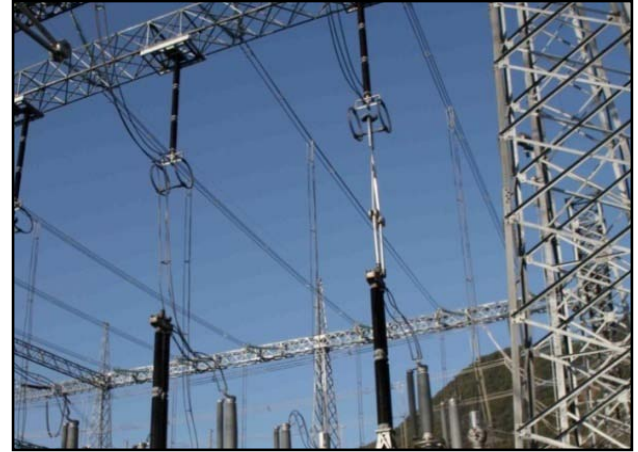
system redundancy. While much of the equipment is the same as that found in North America, Chile makes extensive use of pantograph disconnect switches and candlestick live-tank circuit breakers, which are used sparingly in the earthquake zones of North America, Figure 2. More than 25 failures occurred but that these failures represented a small percentage of the inventory. A couple of towers crossing Biobío River collapsed.

Fig. 2. Candlestick style disconnect switch (Kwasinki photo)

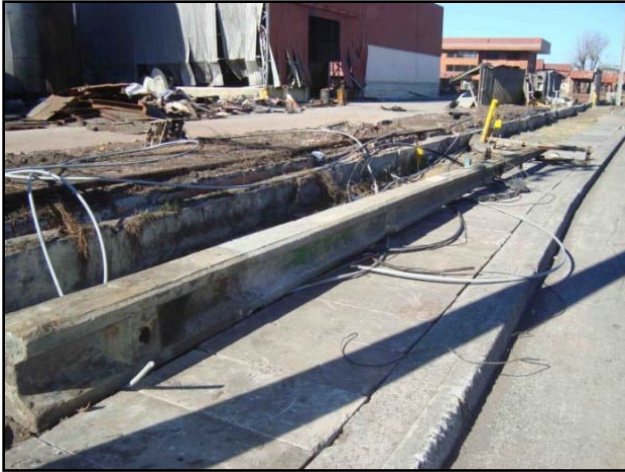
The low voltage (34.5 kV and below) distribution system sustained minor damage due to collapsed buildings and damaged poles. The hardest hit regions were Region VII (Maule) and Region VIII (Biobío). One power company had to replace 450 poles and lost 1,500 poles out of an installed base of 759,000, and 82 transformers out of 50,109. Most of these losses were in the tsunami areas. Most of the distribution system damage was a result of building collapse where drop wires were severed or buildings damage the poles.

Two weeks after the earthquake, the distribution system service was restored. Figure 3 shows a typical damage to the distribution system.

Fig. 3. Typical power distribution system damage

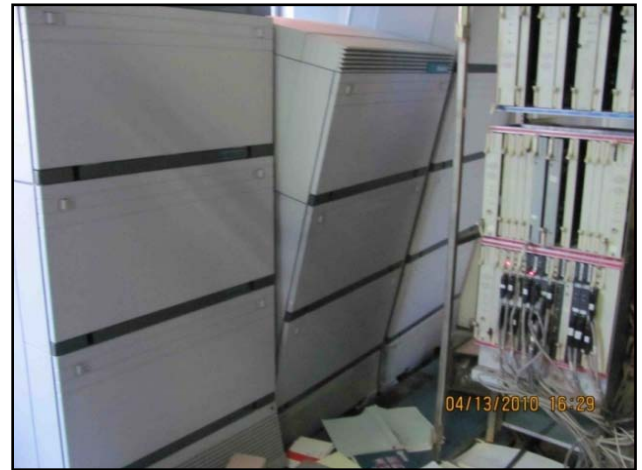
In one CO a backup generator failed due to transfer switch malfunction, which was used to power the air conditioner. This caused overheating of electronic components that resulted in equipment failure.

CO equipment damage, backup generator malfunction, battery damage, and power outage resulted in sporadic service disruption. Figure 4 shows switching equipment damage in a CO in Concepción. Landline system was restored within three days after the earthquake and most of the fixes were temporary. Full restoration will need months.

Fig. 4. Switching equipment damaged in a CO in Concepción

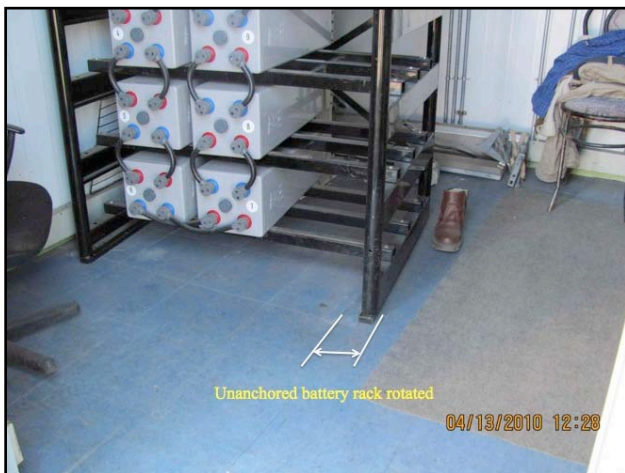
About 70% to 80% of the cell sites in Regions VII and VIII had problems with either equipment or antennas damage. This rate falls to about 50% in Region V (north of Region VII). Equipment in BTSs is not anchored, Figure 5. COs and MTSOs have seismic designed equipment. Fallen perimeter walls or nearby structures collapse affected operation in many BTS sites. Collateral damage to BTS antennas occurred in many locations, Figure 6.

Fig. 5. Unanchored equipment in BTS

Collocated facilities damage happened in most earthquakes, redundancy and dispersed routes should be developed to reduce the loss of service. Anchoring equipment is one of the lowest cost practices to reduce equipment damage. Either extend the battery power supply duration or provide backup generator power should be considered in all BTSs.

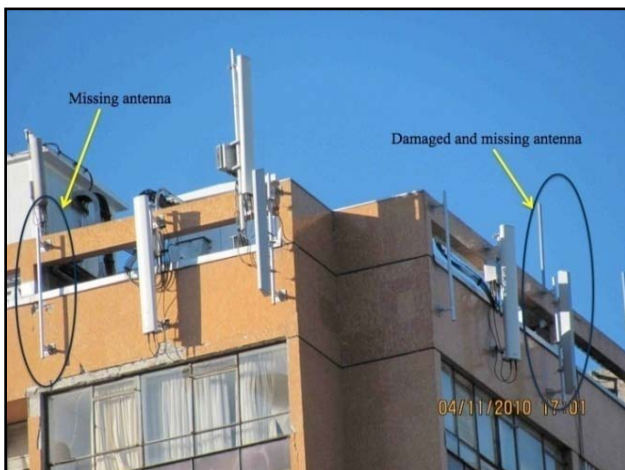
Fig. 6. Collateral damage to BTS - the building is condemned

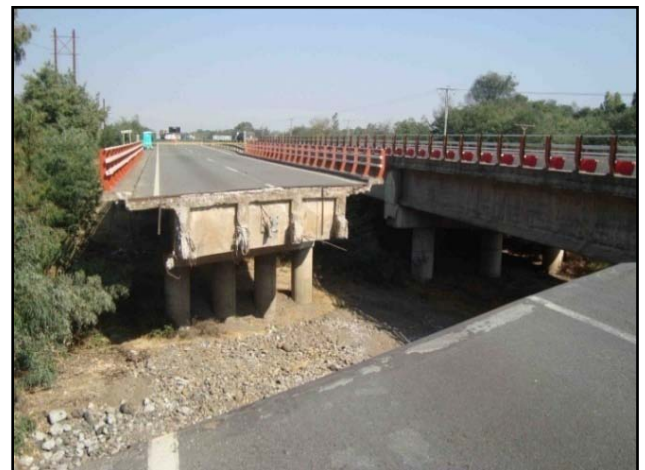
Both roads and bridges damage were significant. More than 300 bridges in the earthquake-impacted area sustained various degree of damage. Along Hwy #5 there were 5 collapsed bridges between Santiago and Chillan, Figure 7 shows a collapsed bridge along Hwy #5. Even in Santiago there were a few overpasses collapsed. Almost all bridges in the tsunami areas were destroyed. In Concepción the three main bridges that cross Biobío River were damage, one was open using a bailey bridge for the collapsed section, Figure 8. The other two were closed to traffic causing congestion during rush hours.

Fig. 7. Hwy #5 bridge collapse, south of Linares

Failure of many bridges may be due to insufficient detailing of joints to develop a load path to the super structure and eventually to the foundation. New bridges with skewed supports failed and old bridges, adjacent to the failed bridge, with no skew remained standing.

Many bridges should have been designed to provide full serviceability following a major earthquake as experienced in Chile.

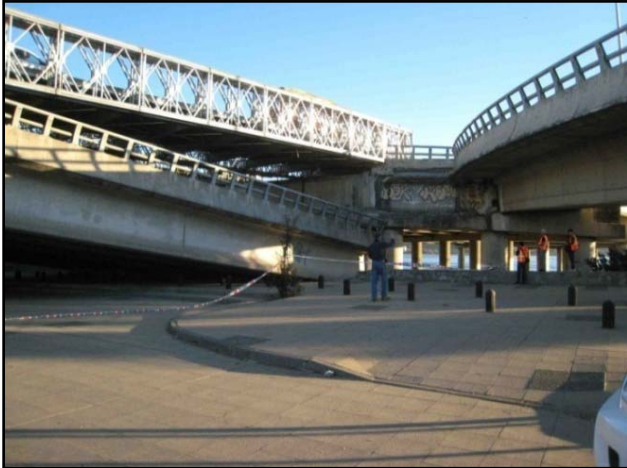
Fig 8. Juan Pablo Bridge - bailey bridge installed as a temporary fix

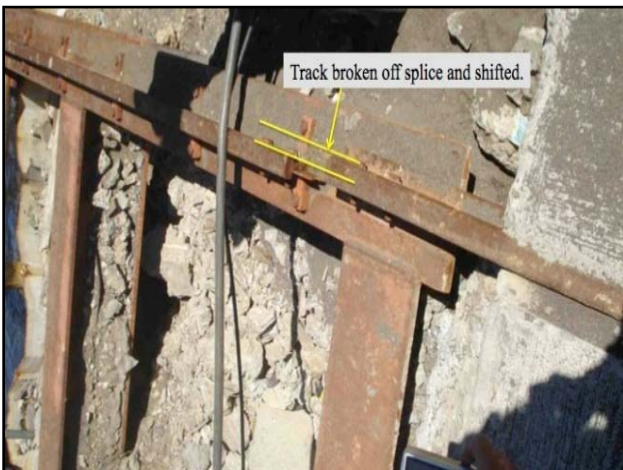
There was minor damage to railway tracks that run along Highway 5, Figure 9. The electric powered cars

Fig. 9. Damage to railway track (Eidinger photo)

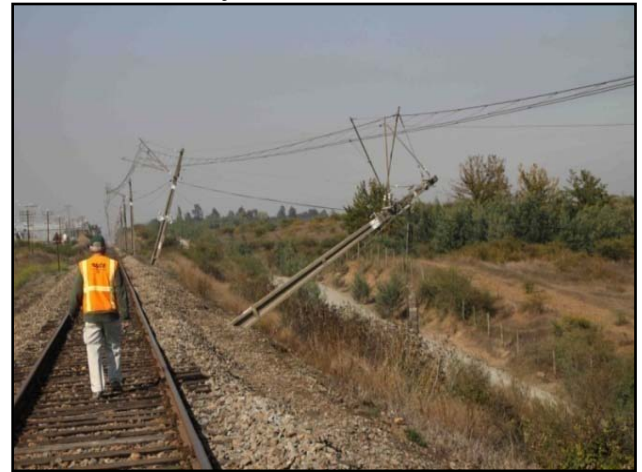
were not operating due to power distribution system failures, Figure 10. A few sections of the railway track had fallen power poles. One of the URM train stations was damaged. It was reported that several of the older adobe stations in the effected regions require significant repairs. Train service between Santiago and the south was not operating in April two months after the earthquake. However, the local commuter trains in Concepción were operating.

Fig. 10. Damage to power poles for railway trains (Eidinger photo)

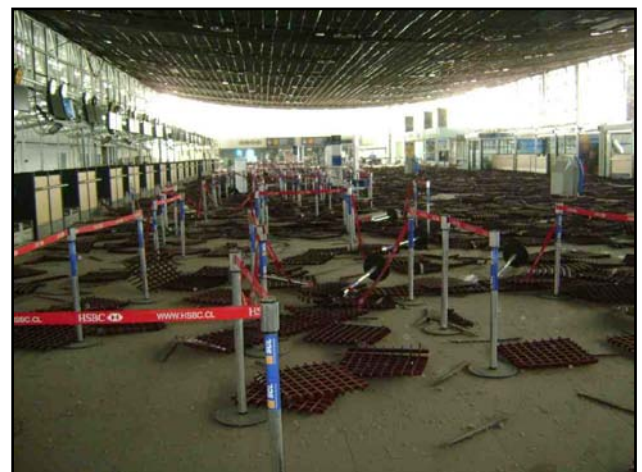
Santiago (Arturo Merino Benítez) International Airport passenger terminal building was close for a week due to extensive non-structural elements damage on both floors, the departure and arrival floor. In the departure hall (about 300 x 60 meters) about 90% of the ceiling tiles fell, Figure 11. A few pipes in washrooms were broken. Many overhead light fixtures were damaged. HVAC equipment and ducts were shaken loose from the ceiling and fell. A few glass windows were broken or shaken loose. The only structural damage was two catwalks connecting the

Fig. 11. Non-structural damage inside Santiago International Airport terminal (Public Works Chile photo)

Non-structural elements in airport terminals should be installed with good seismic designs to prevent damage that cause disruption.

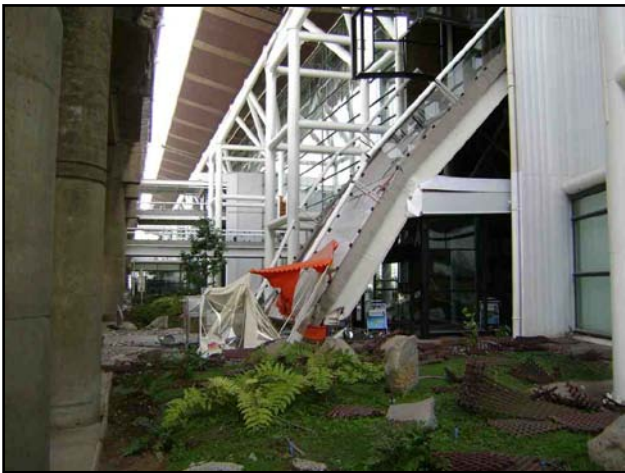
terminal building to the overpass collapsed, Figure 12. If the earthquake happened during peak occupancy of the terminal, many injuries and casualties could have resulted from these fallen objects.

Fig. 12. Damage of overpass connected between the terminal and the raised access road (Public Works Chile photo)

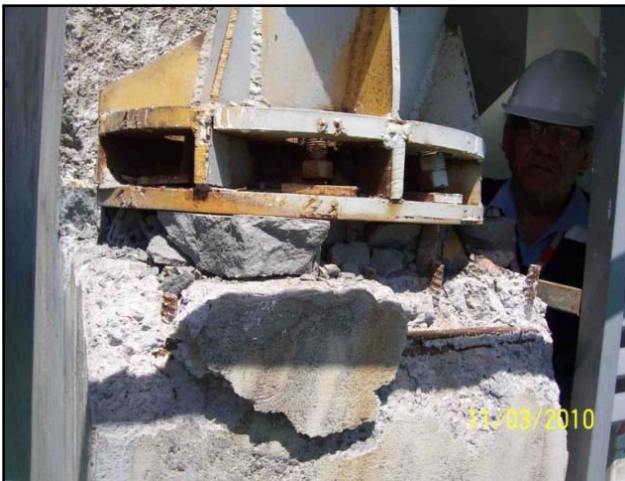
The mounting pedestal of the steel frame that connects the cab of the control tower to the concrete structure was damaged; the anchors were too close to the edge of the concrete pedestal, Figure 13. Due to strong shaking the equipment in the cab was damaged. One wood equipment cabinet that was anchored to the concrete floor was sheared off at the base. Only two glass windows were broken. The traffic control has been relocated to the secondary control tower until the main tower is repaired.

Fig. 13. Control tower cabin anchor points damaged due to short edge distance

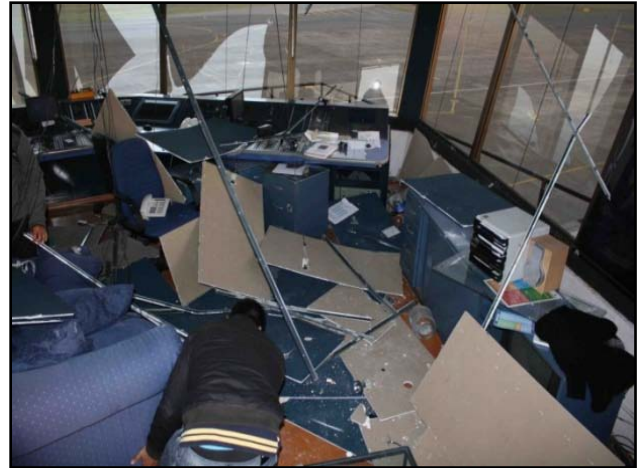
The control tower of this airport had a few panes of glass windows broken (Figure 14) and some equipment on the desks fell over the counter top. An HF communication system was dispatched from Santiago International Airport as a backup communication system, but before it arrived the communication link was up. There was no commercial flight for 10 days after the earthquake. The

Fig. 14. Broken glass windows of Concepción (Carriel Sur) International Airport control tower (Public Works Chile photo)

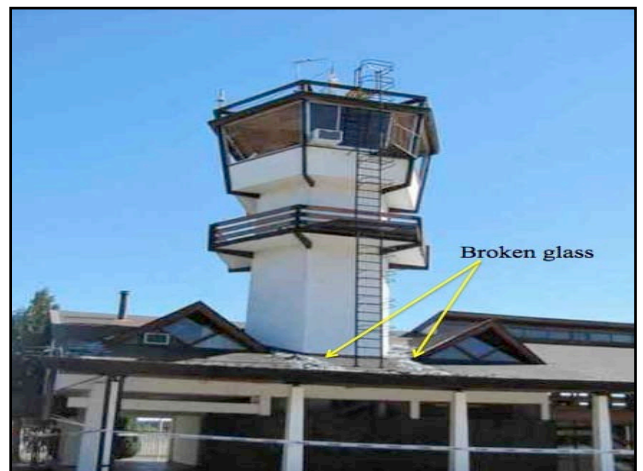
Fig. 15. Los Angeles Airport control tower

This is a small commuter flight airport that serves the Los Angeles area. It was close to all flights except relief supply flights. According to the airport director, the airport will not be open until the control tower and the terminal building are fixed. There was extensive damage to the control tower (Figure 15). The terminal building a wood construction and the damage was limited to glass on door and windows. A few light fixtures were damaged.

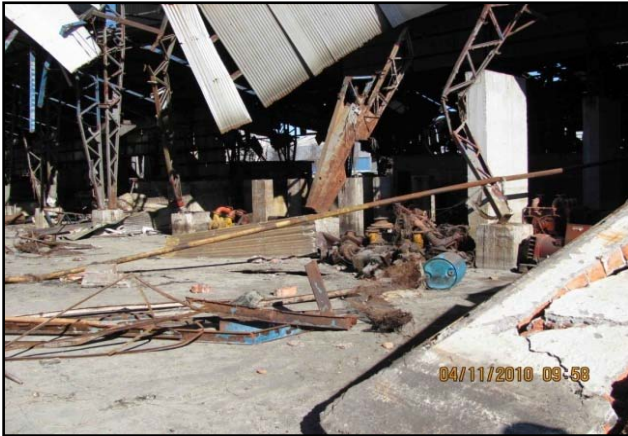
Isla Rocuant, an industrial area of fish processing plants, was almost demolished by the tsunami. The industrial portion of the port was devastated with wave of 4-5 meters high (Figure 16). A fish oil tank was relocated by the tsunami more than 300 meters from its original location (Figure 17). The container-handling portion of the port was not as severely damaged. Depending on orientation relative to the tsunami, some nearby ports suffered only minor damage.

Fig. 16. Fish processing plant damaged by tsunami

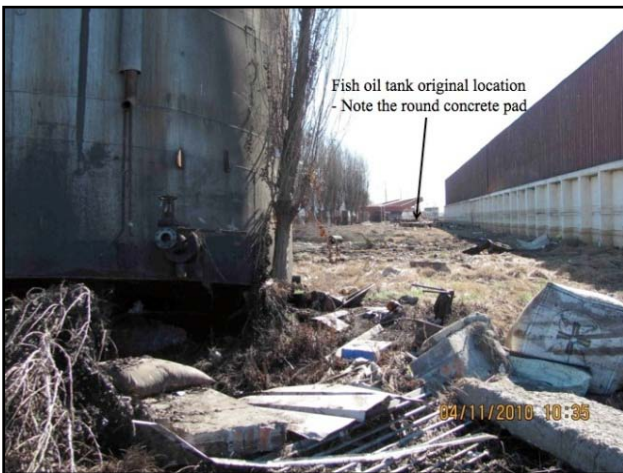
Fig. 17. Fish oil tank relocated by the tsunami

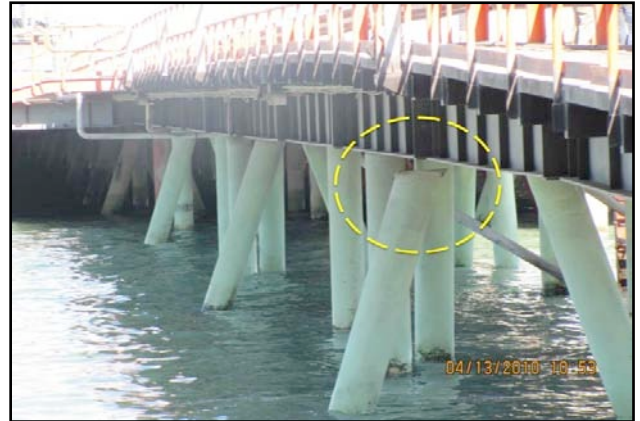
Pier 1 at the Coronel Port sustained significant damage to piles that are close to the shoreline; a few piles had welds completely broken from the bottom of the pier deck (Figure 18). Supporting beams close to the abutment were deformed. Damage observed mainly was due to permanent ground deformation and lateral spreading.

Fig. 18. Coronel Port pier #1 - pile with weld broken off

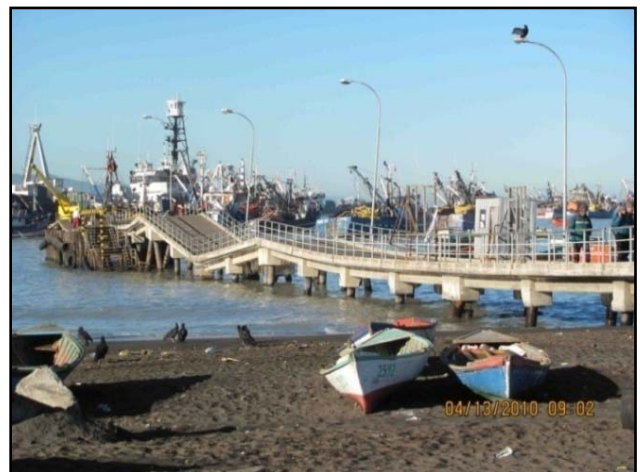
South of Coronel Port, a pier (Lo Rojas) mainly used by the fisheries industry was damaged by lateral spreading and was partially collapsed (Figure 19). The power supply cable for the crane at the end of the pier was severed. It was reported that this pier would be replaced.

Fig. 19. Fishman pier damaged

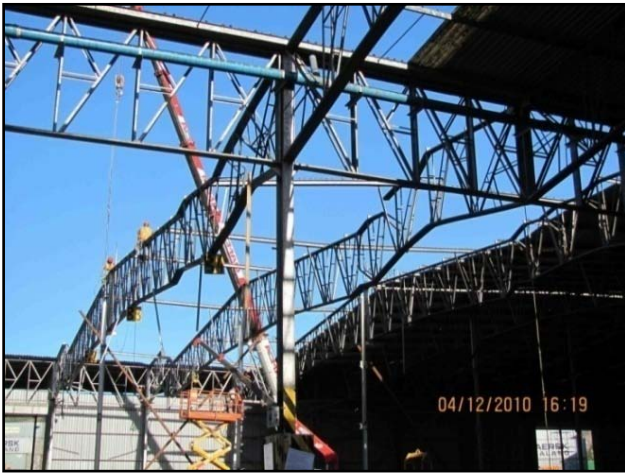
The Lirquen Port sustained very minor damage to the piers. Two warehouses in this port sustained extensive structural damage. In April 2010, one of the warehouses had been demolished, while the largest one was being repaired (Figure 20). Cargo transportation was affected because two railway tracks that routed through the undamaged warehouses were severed in several locations. The severed rail tracks were embedded in concrete and had been snapped longitudinally due to ground deformation (Figure 21). Railway tracks on ties were not damaged.

Fig. 20. Damaged warehouse being fixed

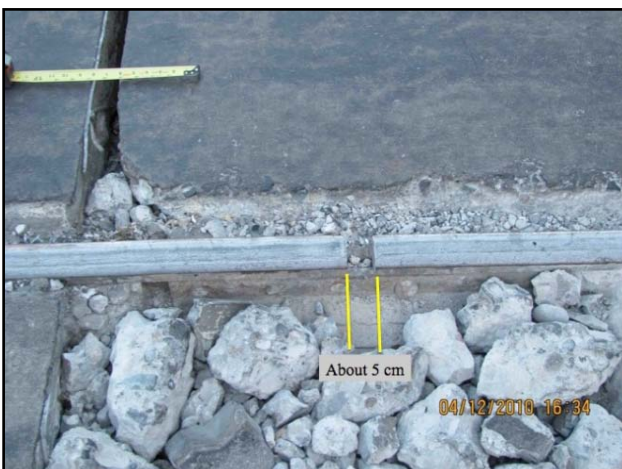
Fig. 21. Severed rail track

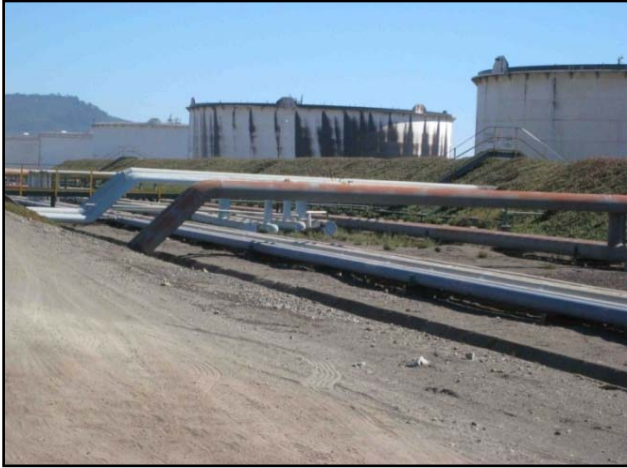
Tank sloshing occurred in floating roof tanks with resulting spillover of product (Figure 22). One floating roof tank developed a leak due to local ground failures.

Fig. 22. Oil leak along the top edge of tank

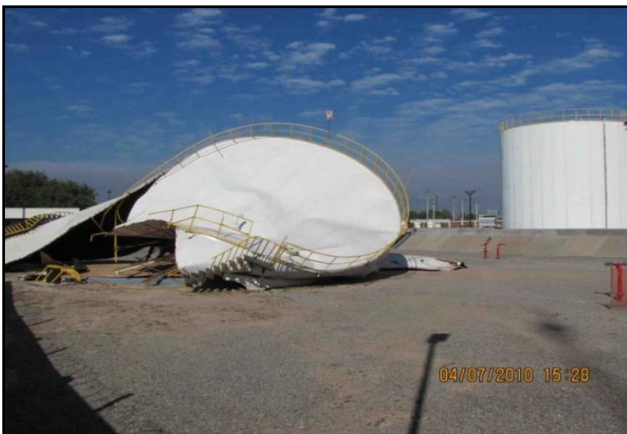
An unanchored 1.4 million-liter welded steel water tank collapsed at the Santiago International Airport due to sloshing (Figure 23). The water is for fire fighting for the airport, and was full at the time of the earthquake. Tank failure was likely due to repeated wall uplifts, and wall buckling.

Fig. 23. Water tank for fire fighting – Santiago International Airport

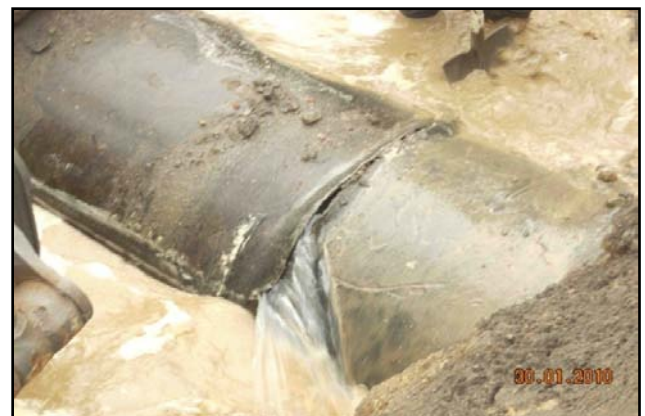
In the Concepción area distribution system, there were 72 breaks and leaks to large diameter welded steel pipes (Figure 24). As of mid-April 2010, about 3,000 repairs had been made to smaller diameter pipes. Prior to the earthquake, the net leak rate was about 40%. The leak rate in April 2010 was about 60%.

Fig. 24. Broken steel water pipe (Essbio)

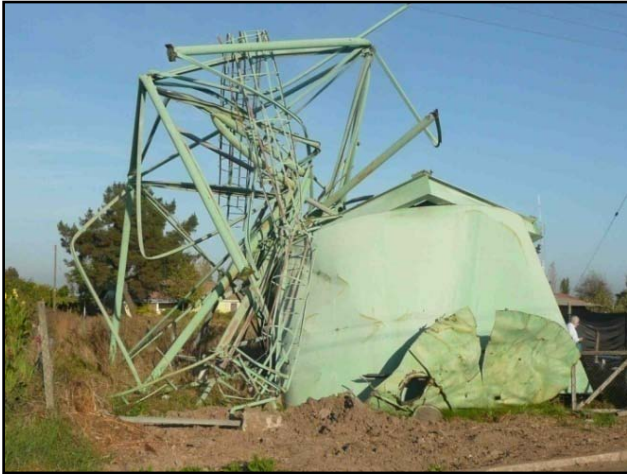
Over the past 50 years, the government of Chile has constructed nearly 2,000 elevated potable water tanks in small rural areas country wide, of which about 420 were in the strong earthquake areas. At least 73 of the elevated tanks completely collapsed (Figure 25). Failures were due to inertial overloads.

Fig. 25. Collapsed water tank (Eidinger)

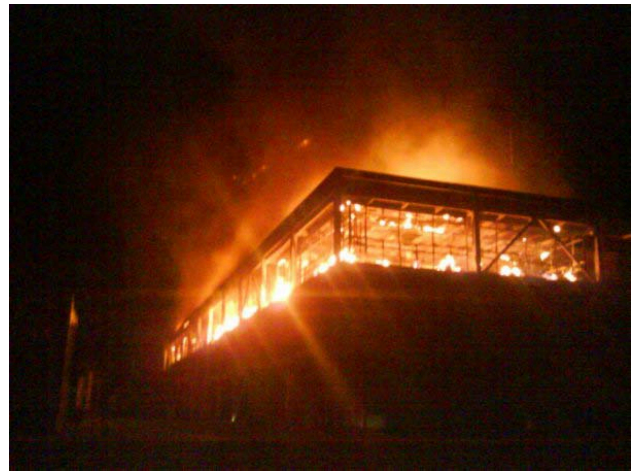
One fire was reported in the Concepción after the earthquake. The fire happened in the Chemical Laboratory of Concepción University, which was burned down (Figure 26). Many research works were destroyed. The lost of water supply might be the cause of the total destruction. There were two other fires reported that had been set by people. Loss of electric power and telecommunication resulted in longer duration to restore service as the utility people use cellular phones (that was not functional for 7 days) to dispatch service crews.

Fig. 26. Burned down chemical laboratory of Concepción University (Concepción University)

The utility should have their own communication system such as radio instead of relying on the cellular phone system that is not under their control.
