Performance of industrial facilities and lifelines during the October 23rd, 2011 Van, Turkey Earthquake

Kiarash Nasseradi^{*a}, Mehran Seyed Razzaghi^b

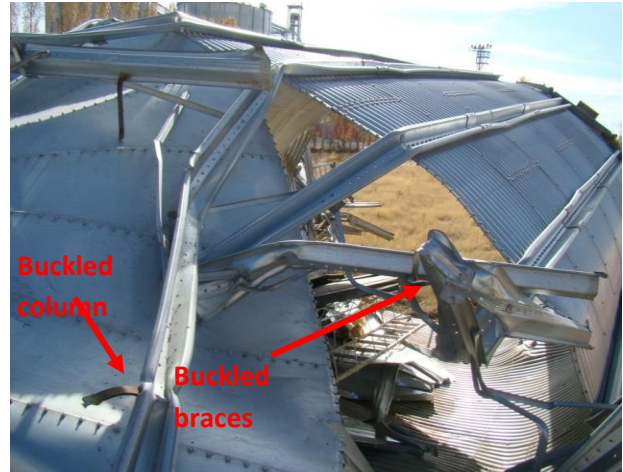
Four types of silos were observed in food industrial plants in an industrial region near Van city. The specifications of the silos are presented in table 1. Following the earthquake several silos suffered damage. All of the observed silos of type “A” and “B” collapsed due to the earthquake (See figure 1). The main reason for collapse of Silo type “A” was buckling of supporting system. As indicated in figure 1 the columns and braces in this type of silos were cold-formed and extremely slender ($KL/r > 120$). Furthermore as indicated in figure 2 the junction of shell and stiffeners strakes was ruptured the main reason for this failure mode is insufficient distance of bolts to the edge of the strake.

Figure 1. Damaged Silo type "A". Buckling of the cold formed column and braces are shown.

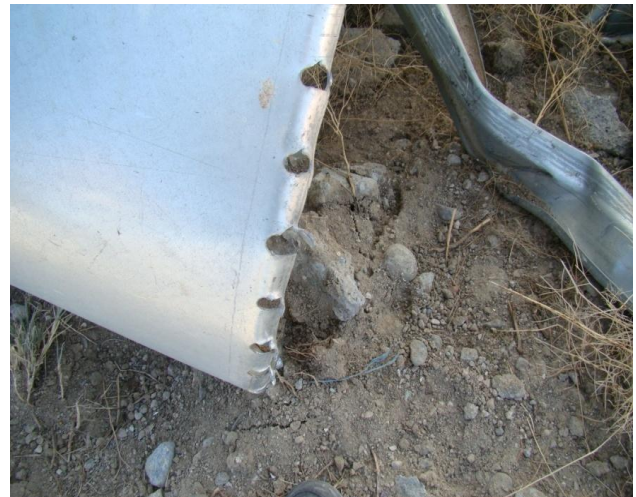
Figure 2. Rupture of shell in junction of strikes

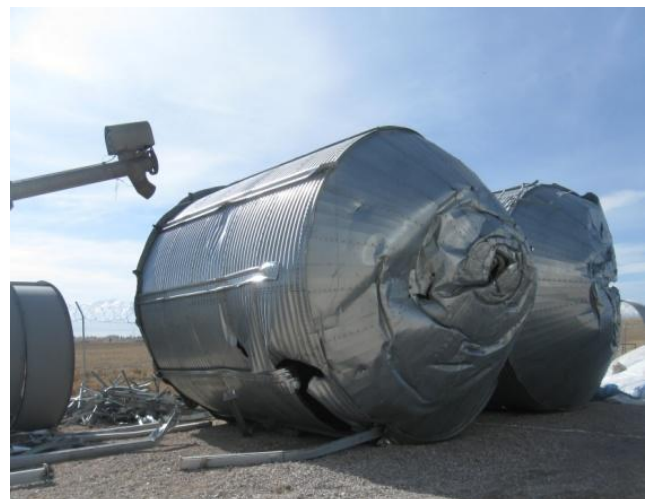
All of the four observed silos of type “B” were collapsed due to failure of cold formed vertical stiffeners of the shell (See figure 3). Local buckling, rupture of stiffener and failure of shell to stiffener connection was three main failure modes of the stiffeners in collapsed silos. Since all of the stiffeners were attached to the supporting system, the silos were felt down after failure of vertical stiffeners. Type “C” is basically type "B" silo but two of them are connected to each other by some ad-hoc connections. These silos suffered slight damage and were operable after the earthquake. As indicated in figure 4, plastic hinges were took place in the columns of silos and connecting truss of this type of silos. Moreover slight local buckling was happened in lower part of one the vertical stiffeners close to the column junction. In Silo type “D”, shell bulge occurred in lowest strike of a cylindrical bin. The silo was repaired and was operable twelve days after the earthquake. As shown in Figure 5, the cement finishing of foundation around the anchor bolts were cracked due to the bin uplift. Type "E" silos, were not damaged.

Figure 3. Collapsed silo type "B".

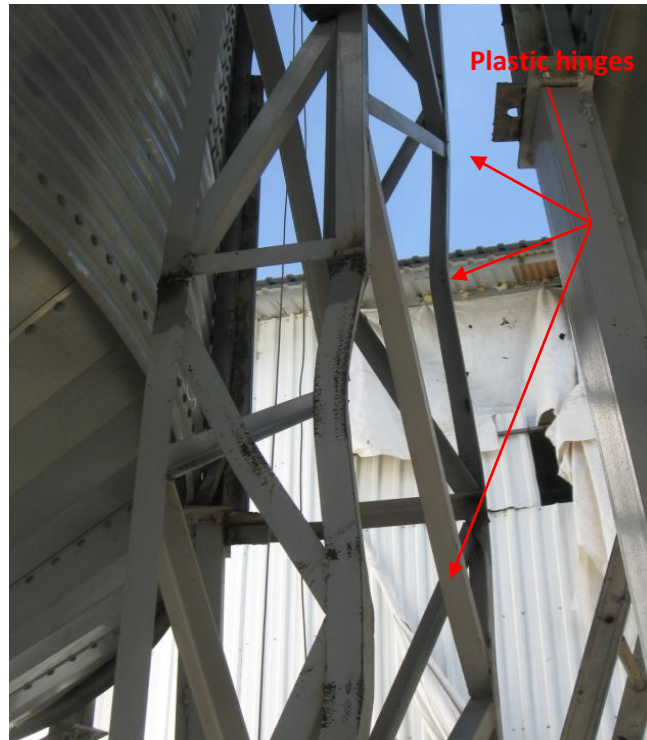
Figure 4. Damage to connecting truss of type "C" silos

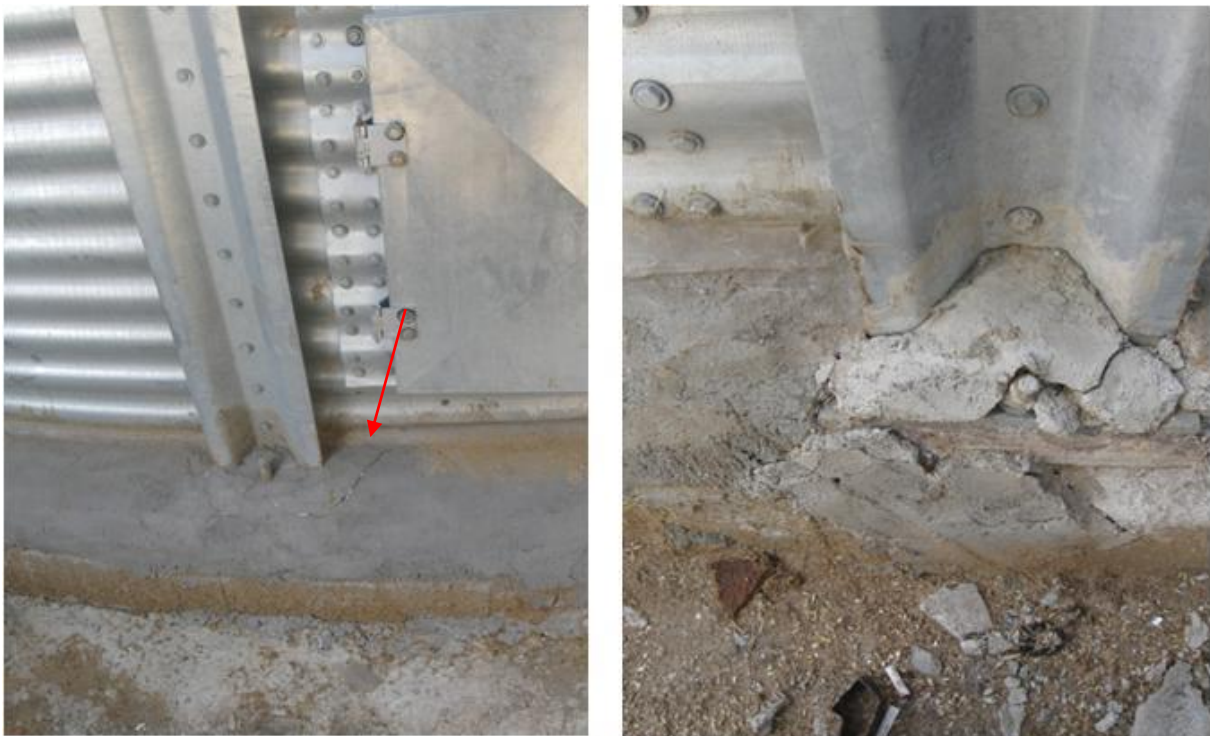
Figure 5. Detail of type "D" silos. Damage to foundation due to uplift of a bin

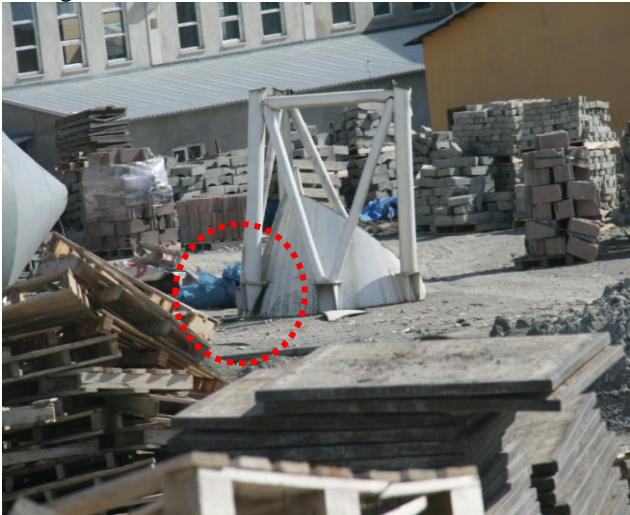
Several cement silos experienced strong ground motion and most of them didn't suffer observable damage. There were two similar cement silos belonging to a concrete factory in an industrial region near van city. One of the silos was full of cement and the other one was 50% full. During the earthquake the silo which was full of cement was overturned and its supporting system and foundation were damaged. The main reason for damage to above mentioned cement silo was failure welding of the shell to column connection in one of the supports (See figure 6). Following the failure of the connection, the silo overturned and one of the columns was buckled. Due to the overturning of the silo its foundation was seriously damaged.

Figure 6. Failure of welds in shell to column connection of a cement silo

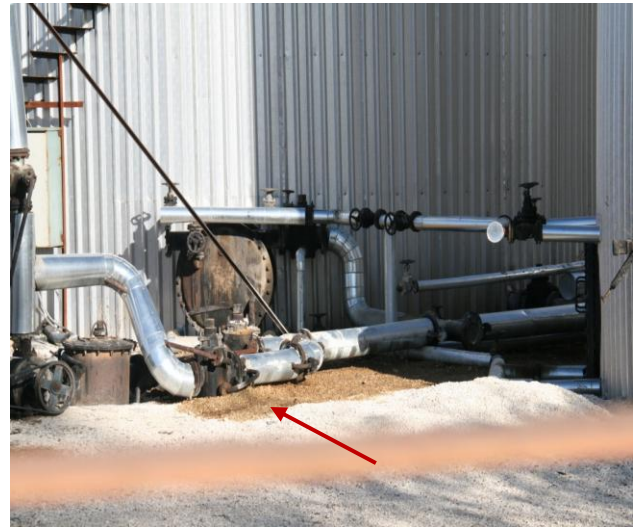
There were three cylindrical fuel storage tanks in a factory in Ercis city. The tanks were interconnected by pipes with several rigid links as shown in figure 7. During the earthquake, the piping connections were damaged and leakage of fuel occurred. The cylindrical tanks were repaired two weeks after the main shock. It seems that the stress concentration and complexity of stress field in piping connection was the main reason of failure of the connection.

Figure 7. Repaired connection of piping system of cylindrical tanks

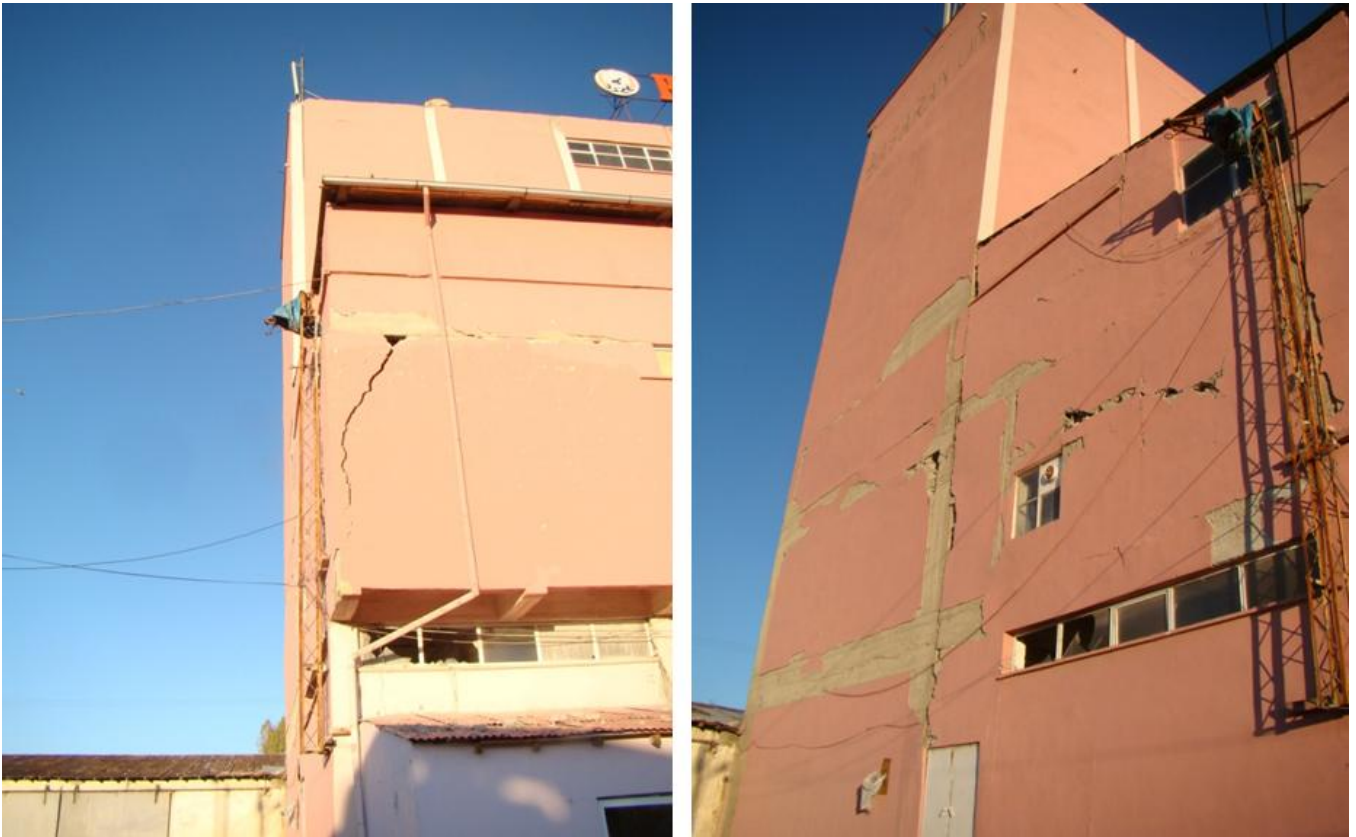
Figure 8. Out of plane failure of masonry infill walls of industrial buildings

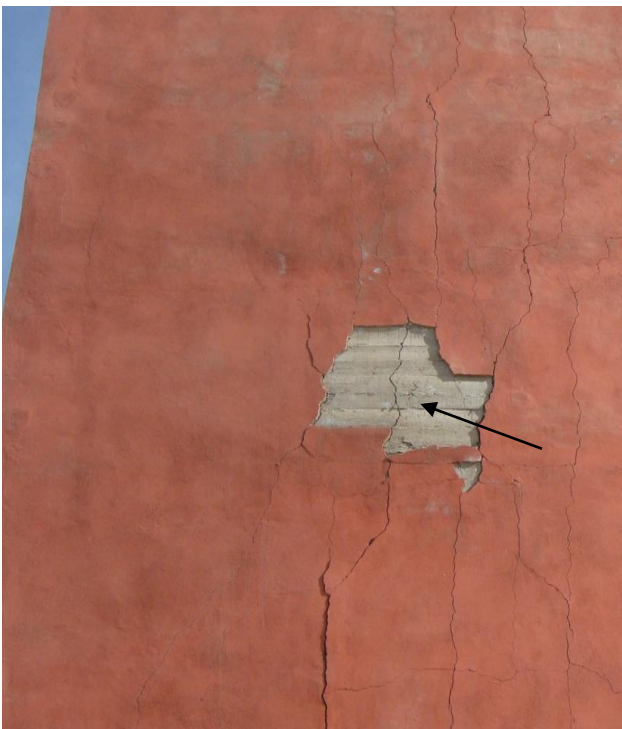
Figure 9. Observable crack in a RC wing walls in a low ductility RC industrial building.

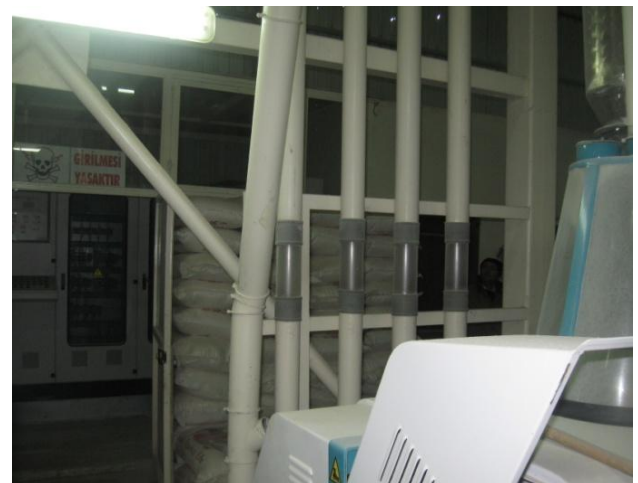
Figure 10. Undamaged pipes with flexible joints

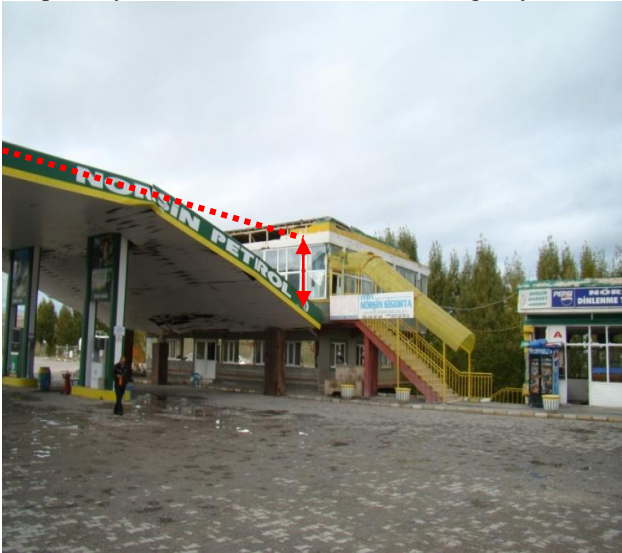
Several gas stations were located in earthquake affected area. Most of them didn't suffer observable damage and were operable after the earthquake. Figure 11 shows a damaged gas station. The light weight roof of the station was connected to a RC annex building before the earthquake. During the earthquake due to lack of anchorage the connection damaged and part of the roof

Figure 11. Collapse of the light weight roof of the gas station

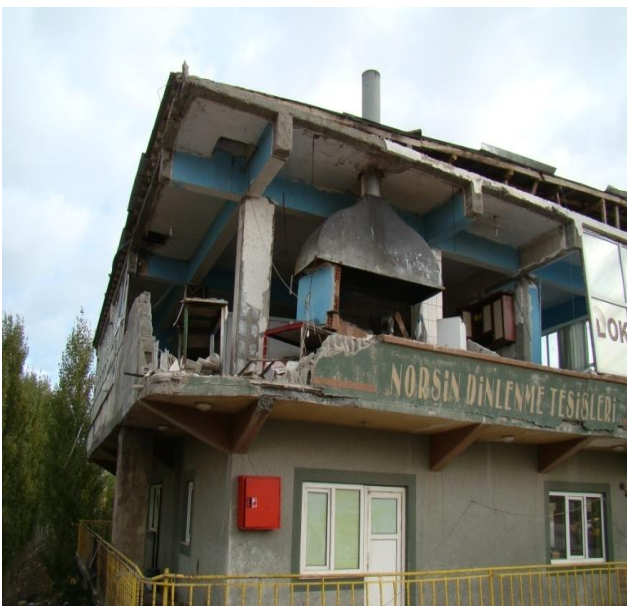
felt down. Moreover as indicated in figure 12 the two story annex RC building were damaged due to the earthquake. Following the seismic event the gas station was not working after the earthquake but some temporarily tanks are located there for emergency uses.

Figure 12. Noticeable damage to annex building of the gas station

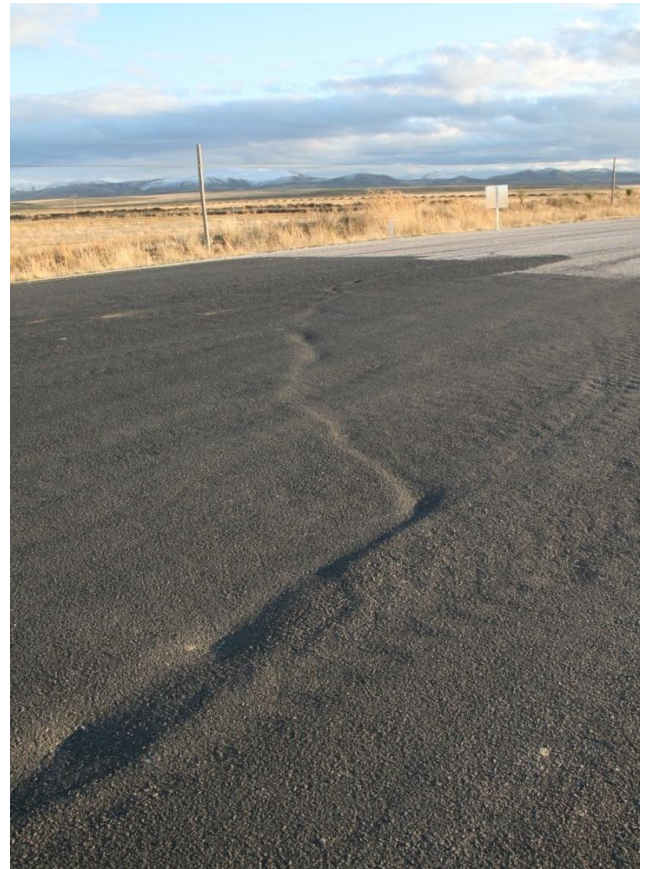
Although roads suffered some damage due to the earthquake, they were serviceable after the earthquake. The asphalt pavement of the Van-Ercis road cracked in several parts of the road due to the fault rupture, geotechnical instabilities and settlement of the bridge abatement. Figure 13 indicates some of the cracks observed in Van-Ercis road.

Figure 13. Cracks observed on road surfaces

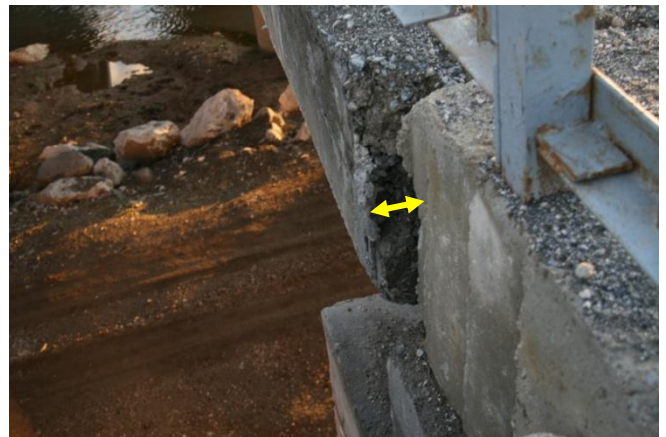
At least two concrete bridges damaged due to the earthquake. Figure 14 shows a damaged bridge in Van-Ercis road. As indicated in this figure, the bridge deck

suffered residual lateral displacement. Moreover pounding of deck to abatement happened due to longitudinal movement of the bridge deck. There was an observable evidence of the sand boiling next to the one of the bridge columns. The bridge was serviceable right after the earthquake. In another bridge, remarkable rotation of pier happened due to the liquefaction but the bridge didn't collapse.

Figure 14. Damage to a RC bridge.

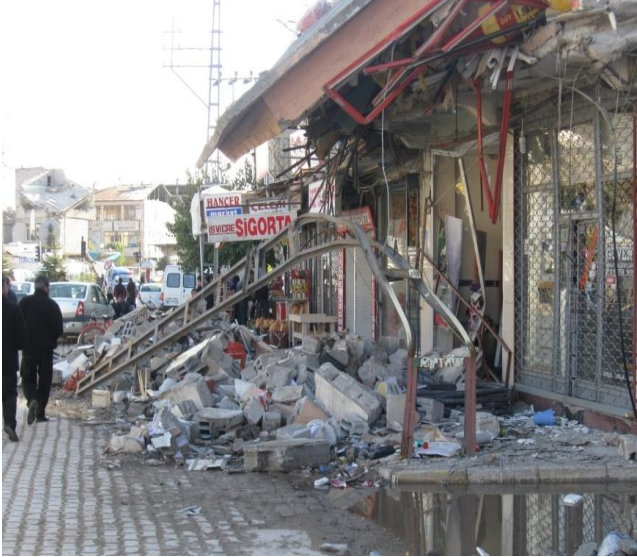
No observable damage occurred in electrical substations. Some electrical poles damaged because of debris from the damaged buildings. Figure 15 indicates one of the damaged electrical poles. In some other poles the connections of cables from poles were cut due to the main shock. Most of them have been repaired twelve days after the main shock.

Figure 15. Collapse of an electrical pole due to collapse of adjacent building
