Physical and Numerical Investigations of Gas Turbine Blades Failure**H.R. Faridi¹, A. Momeni¹, M. Mohammadpour¹, V. Sarfarazi^{2,*}**¹*Department of Materials Science and Engineering, Hamadan University of Technology, Hamadan, Iran.*²*Department of Mining Engineering, Hamadan University of Technology, Hamadan, Iran.**Received: 15 July 2017 - Accepted: 27 August 2017***Abstract**

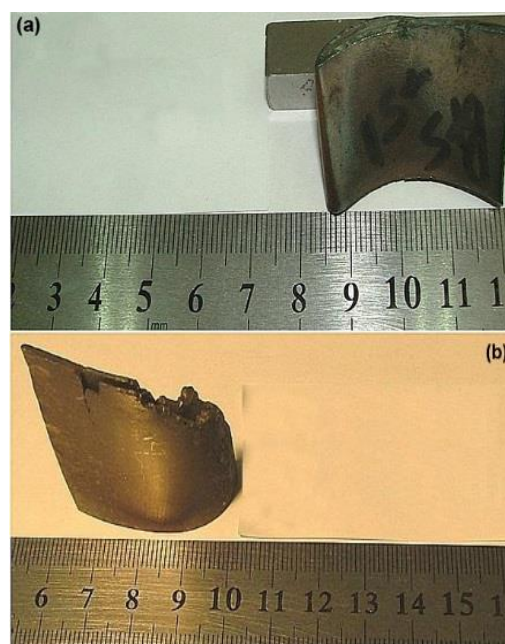
Figs. 1a and 1b show the appearance of the damage occurred in the blades of stage 1 and 2. The visual inspections of the fractured surfaces in the samples showed only mechanical damages. Although the sample of stage 1 shows extensive cracking at the edge, the second sample has failed due to severe surface crack and splitting off the edge. Apparently, the blade of stage 2 may be subjected to high speed impacts which have caused cracking and breaking. It seems there were pieces of hard material separated from a defective first stage blade hit the others causing a chain of reactions to happen, resulting number of broken blades in the first and second stages.

Fig. 1. Visual inspection of the damaged blades of (a) stage 1, and (b) stage 2 of a gas turbine.

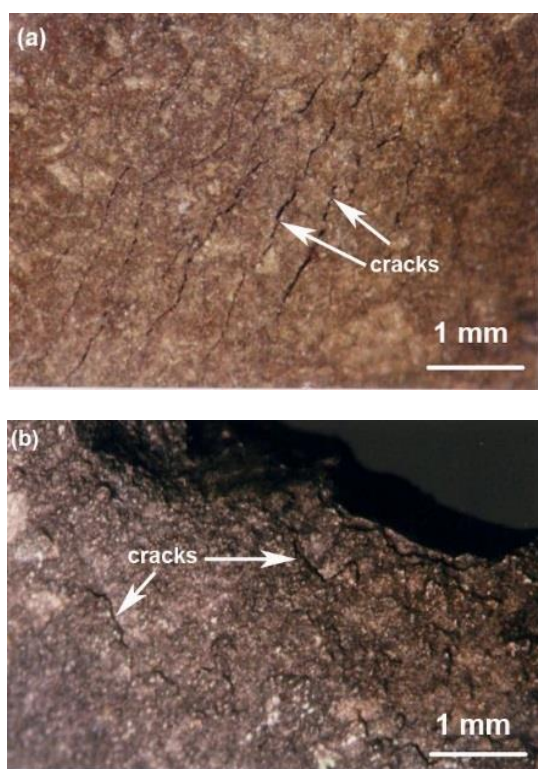
Figs. 2a and 2b illustrate the existence of numerous cracks at the blades tips, which can be associated with thermomechanical fatigue. The magnified images of the blades tips exhibited in Fig. 3. shows that the cracking is accompanied by coating removals, some hot corrosion products. This, in turn, suggests that a combination of damaging factors including fatigue, corrosion and creep may counteract for the failure of the blades.

Fig. 2. Optical micrograph of the damaged blades, illustrating the existence of numerous cracks at the blades tips, (a) stage 1, and (b) stage 2 blades.

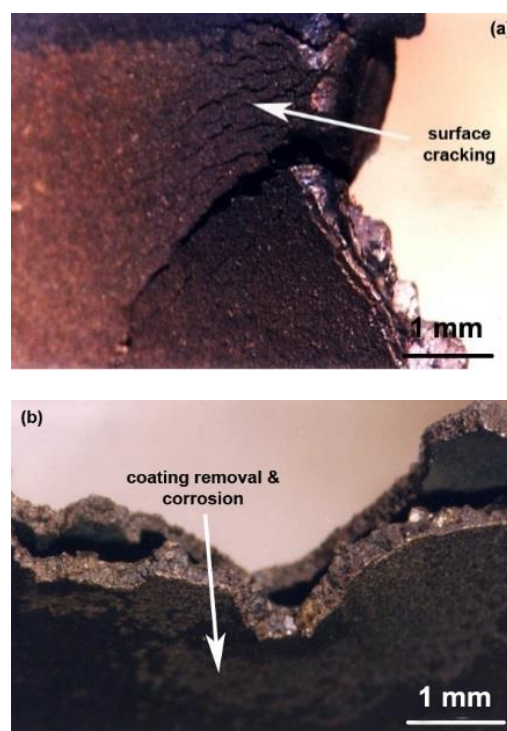
In summary, Figs. 2 and 3 imply that the damage in the second stage sample has been more severe than that in the first sample. This is well understood from more cracks and severe damage of the second sample blade tip. A closer look at the samples by SEM, shows in Fig. 4. , this Fig. shows that only on the second stage sample, traces of severely damaged thermal barrier coating layer on top of a diffusion layer were found. The same damage was not observed on the first stage sample. The damage of the TBC layer presumably due to mechanical hit of small particles separated from the first stage sample or carried by the fuel gas seems to be the starting point. Another issue which can harm the TBC layer is thermal expansion mismatches

Fig. 3. Magnified view of the damaged blades: (a) stage 1, and (b) stage 2.

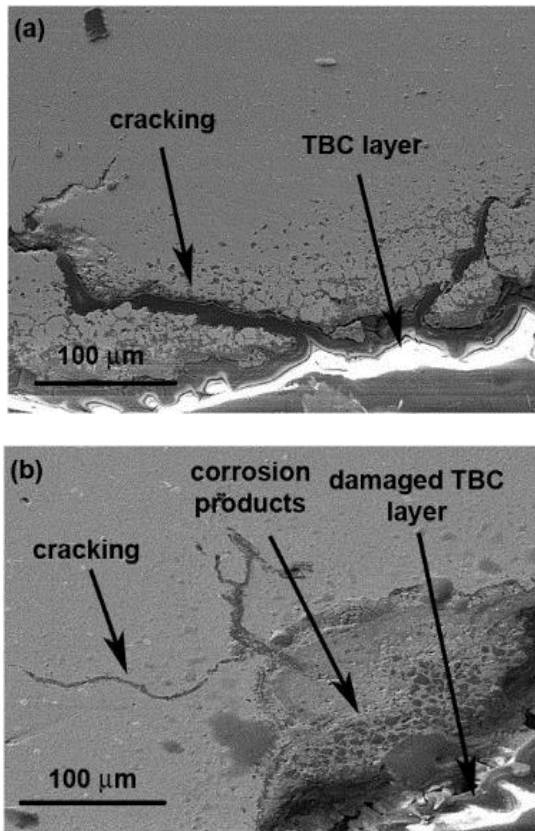
between the coating layers and the substrate, specifically when the blades are suffering excessive heats or frequent shut downs. By local damaging the TBC layer, the underneath layers are subjected to corrosion of oxidation and sulfidation as well as overheating. This, in turn, weakens the underneath layer and facilitate cracking due to thermomechanical fatigue. In case of the first stage sample, this scenario is postponed, because the synergy of corrosion and thermomechanical fatigue is not observed. However, the cracks are still originated from the inter-diffusion layer (under the TBC layer), where the greater thermal gradient present. However, in the case of the first stage sample, the TBC layer has effectively suppressed severe corrosion and only thermomechanical fatigue has caused cracking.

Fig. 4. SEM micrographs of the blade tips of (a) stage 1, and (b) stage 2, showing different cracking mechanisms and TBC layer conditions.

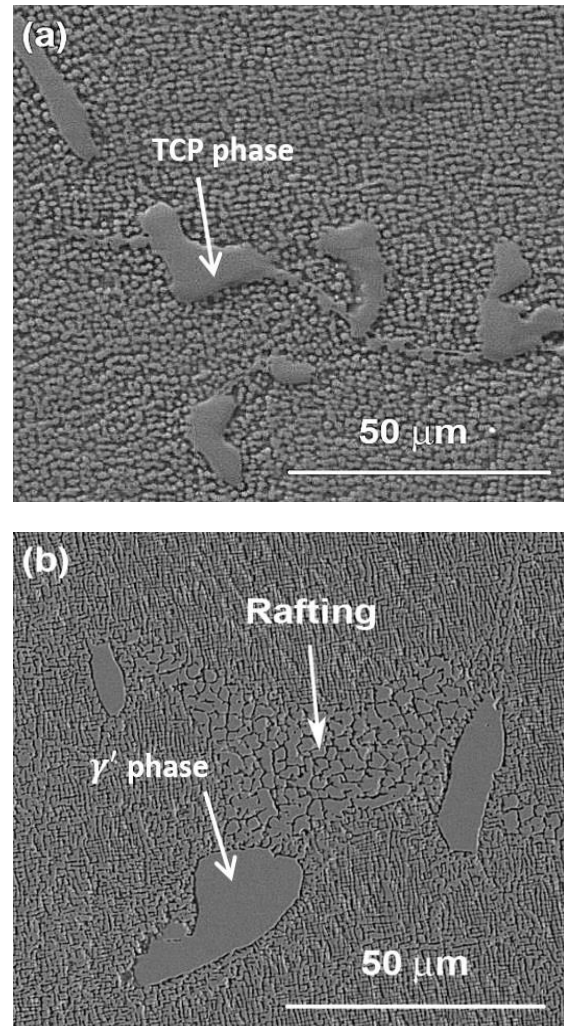
Fig. 5. shows the microstructure of the blades just below the TBC layer characterized by SEM. It is interesting that the observations are in agreement with the previous ones and imply that the sample of second stage (Fig. 5b), unlike to the first stage sample (Fig. 5a) has subjected to more excessive heat. This is elicited from the evolution of γ' precipitates (the cubic-formed precipitates) distributed in the γ matrix.

It is known that creep resistance is dependent on slowing the speed of dislocations within dual-phase structure of γ - γ' . Therefore, it is very important to have a uniform, well distributed fine γ' phase in γ matrix for the superalloys. It has been well known that γ' precipitates tend to coalesce and grow when subjected to heating for a long time. This phenomenon is clearly seen in the second stage sample and is attributed to the mechanical damage of the TBC layer, which has caused the overheating of the layers underneath. The coarsening of γ' precipitates, which is termed as rafting, is a primary step of creep and substantially decreases the strength of the alloy. Therefore, in addition to corrosion and thermomechanical fatigue, creep should also be taken into account as a detrimental player in the scenario of cracking and damage of the second stage sample. Unlikely, Fig. 5a shows that the uniform distribution and size of the γ' precipitates has remained unchanged in the first stage sample due to the fact that the TBC layer has played its role in making a barrier against excessive heating of the blade.

Fig. 5. Microstructure of (a) first stage sample, and (b) second stage sample, indicating the structure and distribution of γ' precipitates distributed in the γ matrix.

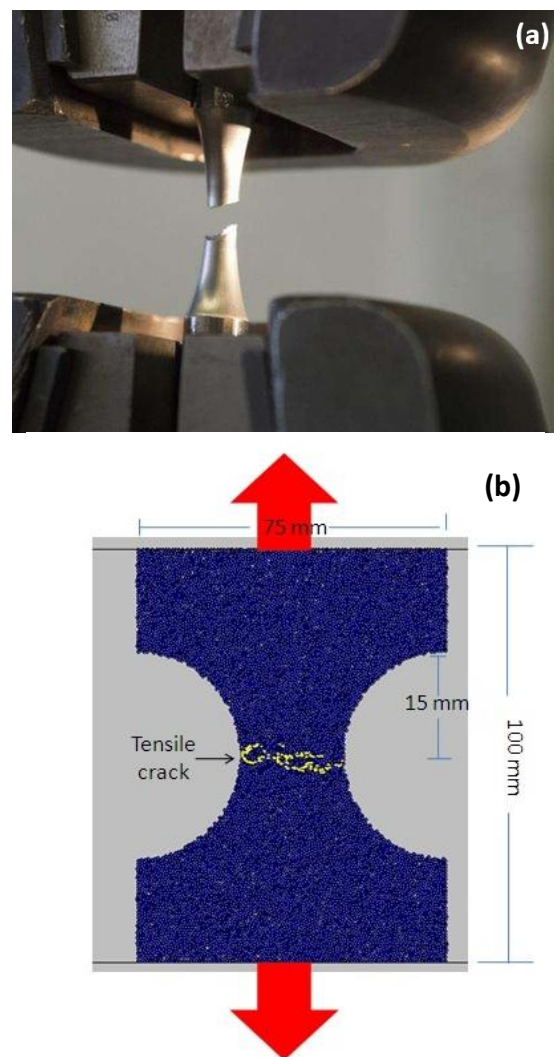
Direct tensile test was used to calibrate the tensile strength of specimen in PFC₂D model. Adopting the micro-properties listed in Table 8. and the standard calibration procedures [5,17] a calibrated PFC particle assembly was created. The geometry considered in the numerical tests was shown in Fig. 7b. The specimen was made of 5,615 particles. The disk was crushed by the upper and lower walls moved opposite from each other with a low speed of 0.016 m/s. Fig. 7a , b illustrate the failure patterns of the numerical and experimental tested samples, respectively. Tensile cracks were shown by yellow line. The failure planes experienced in numerical and laboratory tests are well matching. The numerical tensile strength and a comparison of its experimental measurements are denoted in Table 9. This table given a good accordance between numerical and experimental results.

Fig. 7. Failure pattern in a) physical sample, b) PFC₂D model.

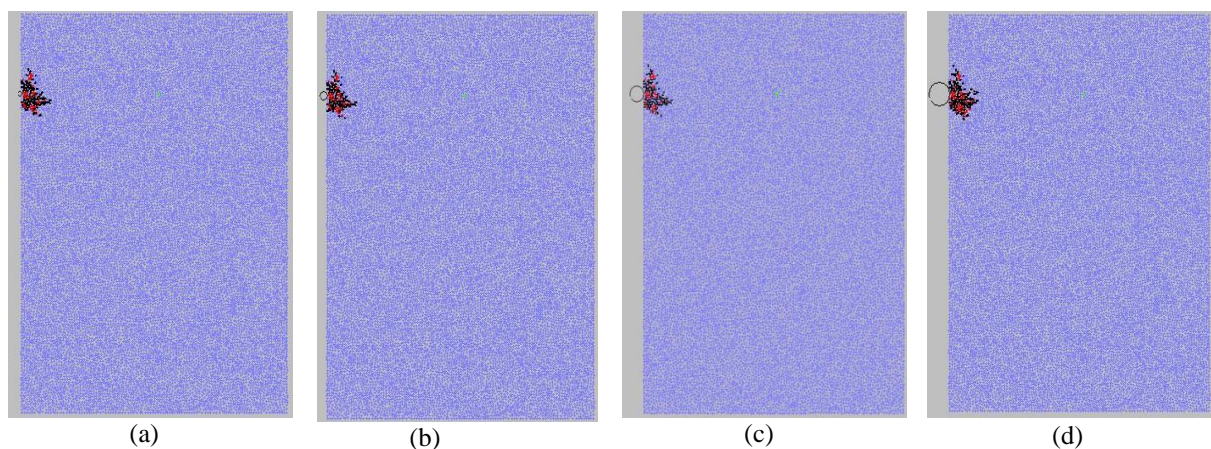
Fig. 9. The fracturing of blades as a results of them by particles with four different diameter of, a) 1, b) 2, c) 4, and d) 6 mm.

Fig. 9. shows that the blade fracturing is caused by sliding between the disks and their splitting from each other. In all cases, cracks are initiated at particle-blade hitting interfaces and progressed in triangle forms through the remaining indentations. It can be said that by increasing the particle diameter, the sizes of indented areas remain approximately constant. As indentation depth was the same for all, only impact stress caused fracturing in all modeling. Then as the impact stresses are constant for all, the indentation areas remain unchanged too. If the indentation depth becomes larger, then it can be said that the intended areas are affected by disk dimension.

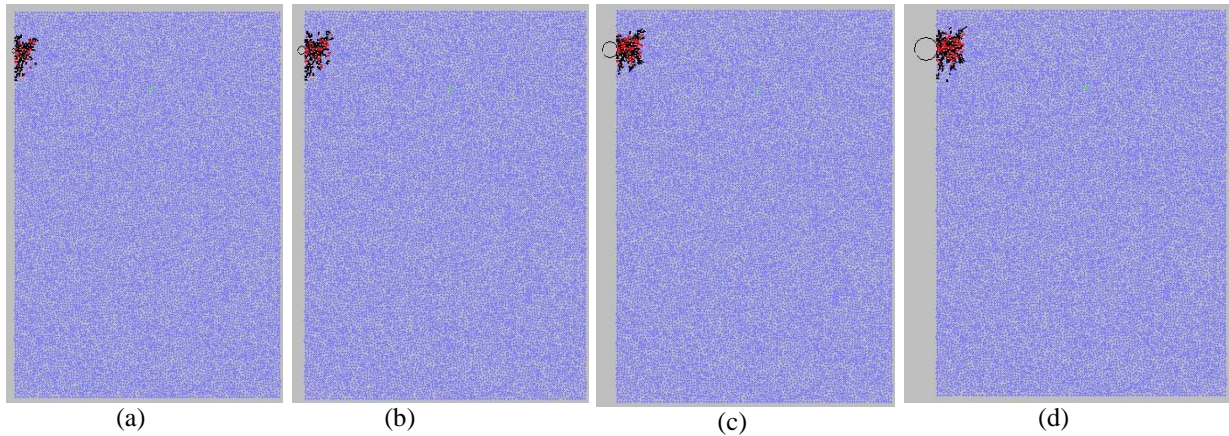
Fig. 10. The fracturing of blades as a results of them by particles with four different diameter of, a) 1, b) 2, c) 4, and d) 6 mm.

In all models, shear and tensile cracking initiate under the particles and propagate at indentation surfaces.

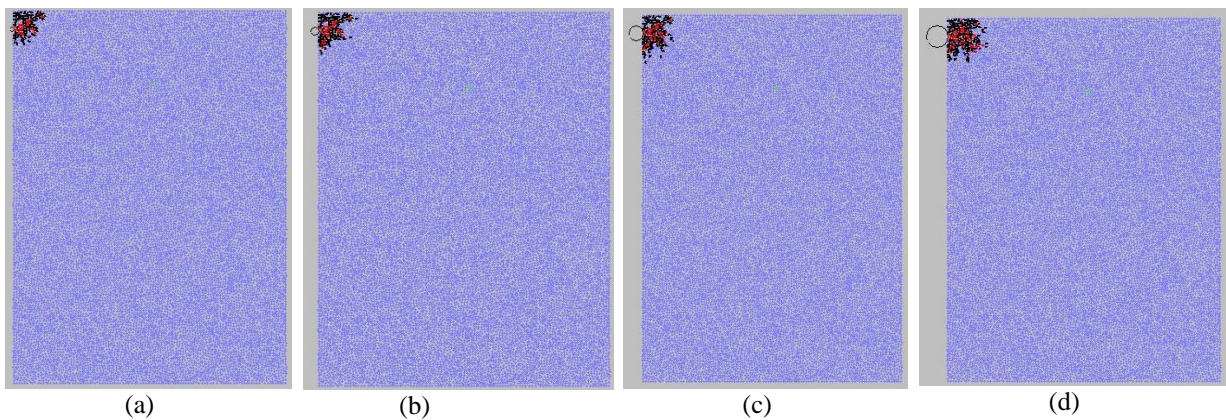
Tensile and shear cracking patterns on blades are showing crystals sliding and ruptures. These cracks

initiate under the particles on blades surfaces and progress towards the tips and also the bulk. The results will be pieces of blades separated from their tips. The fracture patterns in all models are circular with constant fracture surface.

Fig. 11. The fracturing of blades as a results of them by particles with four different diameter of, a) 1, b) 2, c) 4, and d) 6 mm.

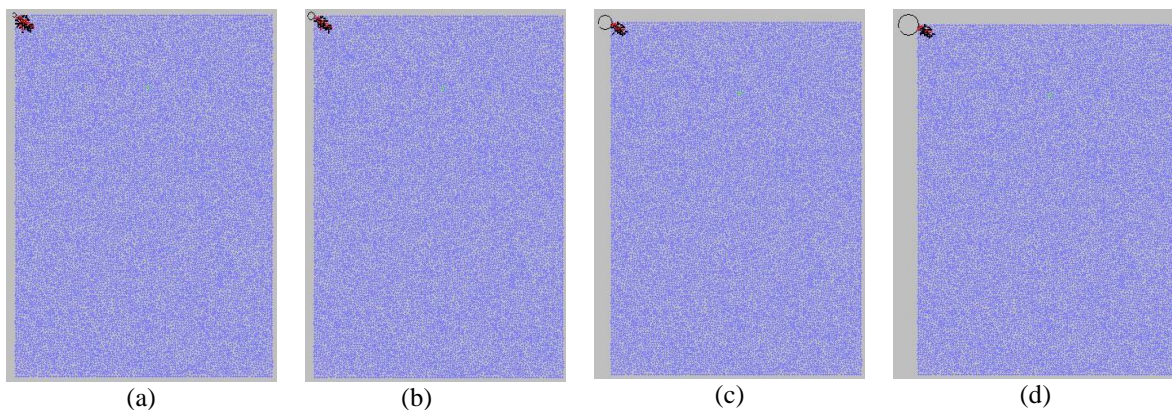
Fig. 12. The fracturing of blades as a results of them by particles with four different diameter of, a) 1, b) 2, c) 4, and d) 6 mm.

In general, tensile and shear cracks initiate at the point of hitting blades by particles and they propagate under an angle of 45° through. The length and width of defected areas in all models are similar at 5mm and 2mm respectively. In this condition, only the blade tip will be flawed.
