# **Design Enhancement of EGR System for Improved Vibration Performance on Truck Diesel Engine**

**Abstract:** In the diesel engine Exhaust Gas Recirculation (EGR) components, valve and connecting pipes are the critical components and often fail during new engine development. These components are important for meeting NO<sub>x</sub> emission norms. Thus design of these components should remain robust. The compact packaging of complete EGR components on the engine, however, is counted as a designing challenge in which the consequent vibration-related failure plays a major role. Normally in pneumatic EGR valve, shaft spring stiffness is considered important for shaft opening and closing. But during emission testing in this layout, shaft is self-opened without feedback signal from sensor; this is due to resonance where the problem is solved by increasing the spring stiffness. The next key components are the EGR pipes; the flexible bellows on these pipes are useful for thermal expansion during hot conditions. In this case the bellow crack failure is observed due to vibration. Therefore, design improvements due to proper design of bellow geometry and bracket support for these pipes fac

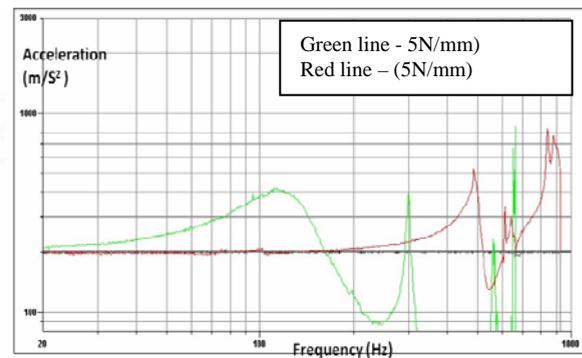
Fig. 4 Acceleration measurement on the shaft

As Fig. 4 indicates, during valve open condition, valve resonance occurs at 113 Hz with maximum acceleration of 416m/s<sup>2</sup> for 2N/mm spring stiffness (red line). By increasing the stiffness, the resonance (green line in Fig. 4) did not occur and there is no self-opening of the valve.

According to the vibration test on EGR valve, it is identified that the self-opening of the EGR valve is due to resonance on the valve owing to lower spring stiffness of 2N/mm. Based on vibration analysis, the stiffness is increased to 5N/mm to deal with EGR valve self-opening for rated speed load conditions.

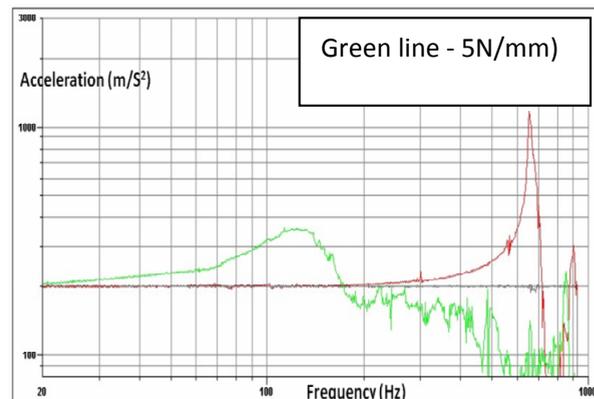
Fig. 6 Cover acceleration measurement

Fig. 5 shows acceleration measurement taken on the cover during valve operating condition. Based on Fig. 6 during valve open condition, valve resonance occurs at 123Hz with maximum acceleration of 362m/s<sup>2</sup> for 2N/mm spring stiffness. By increasing the stiffness, the resonance did not occur concerning the fact that there is no self-opening of the valve.

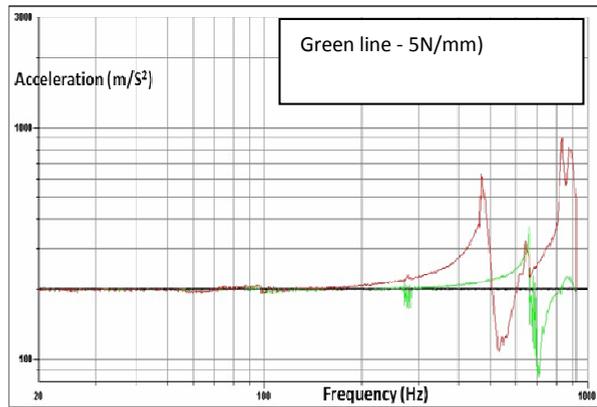
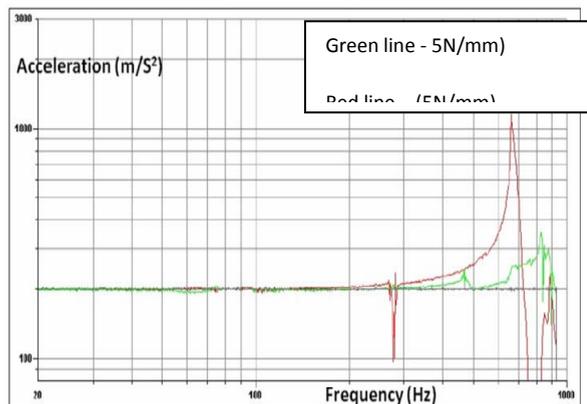
As figures 7 & 8 show, during valve closed condition, valve resonance did not occur within 130Hz, which is an appropriate condition for self-opening of valve. Fig. 9 shows EGR valve with both springs' stiffness mounted at right angle for acceleration measurement.

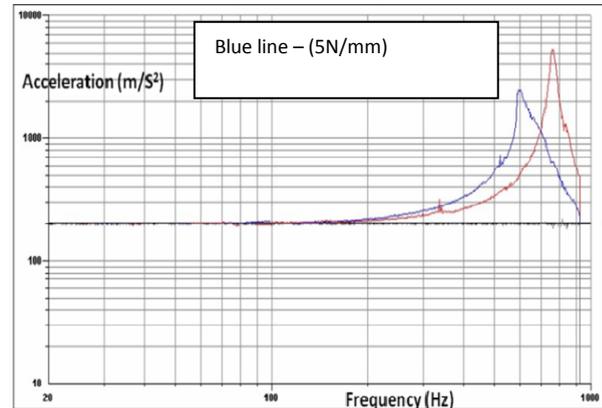
Fig. 10 Vibration measurement on the valve cover

Based on figure 10, during valve closed condition, resonance did not occur with 130HZ for both springs' stiffness.

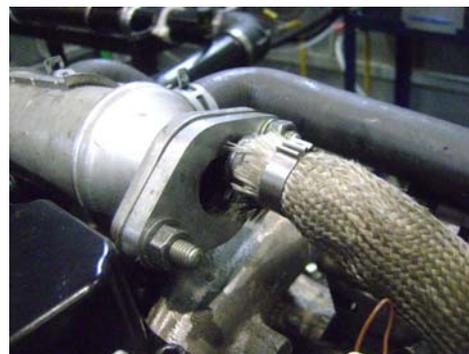
Regarding the figures 11, 12, & 13, ring failure (0.4mm pipe thickness) is due to forced vibration from the EGR cooler side. To solve this problem full pipe thickness is increased to 0.6mm. This, however, created again a failure slightly at a lower point. As part of design improvement, the ring thickness alone changed to 0.6mm and overall pipe thickness is made 0.4mm, this solved the failure and thus, the durability in vehicle is increased to 100000km for RGR pipe-LH.

Fig. 11 EGR pipe-2 (LH) failures [0.4mm thickness]

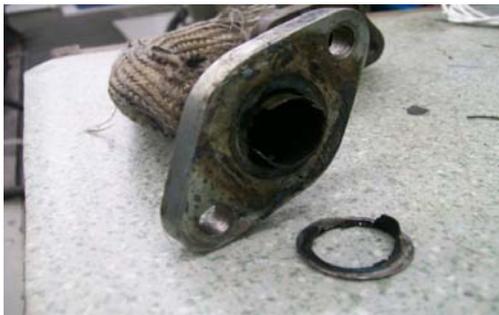
Fig. 12 EGR pipe-2 (LH) ring failures [0.4mm thickness]

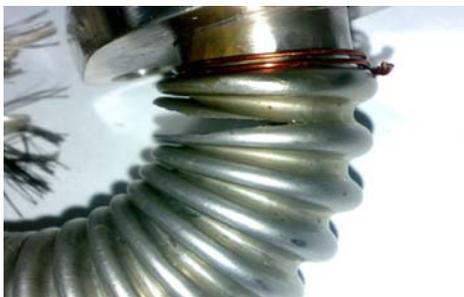
Fig. 13 EGR pipe-LH failure at a lower point (0.6mm)

Related to EGR pipe LH, the failure at a lower spot is solved by changing the position and increasing the durability to greater than 100000km. Furthermore, there is no suspicion for EGR pipe-RH failure with respect to thermal stress, and full engine assembly with respect to pipe mating components for vibrations are studied as well. EGR pipe and connecting component (air duct) amplitude level is found to be high due to improper air duct bracket support.

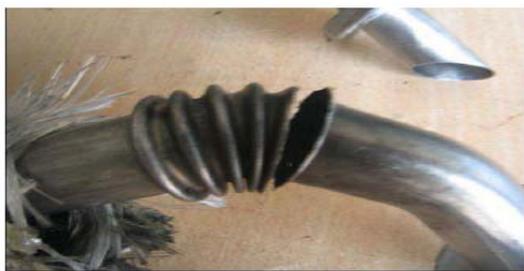
Based on figures 14 & 15, EGR pipe-RH under investigation has exhibited an undesirable number of failures during durability test. With 0.6mm the thickness failure is observed near the lower points, so the thickness is reduced to 0.4mm and the location of the mentioned points is changed and the quantity of the points is reduced to 5 as well, however, the failure is

still observed. The suspected reason for failure is probably due to material or thermal fatigue creep.

Fig. 14 EGR pipe- RH failure of a lower spot (0.6mm)

As a result, the vibration is transferred to the EGR pipe which results in failure within two hours of engine running. By increasing the stiffness of the bracket the pipe, no failure is observed after 100 hours of engine running. Through conducting structured failure analysis, factual failure, thus, is identified and necessary design modifications were implemented without increasing the cost and performance of the component within stipulated time during new product development.

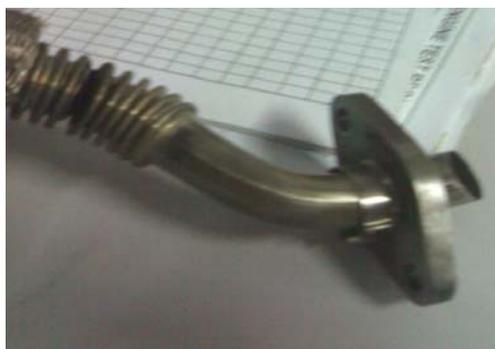
Fig. 15 EGR pipe-RH failure of a lower spot (0.4mm)

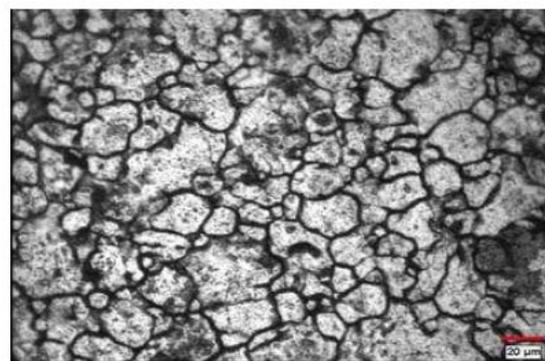
Fig. 16 Microstructure Analysis

As the table 1 indicates, the composition of the part is analysed via inductively coupled plasma (ICP). The result is indicative of specified SS-304 and shows no compositional deficiencies. According to the Fig. 16, the microstructural analysis shows Austenitic grains with carbide precipitation. The carbide precipitation occurs at the welding temperature near the welded zones and it may also occur during the service if the temperatures are of the order of 600°C. The carbide precipitation decreases the strength of individual cracks and is responsible for a great deal of intergranular propagation of cracks as the grains become Cr depleted. This is not observed for the second time, so this may be due to atmospheric conditions also.

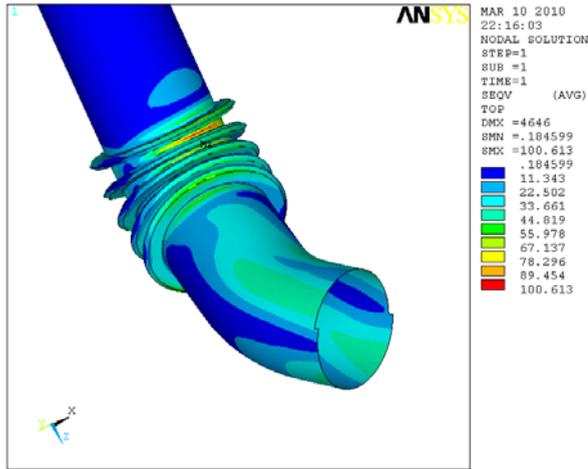
Fig. 17 Stress analysis of EGR pipe-RH

Based on the Fig. 17 the stress level of maximum Von-Misses stress on the EGR pipe is 100MPa which is below yield limit (215MPa) of the pipe material. Hence it is concluded that the thermal load considered in this analysis is not the cause of the failure. According to the results of these tests, it is observed that the major cause for the failure in EGR pipe-RH would be because of excessive vibration. Hence to confirm this hypothesis, vibration measurements were taken at different loading

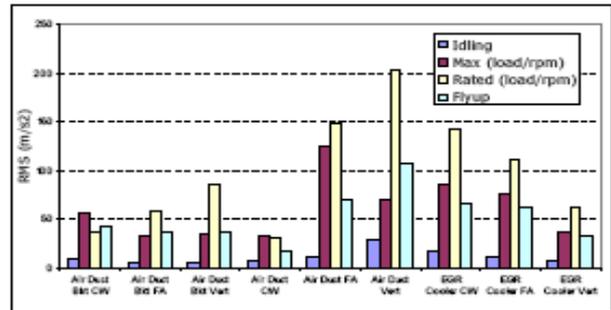
Fig. 21 Vibration levels at different locations

Fig. 21 shows the time domain RMS comparison at all locations within different test conditions. It is observed that the vibration levels during rated load RPM were found to be higher than other conditions. At rated load with rated RPM the vibration on vertical direction is found to be more than crosswise (56.7 %) and fore and aft direction (37.6 %) on the air duct.

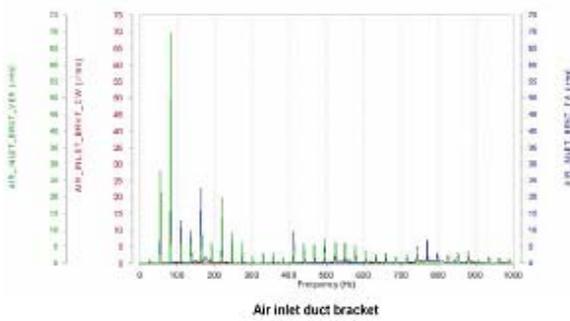
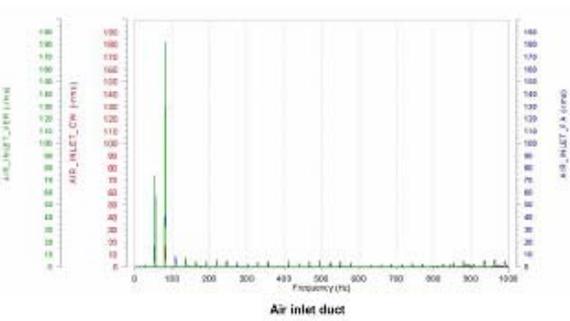
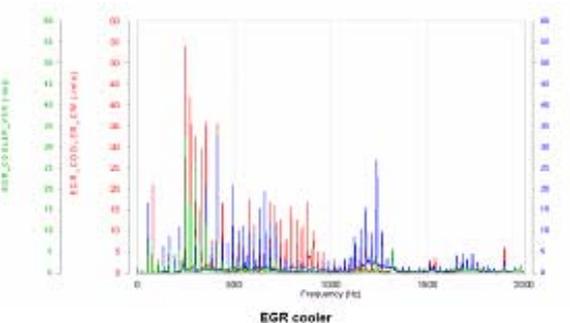
In figures 22, 23 and 24 the frequency spectrum of vibration signals in all three locations has been plotted. It is observed that peak amplitude occurs at 62.26 Hz. The crosswise direction at 62.26 Hz has higher peak than fore and aft and vertical directions, which doesn't get excited much during rated load at rated RPM condition for air duct bracket. It is also observed that from frequency spectrum of the signals at 240 and 1328 Hz, the amplitude of vibration is found to be high in all directions for EGR cooler.

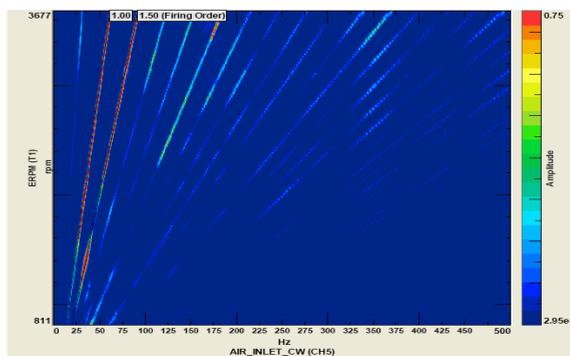
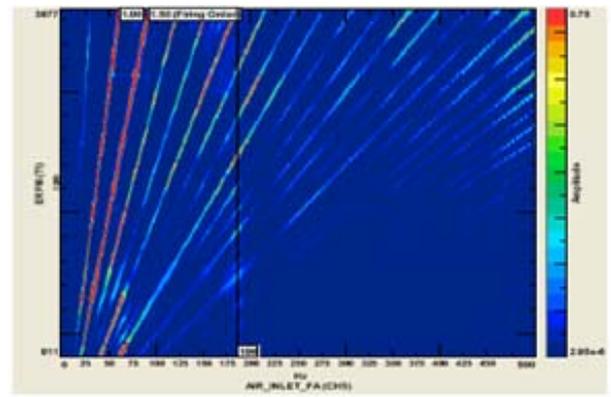
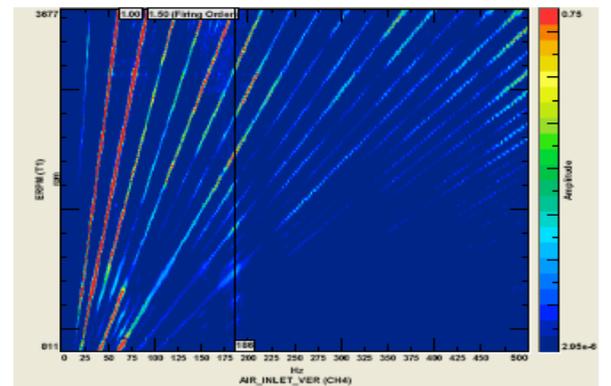
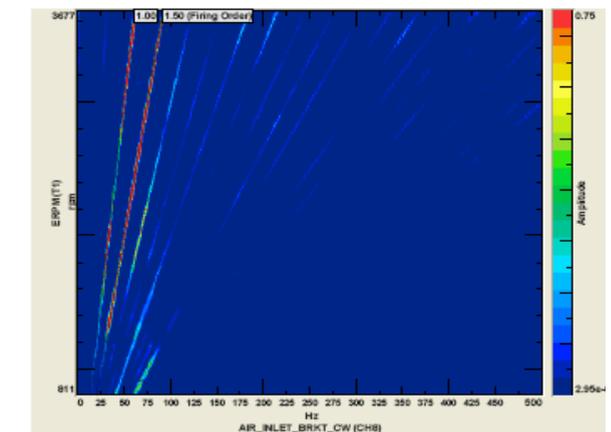
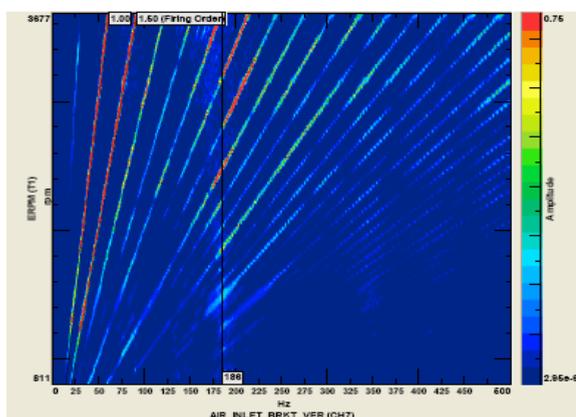
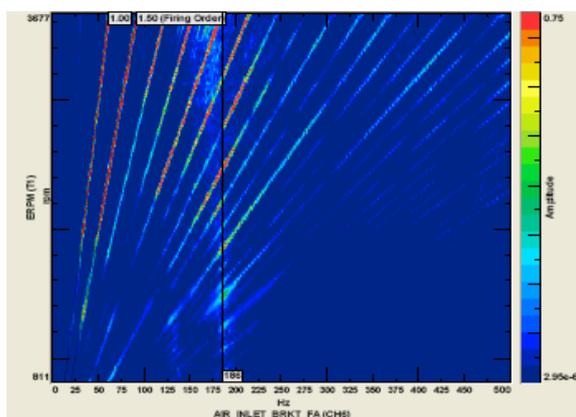
Figures 25–30 show the order plot for air duct and air inlet duct bracket. It is observed that in all firing orders and its harmonics, the vibration amplitude at air inlet duct and air inlet duct bracket is found to be high. Vertical line with higher amplitude is observed, which indicates that the resonance of either air inlet bracket or air inlet duct occurs at 180 Hz in vertical and fore and aft direction.
