## **Failure Evaluation of Cupronickel Alloy Used in the Condenser of the Desalination Unit**

This study looks into the various forms of corrosion that affect various elements of the South Pars Gas Company's first refinery's desalination plant, such as water compartments, tubular plates, support tubes, and the self-tube. To investigate the corrosion variables, a thorough analysis of the device's structure and process, as well as the material, was conducted. During repairs, damaged tubes were sampled and subjected to scanning electron microscopy, X-ray diffraction, and X-ray fluorescence testing. Evaluating scanning electron microscopy pictures from the inner surface of the tube reveals deformation and a rise in the tube's inner diameter. The X-ray diffraction patterns and elemental analysis by X-ray fluorescence show that the inner surface is corroded. The external surface of the tube and analysis of the diffraction patterns in this region reveal the formation of copper oxides on the outer surface of the tubes, which, when compared to electron microscopic images, distinguishes pitting corrosion caused by acid condensation collision on the outer surface of the tube. Finally, the ma

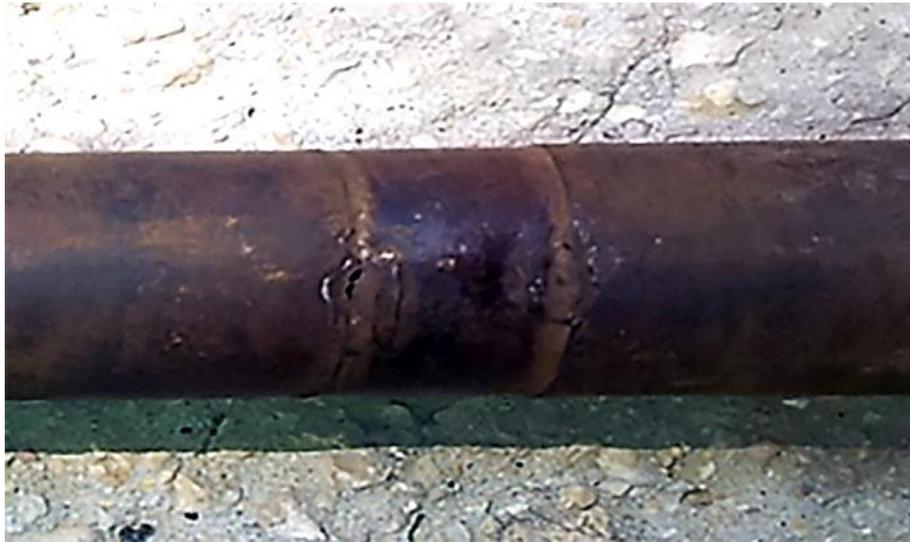
One of the damaged tubes was chosen and cut in length to explore the causes of failure and fracture. This technique was performed multiple times before the best sample was created due to the requirement for a careful operation to minimize failure and fracture effects (Figure 2). The images obtained by the scanning electron microscope from the inner surface of the tube revealed alkaline deposits and pitting corrosion at multiple sites (Figure 3, pits are dark in color and sediments are visible in white spots).

Figure 2. The outer surface of the tube in the fracture area

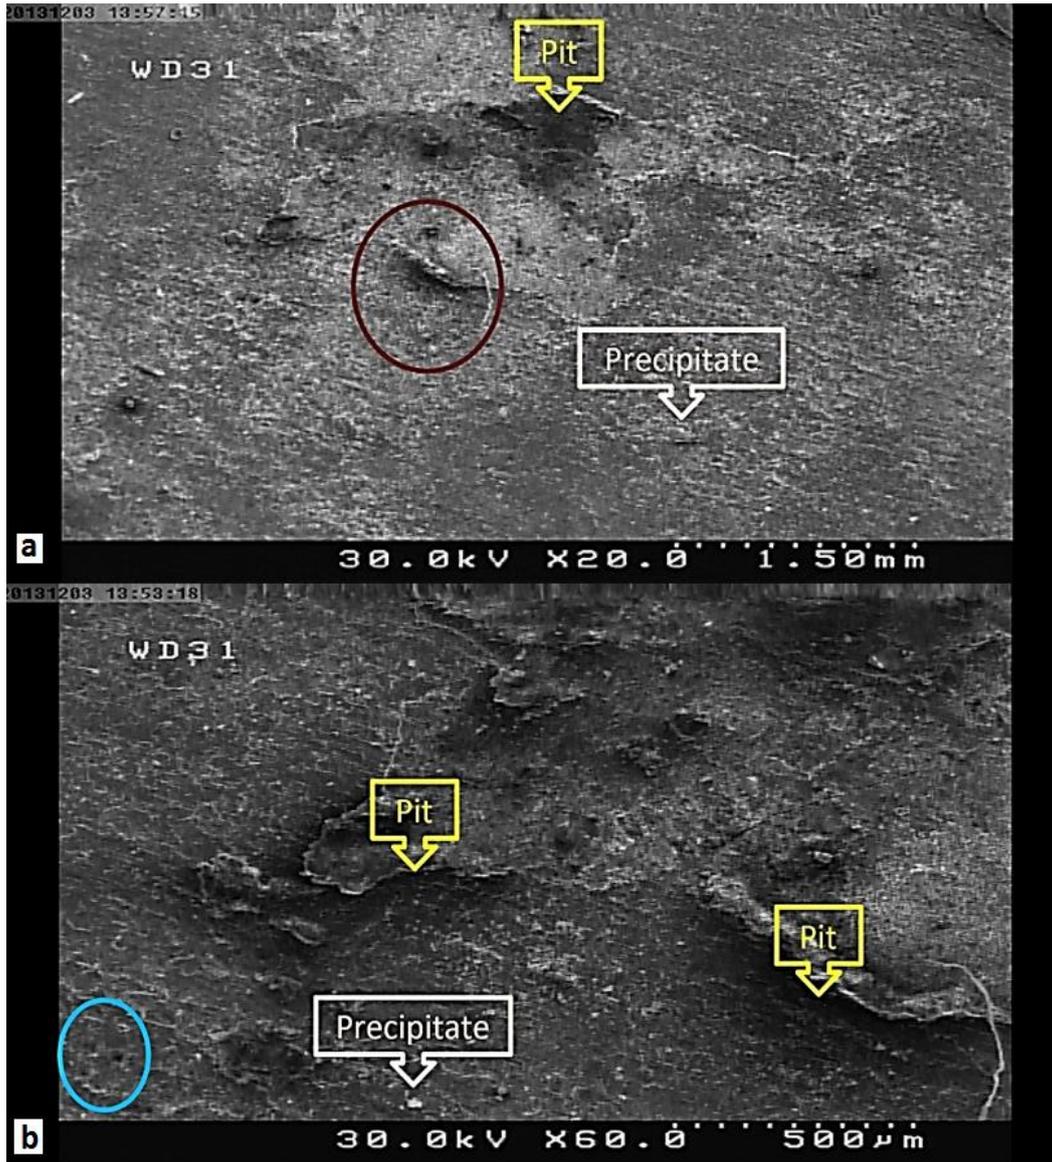
Figure 3. a) Scanning electron microscope image of the inner surface of the tube b) higher magnification on the enclosed area

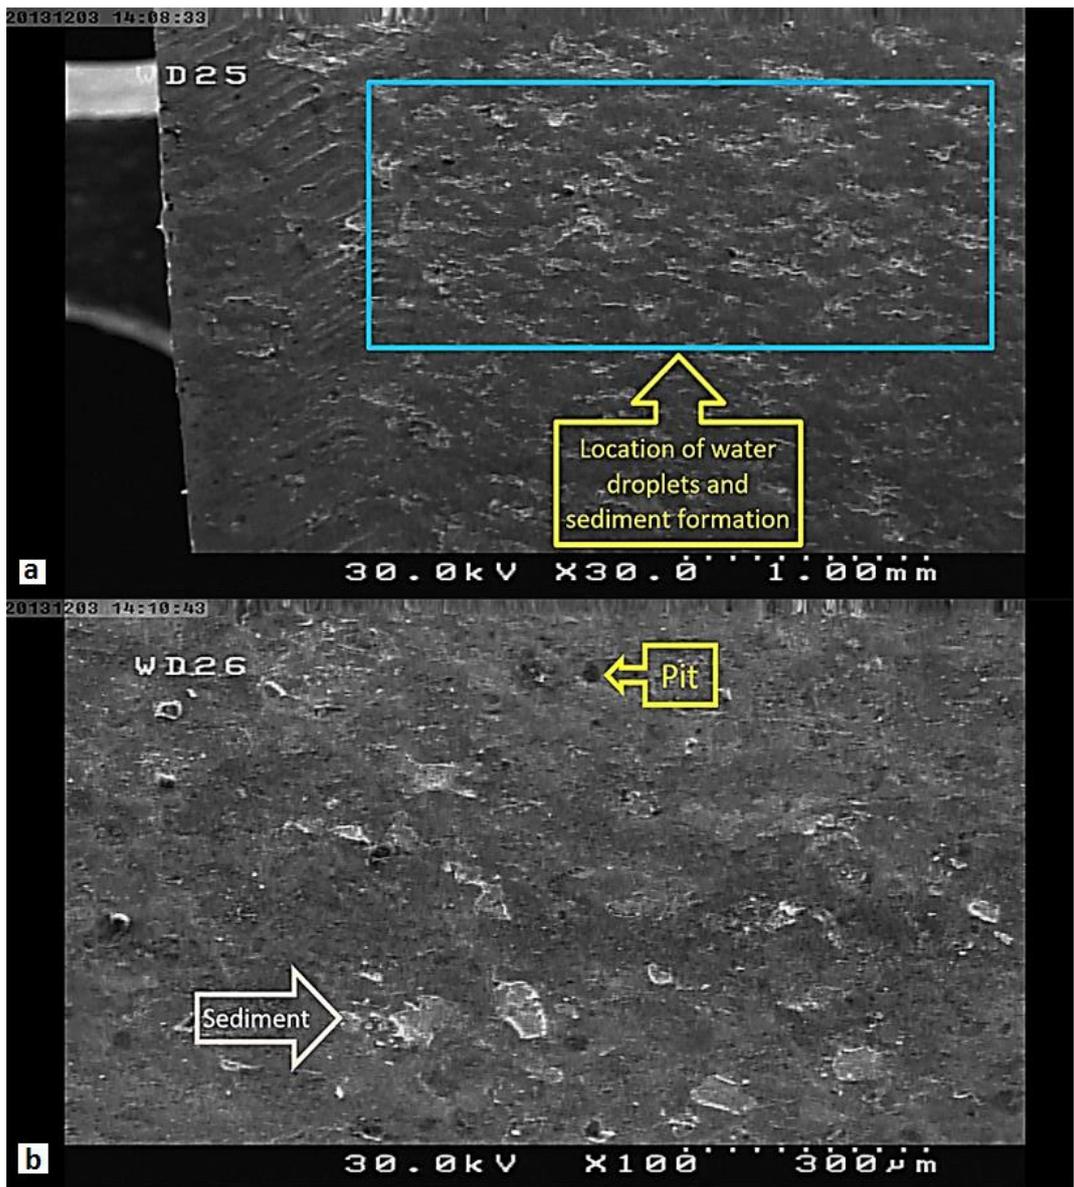
Images of the external surfaces of tubes subjected to direct steam reveal various modifications. These changes are caused by the collision of water droplets with the steam and liquid droplets on top of the condenser (Figure 4). The change in the appearance of the outer surface suggests the continuance of a process, which is the collision of liquid drops and steam on the surface.

Figure 4. a) Scanning electron microscope image of the outer surface of the tube b) higher magnification on the enclosed area

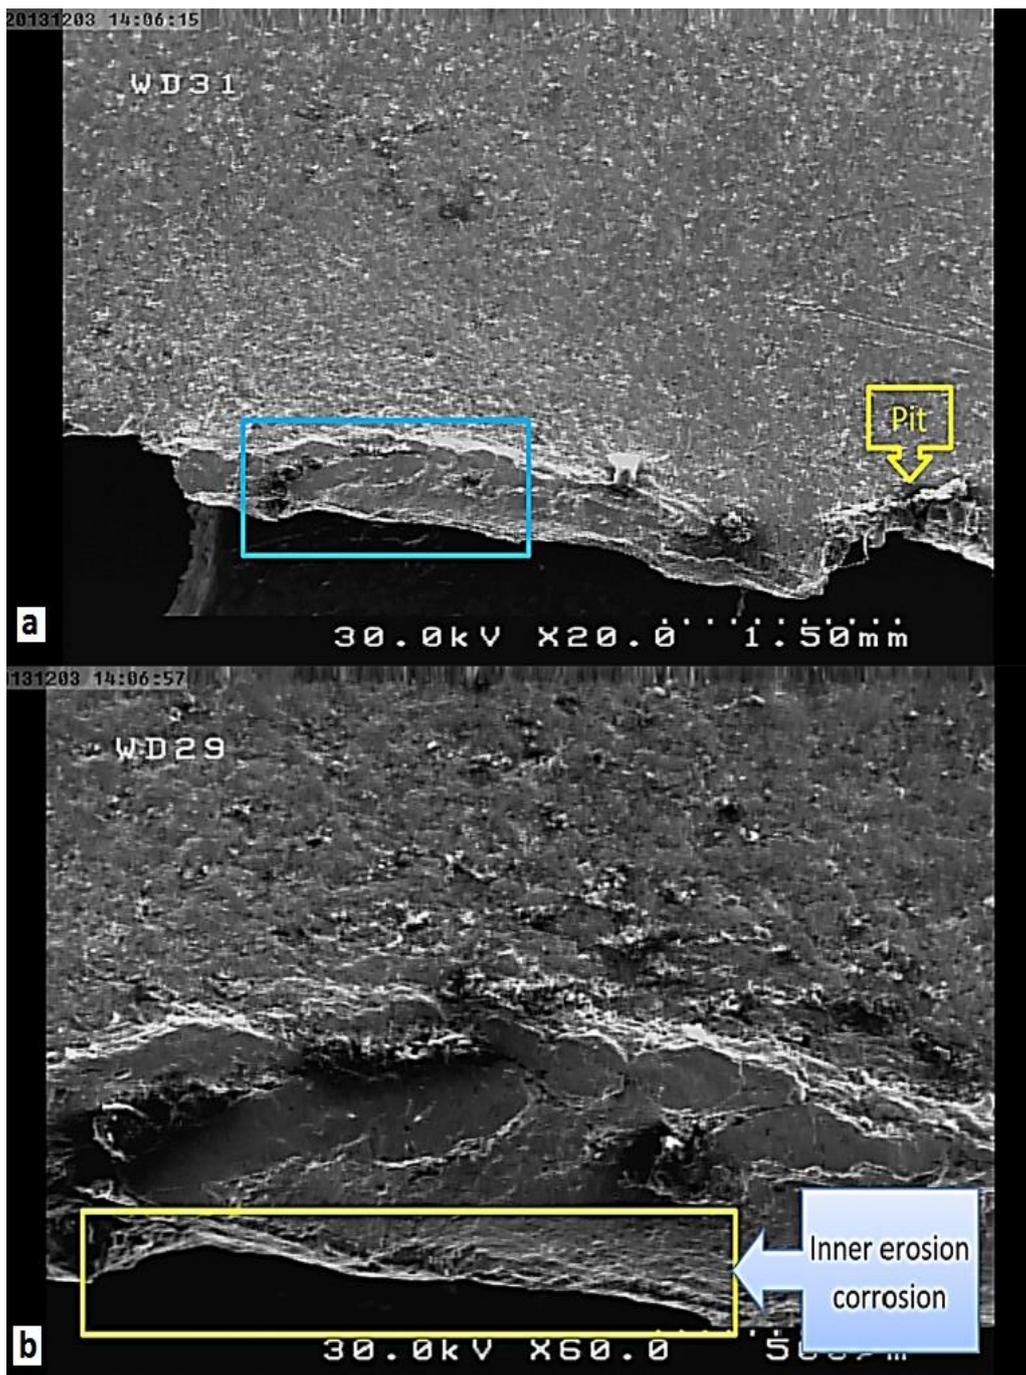
Electron microscope images of the third sample obtained precisely from the cross-section of the tube in the fractured area, reveal corrosion surrounding the tubular thickness and corrosion caused by it (Figure 5). The channel connects the pit to the inner and outer surfaces of the tube, as shown at the bottom and right sides of the figure. When the device is in use, this connection has a defect that causes the conductivity coefficient of the water to exceed the allowable limit. As a result, the device must be decommissioned and fixed.

Figure 5. a) Scanning electron microscope image of the tube cross-section and the pits formed b) higher magnification on the enclosed area

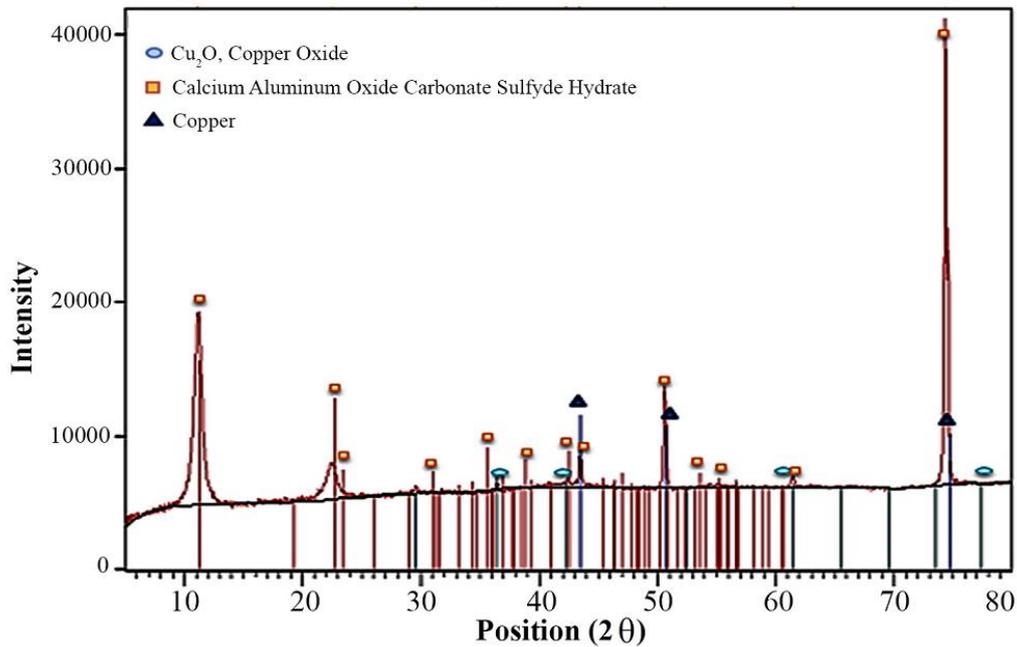
The phase composition of the corrosion products was determined using an X-ray diffraction analysis. After removing the passive layer from the inner surface of the tube, this study reveals the presence of ions in water such as calcium, aluminum, carbonate, sulfide, and others. Furthermore, the presence of copper oxide indicates interior deterioration (Figure 6). Figure 7 depicts the diffraction test result for the tube's outside surface. The presence of copper oxides indicates external corrosion, while the presence of carbon dioxide results in the formation of non-condensable gases (NCG) and carbonic

Figure 6. X-ray diffraction pattern of the passive film from the inner tube surface

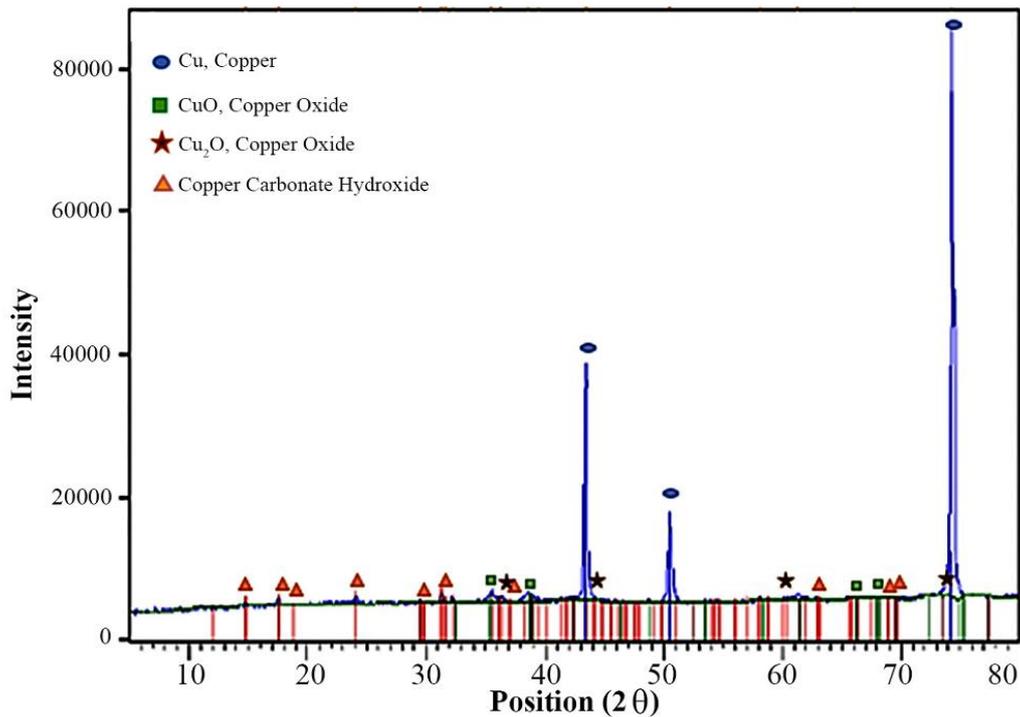
acid. The oxygen penetration from the device's gaskets and pores is efficient in exacerbating it. The copper oxides are easily visible on the outer surface of the tubes.

Figure 7. X-ray diffraction pattern of corrosion product on the outer surface of the tube

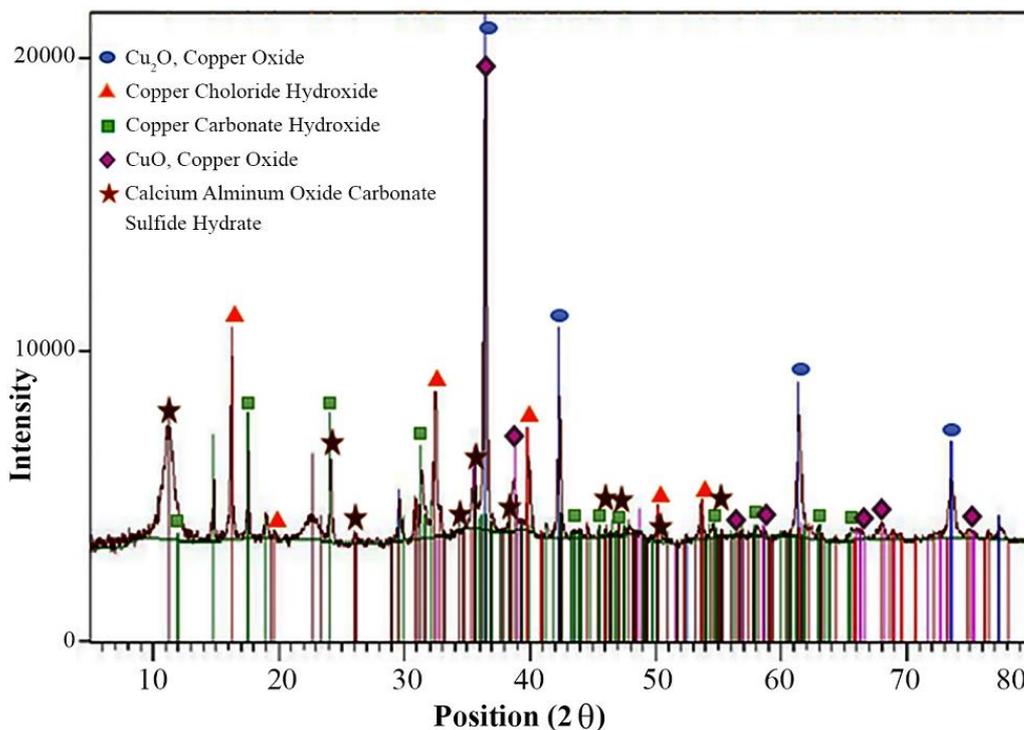
Figure 8 depicts the outcome of the corrosion product analysis. The results show that copper oxide is created by corrosion, copper chloride hydroxide is formed by chlorine injection in a reservoir unit, calcium, aluminum, and other minerals in salt water, and copper carbonate hydroxide is produced as

a result of aquatic corrosion. Copper oxides ( $\text{CuO}$ ,  $\text{Cu}_2\text{O}$ ) and copper hydroxide carbonate ( $\text{Cu}_2\text{CO}_3(\text{OH})_2$ ) are present on the surface of the tubes. The first example is caused by copper oxidation in the presence of oxygen. Oxygen entry pathways should be studied in this case. Seawater contains oxygen, and oxygen can also be delivered by gasket leakage. Oxygen, in any form, is harmful and should be avoided as much as possible. The second example is made by breaking down the carbonate of saltwater at the package temperature and settling down on the tube surface, and  $\text{CO}_2$  gas is produced as a byproduct of carbonate breakdown. This gas forms corrosive condensates in a condenser and causes corrosion by producing corrosive carbonic acid [16].

Figure 8. X-ray diffraction pattern of the corrosion products

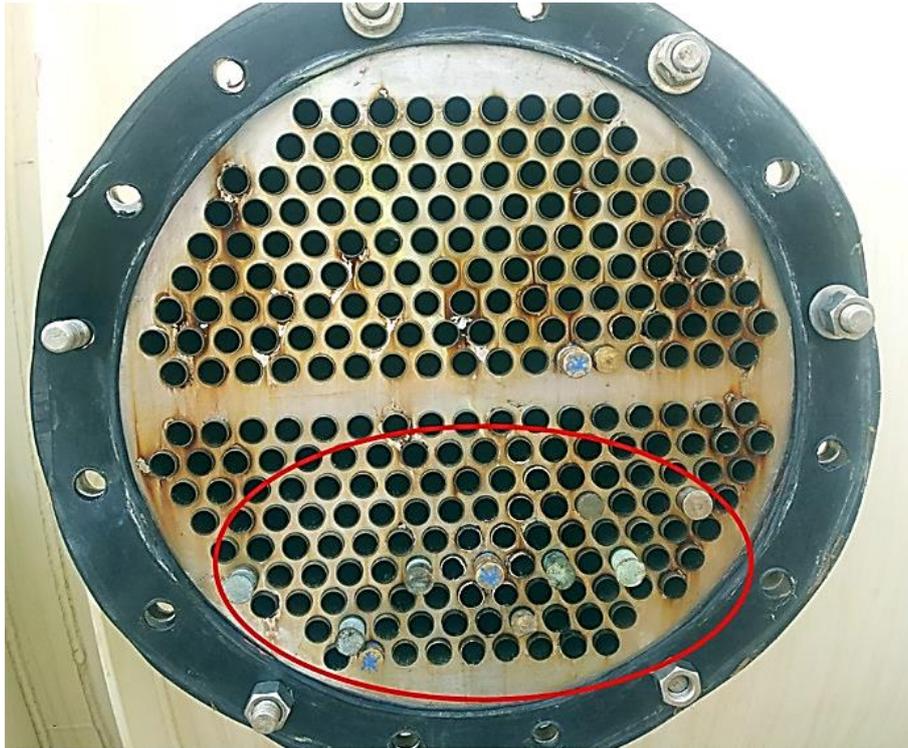
Following visual examinations of the desalination system, we discovered that the majority of the corrosive tubes of the condensers are in the final effects, particularly in the main condenser. Meanwhile, the position of a fracture in a certain condenser is typically fixed. This position is at the lower part of the condenser tubes, at the bottom of the first pass. One of the indicators of tube failure is an increase in the electrical conductivity of distilled water, and to locate and fix the failure, the package is taken out of operation and a hydro-test is performed. The damaged tubes have become blocked (plugged). After the package has been restarted, newly damaged tubes are generally discovered near the same damaged tubes (Figure 9).

Figure 9. Location of tube failure

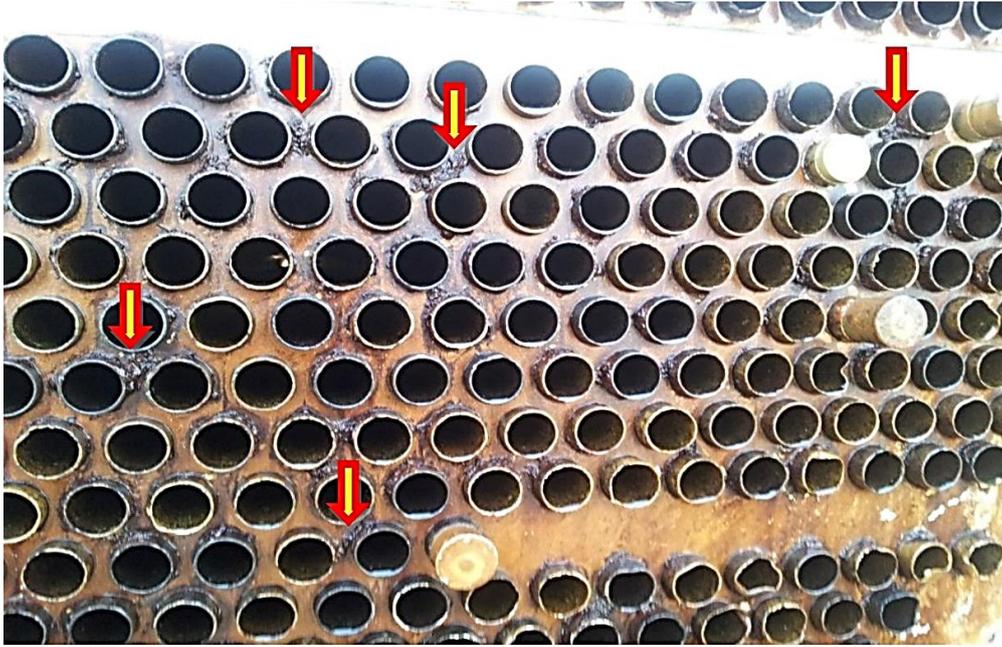
Brown-colored corrosion products of iron oxide form between the tubes and tabular plates during galvanic corrosion. Figure 10 depicts this type of corrosion in the first refinery's desalination unit [6, 17, 18].

Figure 10. Galvanic-Crevice corrosion in tube plates

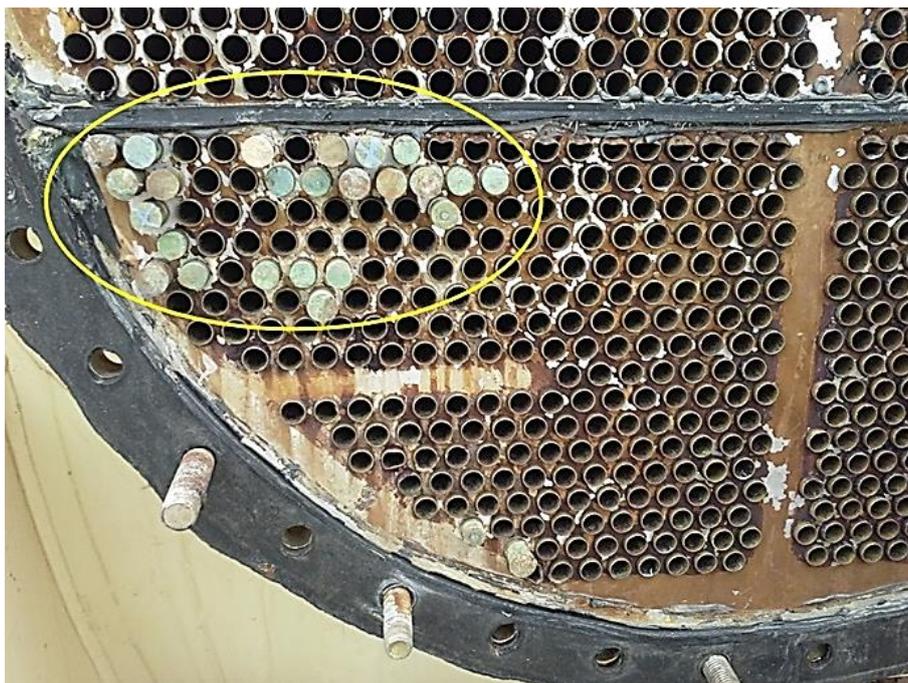
According to information on the alloy used in the first refinery's condenser tubes of desalination, the flow rate can reach up to 2.5 m/s and as high as 3 m/s. Higher velocities and suspended particles in the water caused by a lack of filtration and proper sedimentation in the reservoir, at the entrance to the tubes, before the developed hydrodynamic region with flow separation from the reverse pressure gradient, can cause multiple strikes to the tube wall, causing internal wear in this area in the long run. Figure 11 demonstrates this. Most failures have occurred in the region with the worst turbulence. Erosion corrosion affects the thickness of the tube body from the inside and increases the likelihood of tube breakage [5,17].

Figure 11. The turbulent area in heat exchangers exposed to abrasion

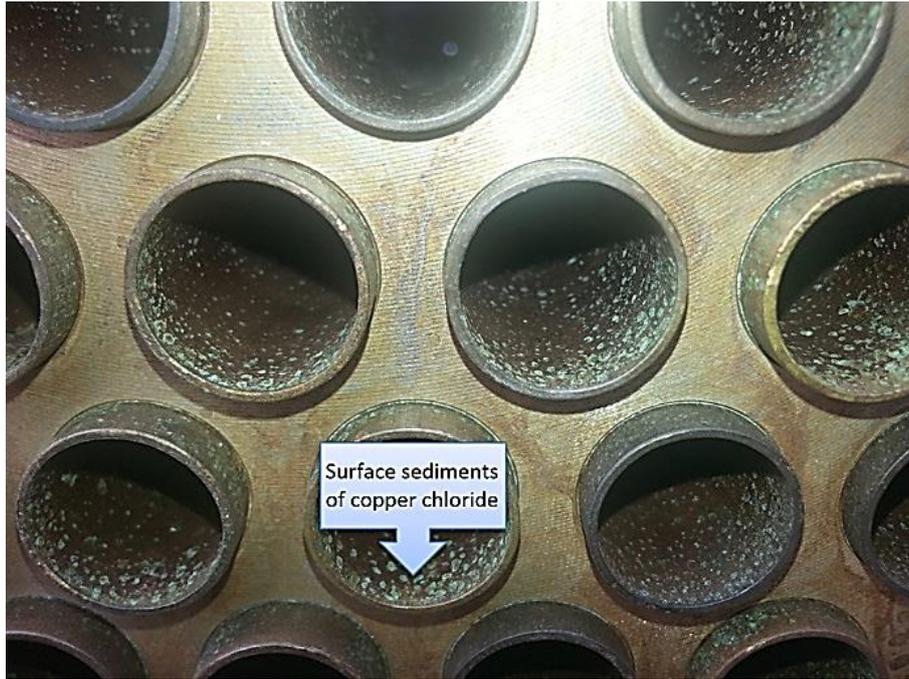
Green deposits are formed in the condenser tubes as a result of the interaction of chlorine with copper and the creation of copper chloride ( $\text{CuCl}_2$ ) deposition, and corrosions are noticed after cleaning the deposits below them. This issue is caused by a lack of control over free chlorine content by sodium bisulfate injection for chlorination at the desalination device's entry. Also, due to the absence of circulations in this condenser with ordinary or distilled water in the first two passes, this green deposit is noticed in the rear cover of the sediment in the main condenser tubes of package C of the first refiner (Figure 12). It is worth noting that owing to the continual monitoring of free chlorine injection and sodium bisulfate, this sort of corrosion in the first refinery's desalination equipment is quite low. The absence of drainage and stagnation of water when the device is out of service, the failure to wash the path with proper water, the failure to dry the device after washing, the absence of harmful gases, and the failure to compress the compartment of the device with nitrogen gas to prevent the introduction of moisture and corrosion are the causes of this corrosion [19, 20].

Figure 12. Partial selective corrosion in desalination tubes

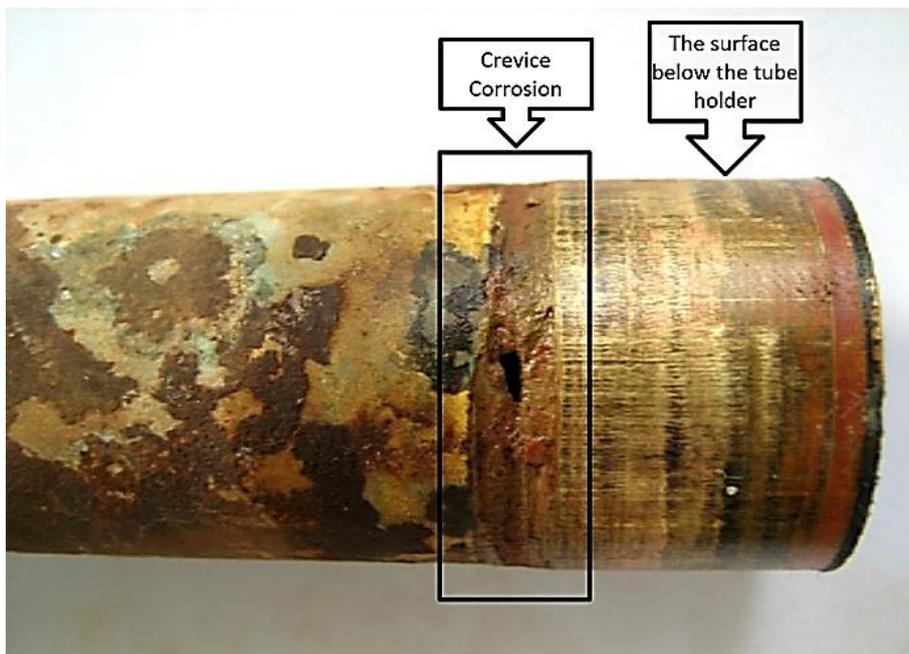
This section will look into corrosion on the exterior of the tubes (steam). There are oxygen, carbon dioxide, nitrogen, and other gases in the steam section. Figure 13 depicts a tube failure induced by an environmental attack at the tube connection point to the tube holder, which is produced by crevice corrosion. The areas under the tube holder did not change in diameter, as indicated in the figure, however, the portions near the outside edge of the tube decreased in diameter owing to crevice corrosion and were cracked due to pitting corrosion. Each desalination equipment offers a unique set of effects. Each desalination device effect is composed of three major components: a condenser, an evaporator, and a flash chamber (Figure 14).

Figure 13. Crevice corrosion in desalination tubes

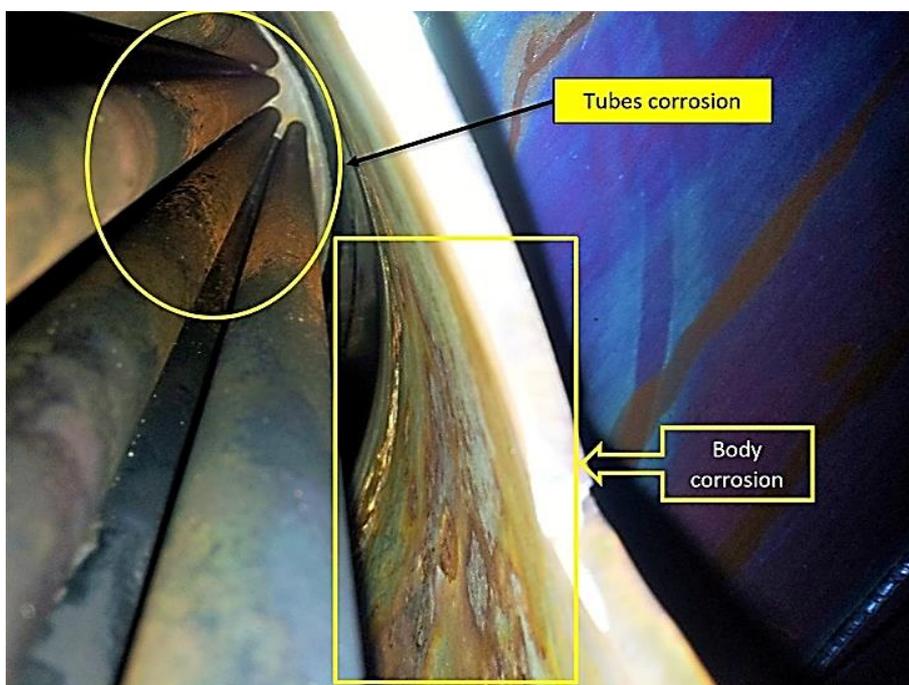
Gas traps typically form between the support tubes and the tubular plate on the device's side. Corrosion conditions are comfortable due to the corrosive gas environment and the ideal time in this location. As seen in Figure 17, there is substantial corrosion in this area.

Figure 17. Another view of the heat exchanger interior

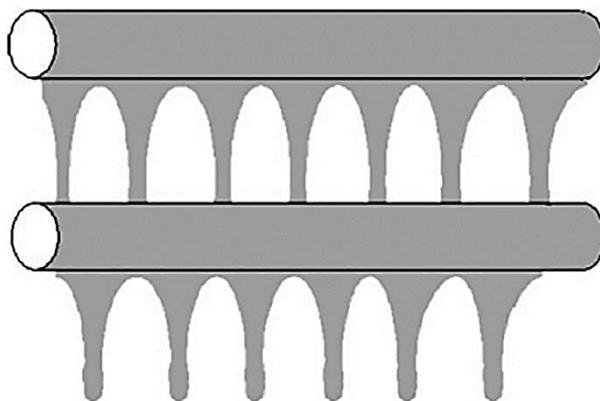
water droplets from the higher tubes collide with the outer surface of the lower tubes, as seen in Figure 18. Therefore, we will have general corrosion on the surface of the tubes [21-23].

Figure 18. Condensate flow in desalination flash chamber

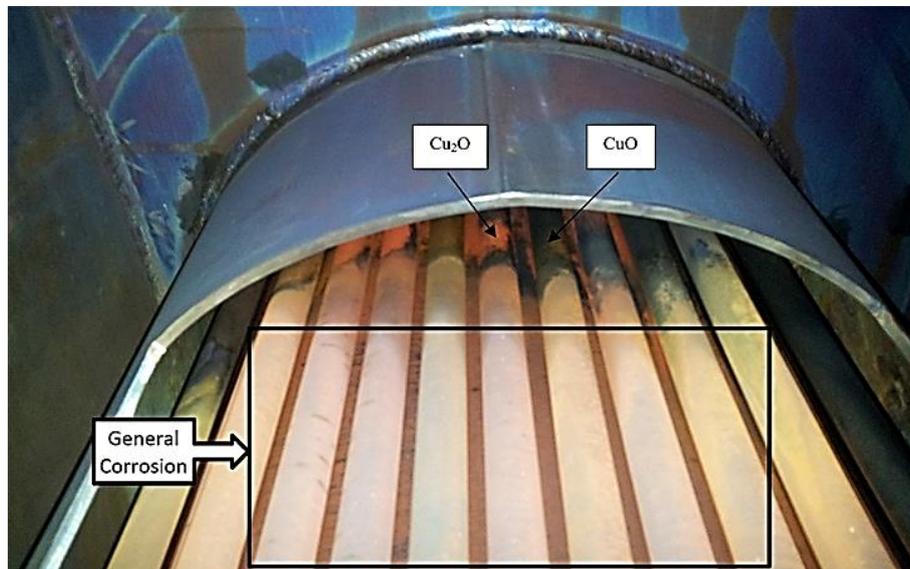
This corrosion, which is a pit, has been observed in many of the desalination condenser tubes in the first refinery. In Figure 19, the formation of copper oxide (CuO), a black substance, and copper oxide (Cu<sub>2</sub>O), which is a red substance, is evident.

Figure 19. Copper oxides and general corrosion
