Evaluation of Acoustic Emission Inspection of Oil Tank Floor via Tank Bottom Plates Thickness Measurement

Abstract: This paper deals with an inspection of defects including corrosion and leakage by Acoustic Emission (AE) in an oil tank floor. 5 AE sensors have been attached to an oil tank and the sensors were calibrated by pencil lead break test. The emissions have been recorded within an oil tank. The oil tank was not emptied and had an amount of oil for the test unlike other test methods like magnetic flux leakage, eddy current or ultrasonic. The test method and formulas of AE investigation and AE source location are presented in detail. The result of AE test in the studied oil tank verifies the presence of corrosion in some areas of the tank floor. After AE test, the tank was emptied and inspected using ultrasonic thickness meter. The result of thickness measurement reconciles in an acceptable manner with AE test.

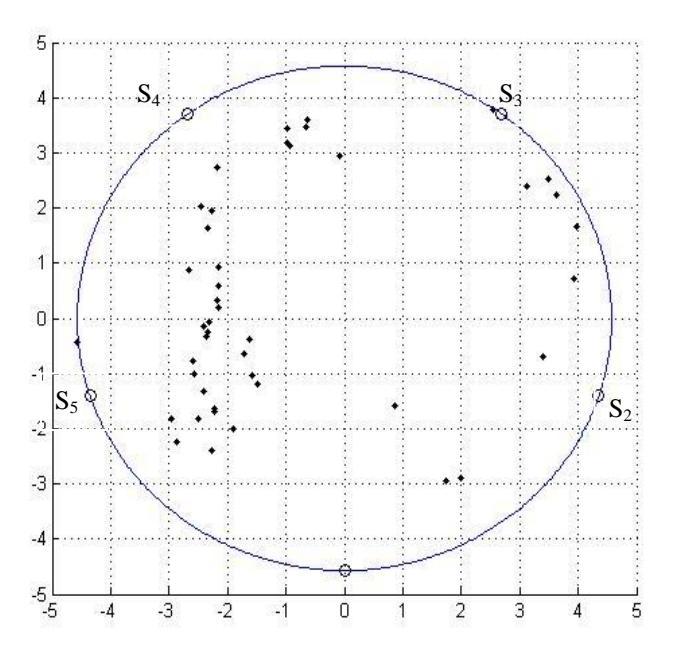
In Fig.7, the big circle displays the tank floor. Small circles along the circumference

present sensors s_1 to s_5 . Black dots represent defects on the floor. From the figure it can be clearly seen that defective points are located mainly in a region between sensors s_4 and s_5 .

Table 1 illustrates defect levels and necessary recommendations for tank floors. Since the low defect activity as depicted in Fig. 7, the tank floor condition is evaluated well based on Table 1 and no repair is required. However, it is recommended to be tested by AE again after three years.

Fig. 7. AE source location of 60 minutes test.

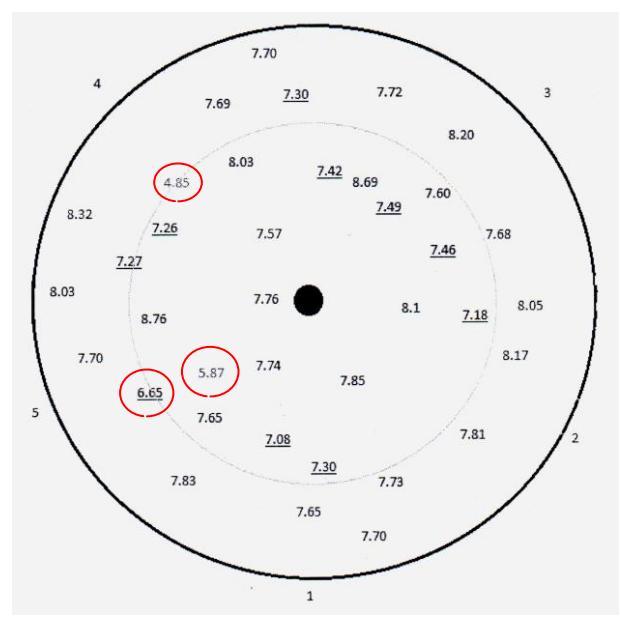
After AE test the tank floor was emptied, cleaned, and tested using an ultrasonic thickness meter. The result is depicted in Fig. 8. The thickness of the floor plates was 8.7 mm since the construction of the tank. As Fig. 8 shows most plates have a thickness of more than 7 mm and only 3 points have a thickness of less than 7 mm. It is also clear that these points are located in an area between sensors s_4 and s_5 . The lower thickness in this area

presents more corrosion and this is in accordance with Fig. 7. where most defects are located in the next region. Though there are points with slight corrosion in Fig. 8 which were not detected by AE test. Altogether it could be inferred that most active corroded points were found by AE.

Fig. 8. Tank bottom thickness measurement.
