Research and Full Length Article:

Assessment of Deli Watershed Flood Causing Damage in Medan City, Indonesia

Sumihar Hutapea^{A*}

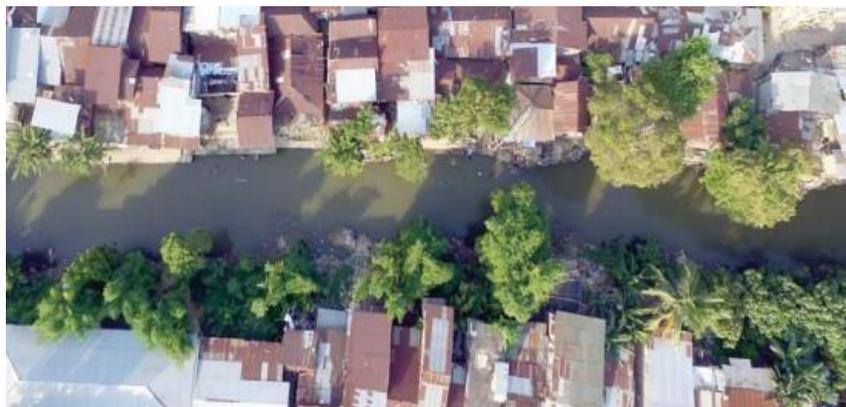
Fig. 2. The top view of Deli river

River Basin (DAS) Deli is located in Karo Regency, Deli Serdang and Medan City, North Sumatera Province. The upstream of Deli River is located in Karo and Deli Serdang District while the middle and downstream areas are in Medan City and Deli Serdang Regency, and empties into Belawan Harbor. Deli watershed is in the east bordering with DAS Percut. Based on its geographical position, the Deli watershed is located between 30 12'58 "to 30 47'15" North Latitude and between 98 02'50 "to 98 41'50" East Longitude (Figs. 1 and 2).
