Research article

The analysis of failure for a stud bolt with reduced shank under dynamic loading

In this research, the failure of a stud bolt was studied. This bolt is under periodic loading, in a multi-stage compressor. The undesired vibration of the system causes vibration load on the bolt. The bolt was modeled in Abaqus software and the generated stress was calculated. To determine the dynamic load on the bolt, the vibration of the system was measured by a digital vibration sensor and this load was simulated in Abaqus software. The boundary condition and loading were considered similar to the real working condition. The failure and fatigue of the bolt was investigated in the periodic loading. The factors such as the shank diameter, chamfer radius and material were changed and the corresponding response of sample and change in stress was studied. The most probable points of the bolt for failure were found and the effect of the reduced shank diameter on its life was considered. In the initial design, the shank diameter was considered 12 mm. The results shown that by decreasing the shank diameter, the stress first decreases and then increases and the minimum of stress occur at t

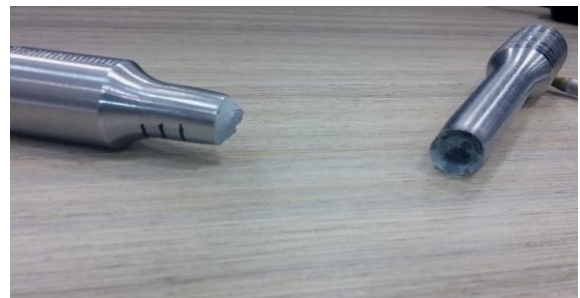
In a tensile test, the sample made from corrosion resistant steel PH-17-4, was produced in standard size for the tensile test. Fig. 2 shows the sample after the test and Fig. 3 presents the strain-stress diagram resulting from the experimental data for the sample.

Fig. 2 The sample after tensile test.

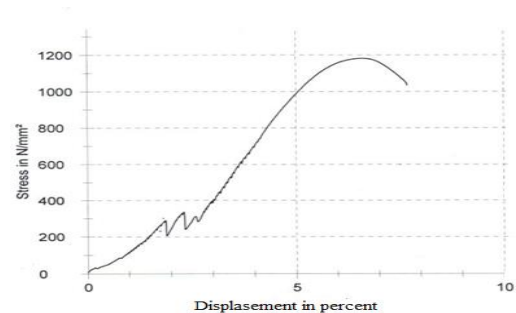
Fig. 3 Stress-strain diagram.

Table 1 shows the mechanical properties of the sample, based on the tensile test, which will be used in modeling in the Abaqus software.

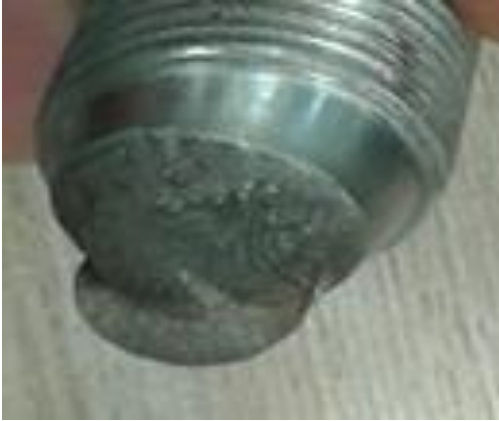
The cross-section of the bolt failure under vibrational loading is shown in Fig. 5. In this figure the lines of the crack growth is visible on the cross-section. The failure started with fatigue cracking and after

fatigue cracking growth, the endpoint of the segment was fractured at a 45° angle.

Fig. 5 Fracture of cross section.

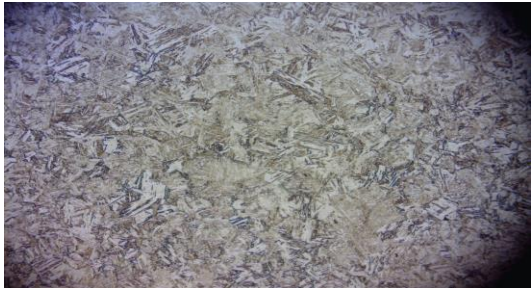
To investigate further on the cause of failure, the metallography test was performed on the sample. In Figs. 6 and 7, the cross-sectional area of the sample in metallography experiment were shown with magnification of 100X and 200X that Photographed by an electron microscope.

Fig. 6 Cross section fracture (100X).

corrosion resistant. Its structure consists of martensitic phase with delta ferrite phase that homogenization and hard deposition are usually provided under heat treatment. Metallography and microstructure images show the presence of the ferrite delta phase in a martensitic matrix. The brittle fracture of this material can be attributed to the type of heat treatment and its martensitic microstructure. The ferrite delta phase affects the mechanical properties and increases the yield stress of the material. On the other hand, it increases the brittleness. Increasing the brittleness of the material can cause the germination of fatigue cracking that by expanding the crack length; eventually the brittle fracture will occur. So we can say that the main reason for the failure of this steel is the high rate of this phase that has caused the piece to fail.

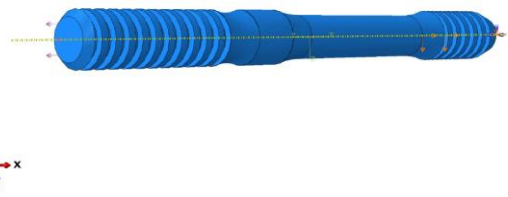
be done dynamically. To apply the boundary condition related to the displacement, using the data resulted from the digital vibration sensor (Fig. 4), we find the maximum value of the displacement and then do a dynamic analysis. To have the maximum displacement, the maximum value of speed is multiplied by the period of oscillation. Fig. 8 shows the way by which the bolt is loaded.

Fig. 8 Load on the simulated bolt.

To consider the boundary condition in the software, the simulation is done for two types of boundary conditions. The head stud is assumed to be fixed and the end of the bolt is assumed to have a periodic displacement.

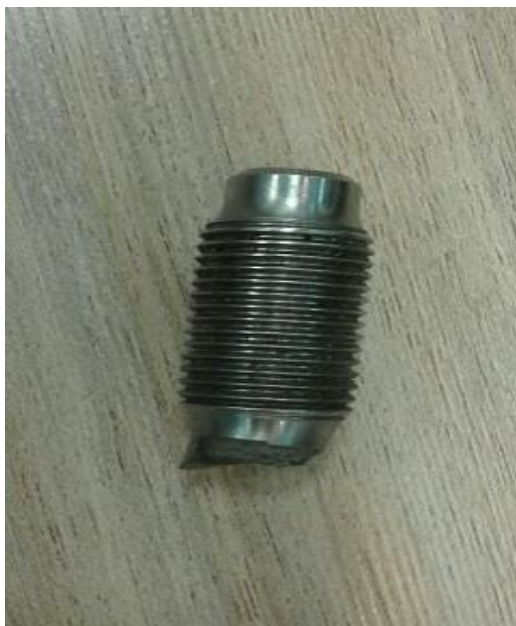
Fig. 11 shows the real failure happened in the bolt, confirming the results of our analysis in Abaqus software.

Fig. 11 Cross section of the failed bolt.

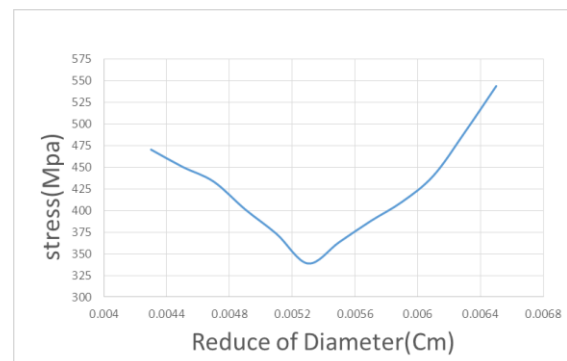
In the initial design of this bolt, the shank diameter was considered 12 mm. The effect of reduction in the shank diameter on the stress by the constant type and loading rate is shown in Fig. 12. As we see in this figure, although, the reduction in the shank diameter results in a decrease in the stress however there is a limitation for such reduction in stress. Because, when the shank diameter decreases more than a critical value, the stresses increase. According to Fig. 12, the optimal value of the reduction in the shank diameter is 0.53 mm. Thus, the optimal value of shank diameter is 11.47 mm. Due to that the vibration loading for this bolt is chosen, that shown in Fig. 12, a small reduction in the shank diameter can cause significant reduction of stress in the critical points of the bolt shank.

Fig. 12 Stress versus reduction of diameter.

The bolt was modeled in Abaqus software and the generated stress was calculated. In the initial design of this bolt, the shank diameter was considered 12 mm. It is shown that by decreasing the shank diameter, the stress first decreases and then increases and the minimum of stress occurs at the shank with a diameter of 11.47 mm. Thus, the optimal value of the shank diameter is 11.47 mm. Also, by increasing the chamfer radius, the stress first increases and then decreases and the minimum of stress occurs at the chamfer radius of 33 mm.

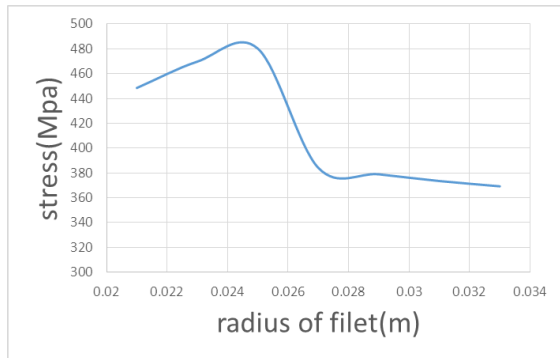
In the following, the variation in the radius of the chamfer and its effect on stress was discussed and the effect of reducing the radius of chamfer, in the part where stud bolt was attached to the shank, on stress was examined. With the reduction of chamfer radius, stress decreases in some critical points and increases in other ones. Fig. 13 presents the effect of change in chamfer radius on stress in the critical points of the bolt where failure occurs. As we see, the reduction in the chamfer radius,

at first, leads to an increase and finally results in a decrease in stress and, in this step; the stress is transferred to other parts of the bolt. According to Fig. 13, the best value of the chamfer radius is 33 mm.

Fig. 13 Stress versus chamfer radius
