Research article

Specifying the allowed remained bottom thickness after milling in CNG steel cylinders by FEM analysis and experimentation

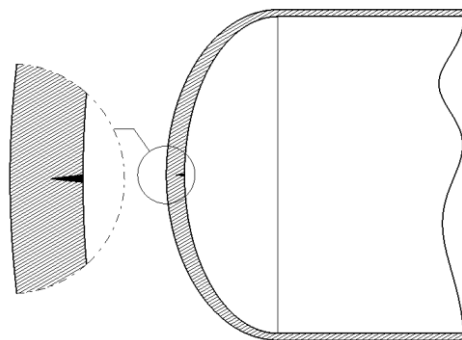
Fig. 1 The heterogeneous region which is created in the bottom of the cup in the spinning process

As shown in Figs. 1 and 2, in the bottom closing step, materials may be heterogeneous in the closed region and there may be a rather big conical crack called ‘channel’ which may cause leakage. To eliminate this region, the bottom side of the cylinder is put under the hot pressing immediately after spinning to form the bottom shape; in addition, this process extrudes the created channel out through the material flow. After this step the extruded area is milled and eliminated [12].

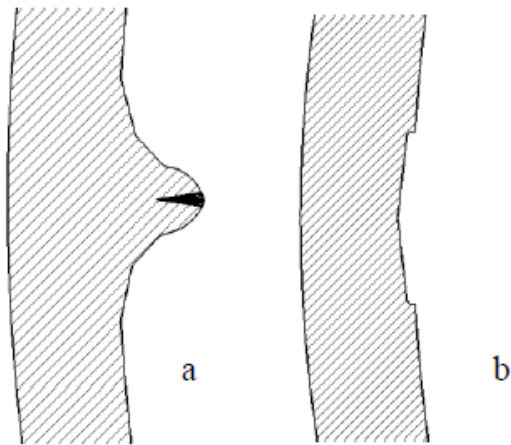
Fig. 2 The heterogeneous region in the cup center (a) After pressing, (b) After milling

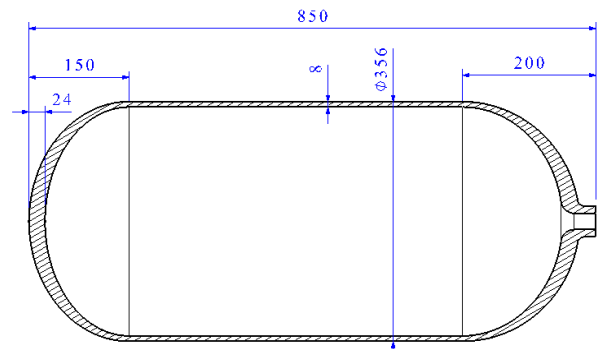
Fig. 3 Dimensional specifications of considered cylinders (mm)

The 62-liter steel cylinder is one of the frequently produced products of the factory, so as an appropriate sample it was chosen for the test. The important Geometrical dimensions of this cylinder are according to Fig. 3.

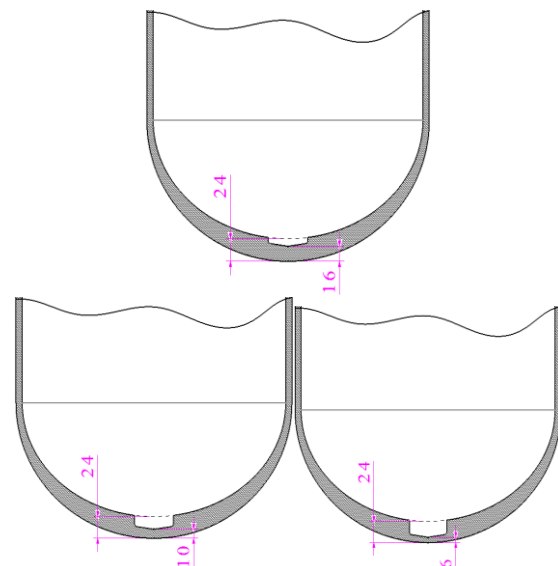
Fig. 5 Milled profile in the three different types of specimens

To confirm and validate the obtained results from FEM analysis, and investigate the fatigue effects and crack growth, 6 normal cylinders consisting of three pairs of samples by the different depths of milled bottom according to Table 3 were used for burst and pressure cycling test. Considering the maximum machining error and operator, the remained thickness cannot become less than 6mm. So, these vessels were produced with low to high critical bottom thicknesses of 16, 10, and 6 millimeters of remained thickness respectively. Samples 1 to 3 were chosen for the burst test and samples 4 to 6 were taken under a pressure cycling test. The results are given in the next sections. The machining depth and remained thickness in created profile in the three different types of test samples are shown in Fig. 5.

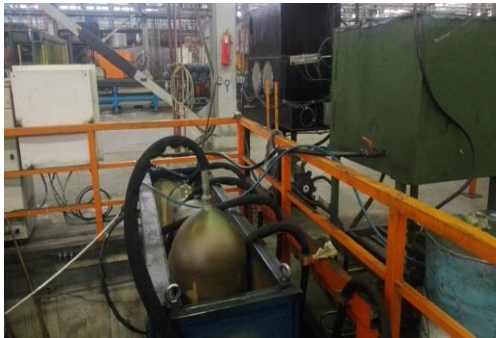
Fig. 6 Pressure cycling test device

After demonstrating the safety of the milled area by static strength assessment, three other vessels, with the same considered condition, were used for the cycle pressure test to ensure resistance to the effects of fatigue and crack growth. In the process of this test, firstly, the cylinder is filled with the hydraulic oil and after mounting the connections, it will be under the periodic cycling pressure between 30 and 300 bar while the number of cycles is recorded. It should be said that, according to the related standard [1-2], vehicle cylinders must pass at least 15000 cycles of filling and emptying without any leakage. The pressure cycling test device is shown in Fig. 6.

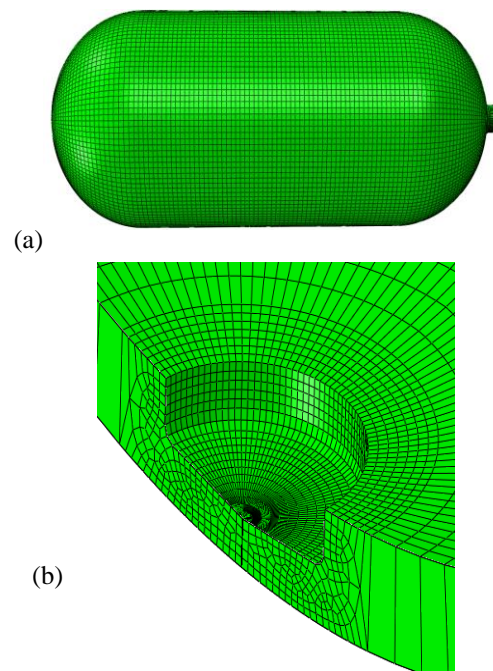
After applying the above conditions and solving the problem, the contours of Von Mises stress distribution would be according to Fig. 8. Outer surface of the vessel body, (b) Sweep mesh of the milled area.

Fig. 7 Meshed structure of storing vessel: (a)

more than 480bar [1]. Having this, specimens were analyzed under hydrostatic pressure of 480bar. ABAQUS 6.10-1 software was used to simulate the pressure applying process. To apply boundary conditions, cylinders were clamped from the neck thread. A Hexagonal type mesh structure of about 8 millimeters size was considered on the sample. To obtain more accurate results in the milled area, in a circle in this region with a 5cm radius, hexagonal elements by the approximate size of 2mm were distributed by sweep technique [13]. The meshed structure is shown in Fig. 7.

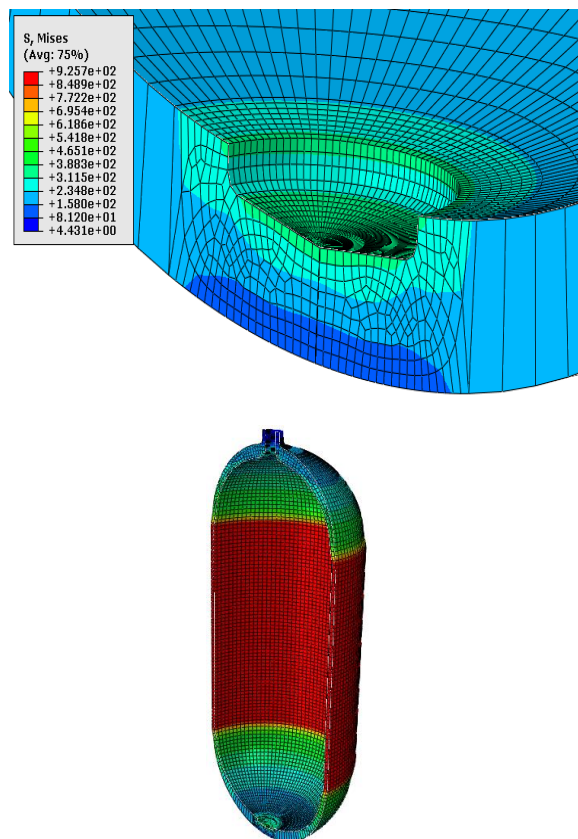
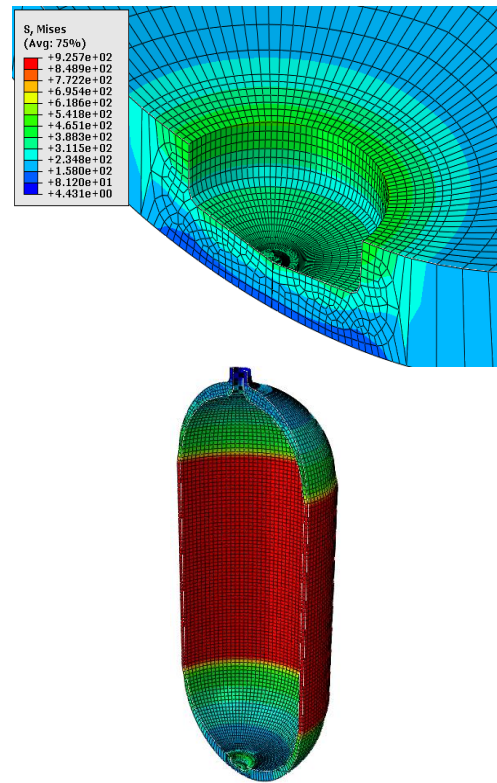
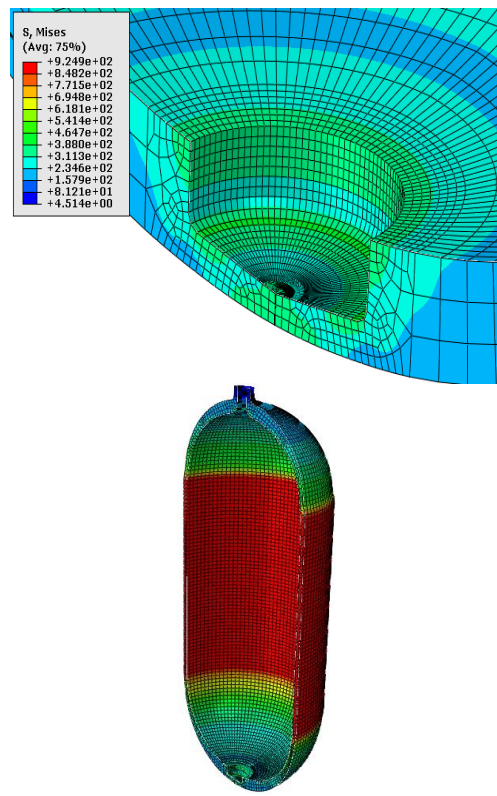
Fig. 8 Distribution of Von Mises stress, (a) remained thickness 16mm (b) remained thickness 10mm (c) remained thickness 6mm

Looking at the stress distribution in Figs. 8 and 9, it can be seen that in the first and second cases (remained thickness of 16 mm and 10 mm, respectively), the maximum stress on the wall (cylindrical region) by about 925 MPa is much more than that of the milled area by about 388 MPa. This issue provides an extended safety border for the milled area. In the third case (remained thickness of 6 mm), the cylindrical part is also more critical than the milled area. However, according to the graph, in these conditions, the average of Von Mises stress along the central bottom thickness is about 1.7 times more than two other specimens; so, it can increase the possibility of failure in the milled area, especially in fatigue presence.

Moreover, by comprising the stress distribution in the central thickness of the milled region (Fig. 8), it is confirmed that in all three specimens, by moving from the external surface to the internal, the Von Mises stress consistently increases to the maximum amount of around 390 MPa. It means that the internal milled surface is more critical than the external surface and failure would begin from this region. Therefore, the surface needs to be finished well to avoid creating cracks and fatigue failure [5].

As it is obvious from Table 4 and Fig. 8, in all three specimens the failure was in the cylindrical part under the pressure of around 565 bar while the milled bottom endured this pressure and remained safe and without any signs of failure.

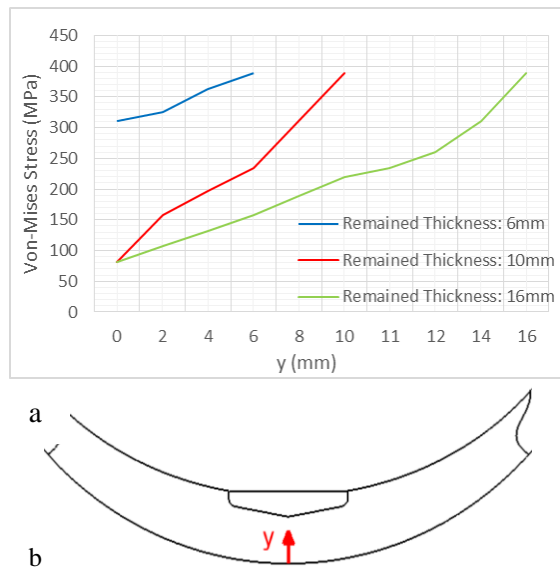
Fig. 9 (a) The graph of stress distribution in the central thickness of machined area in three specimens, (b) Direction assignment to the stress measurement.

In Fig. 9, the graph of stress distribution in the central thickness of machined area in three specimens and direction assignment to the stress measurement.

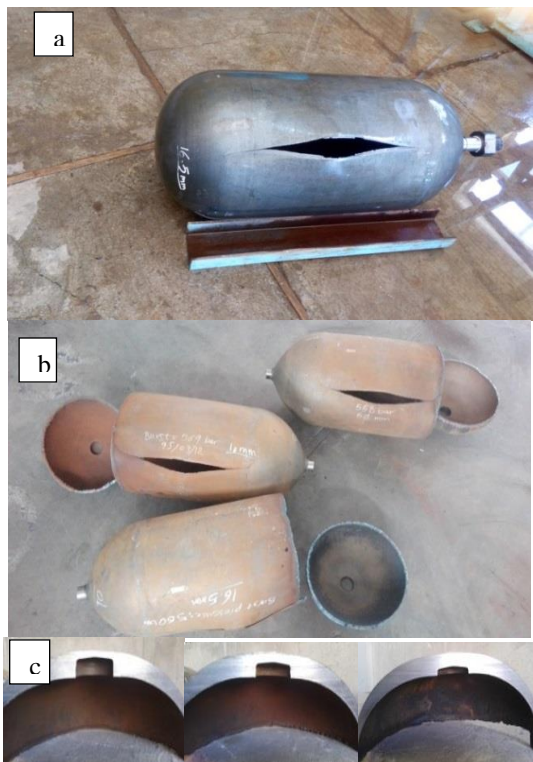
Fig. 10 (a) Cylinder just after burst (b) The bottom of cylinders are cut after burst (c) the section views of bottoms for checking the milled area.

Obtained results of burst test can be seen in Table 4. In addition, some images of the burst cylinders and also sections of the milled region are given in the Fig. 10.

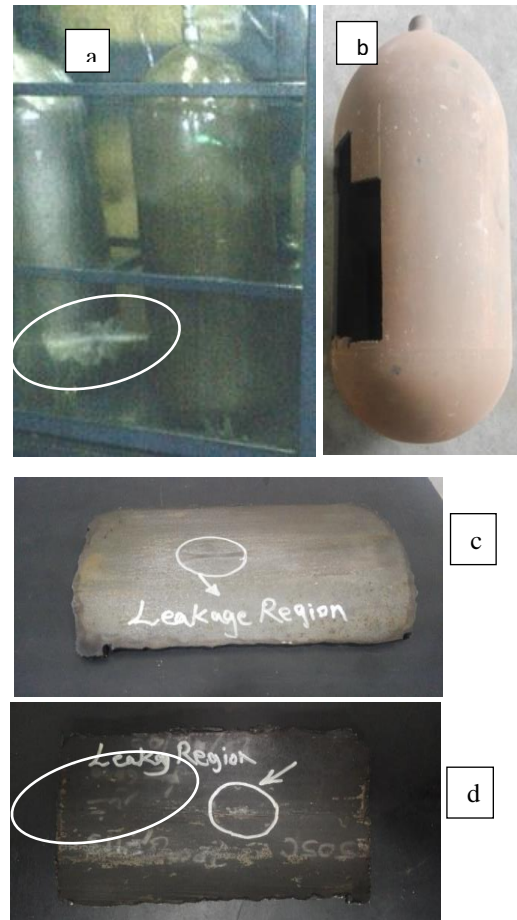
Fig. 11 (a): cylinder is leaking from the cylindrical part under test, (b): the leakage area is cut out to internal and external inspection, (c): external surface of leakage area, (d) internal surface of leakage area

The results of pressure cycling tests are given in Table 5. As it can be seen, all three vessels passed 12000 cycles which is the required number for approved products. In the worst-case 6-mm remained thickness, loading had been continuously done until leakage appeared after 35260 cycles which is nearly three times more than the specified number. As it can be seen from Fig. 11, even in this case, in addition to significant resistance to fatigue failure, the leakage occurred through an about 5cm axial crack on the cylindrical part of the vessel.
