## Biological and microbiological factors involved in the corrosion of concrete structures and solutions to deal with the corrosion of concrete structures

**Mohammad Mahdi Zakai**

Bachelor's student in civil engineering, Islamic Azad University, Lahijan branch  
Responsible author: Mohammad Mehdi Zakai (mohamadmehdizakai@gmail.com)

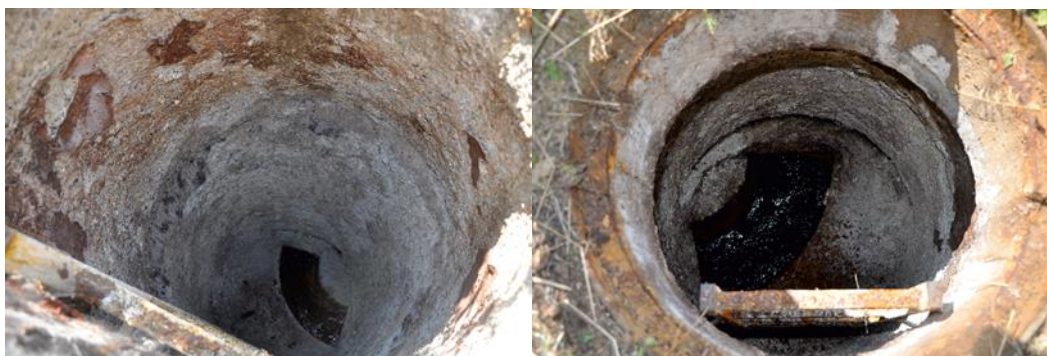
**Fig. 1. Typical damage of concrete elements caused by MICC in different sewage systems (Grenng et al., 2018).**

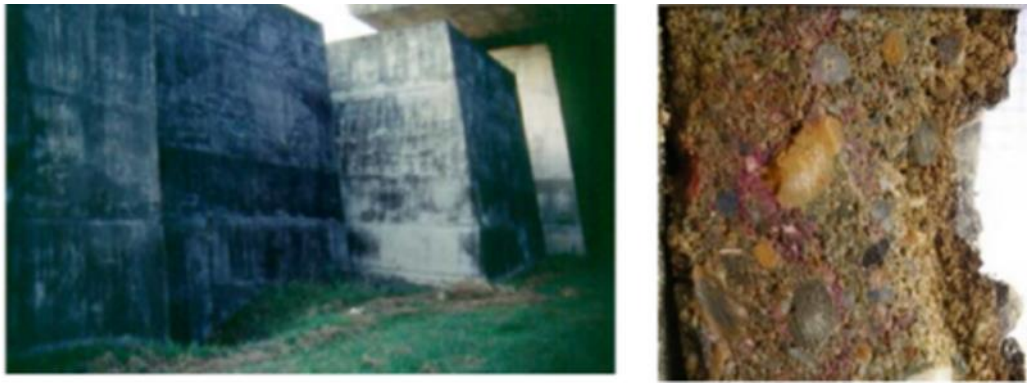
**Fig. 2. cases of biological degradation of concrete (Jiang et al., 2022).**
