Investigation of the causes and prevention of corrosion in the 11-megawatt electric motor of the Khatun Abad copper melt oxygen plant

¹ Senior Expert in Planning and Status Monitoring, Engineering Affairs, Shahre Babak Copper Complex, National Copper Industries Company of Iran. Shadman.mj61@gmail.com

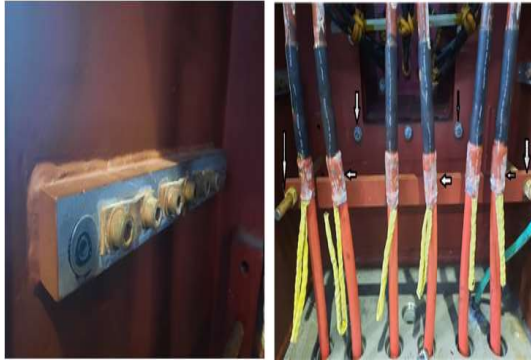
Figure 2: Corrosion in the electric motor power panels.

As illustrated in Figures 1 and 2, corrosion is observed in various parts of the electric motor. Considering the critical importance of the motor in the oxygen production process, further investigation and resolution of this issue have been undertaken, as detailed below.

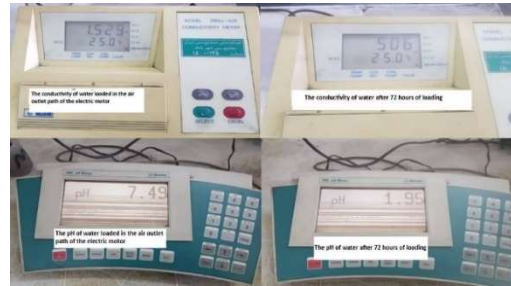
1. Investigation of the gas emitted from the electric motor housing and its effects on water properties (details provided in Activity Description, Item 1) (Figure 3).
2. Analysis of the Grounding System of the Electric Motor and the Oxygen Plant, and the Proposed Modifications to the Existing System Description of Activities Performed (Section 2) (details provided in Activity Description, Item 3) (Figure 4).

Figure 3: Examination of the type of gas emitted

To investigate the type of gas emitted from the electric motor, in addition to the initial mercury test, two further experiments were designed and carried out, as described below (Figure 3). First Experiment: Initially, 800 mL of demineralized water was prepared, and its pH and electrical conductivity were measured. The initial pH was recorded as 7.49, and the initial electrical conductivity was 1.52 $\mu\text{S}/\text{cm}$. Subsequently, the water was exposed for 72 hours to the gas released from the motor housing via the drainage outlet of the water leakage detection switch. The results revealed a significant drop in pH to 1.95, accompanied by a substantial increase in electrical conductivity. These findings clearly indicate that the emitted gas is acidic in nature. In the second experiment: To identify the constituent molecules of the air inside and outside the electric motor housing, an analysis of the air was performed. The results revealed that the concentration of ozone inside the motor housing was higher than that of the surrounding ambient air. This indicates that the electric motor generates ozone gas. (Tables 1 and 2)

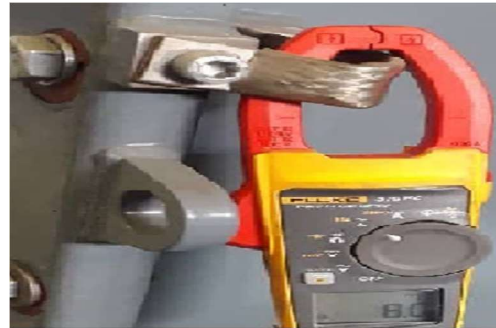
Figure 4: Examination of the electric motor grounding system and the presence of circulating currents

oxygen plant is a rod-bonded configuration, and based on the measurements performed, the system's resistance does not meet the required standard, with the measured value being approximately 40 ohms. Moreover, due to the presence of circulating currents in the bonding loops—caused by the high resistance of the plant's grounding system—these currents are discharged through the outer casing of the electric motor.

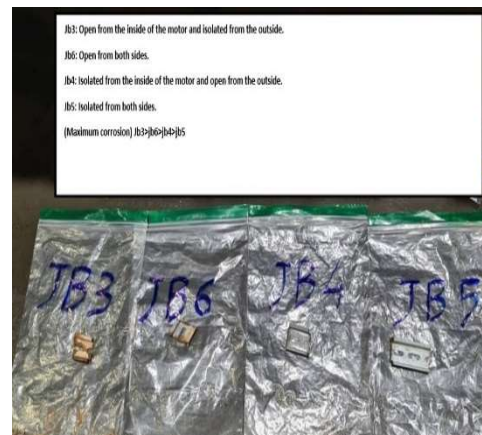
3. Examination of Existing Samples of Component Corrosion (Figures 5, 6, and 7)
4. Disassembly of the Electric Motor Cooler, Cleaning, and Restoration of the Insulation Coating

Figure 5: Available samples of corrosion on
