Investigation and Effective Indicators of Failure and Leakage in Water and Sewage Transmission Lines (Case study: Ghadir Water Transmission Lines in Khuzestan Province)

Keywords: Water Transmission, Transmission Lines, Leakage, Pipeline, Bursting and Leakage, Pollution and Problems, Ghadir Water Supply Project

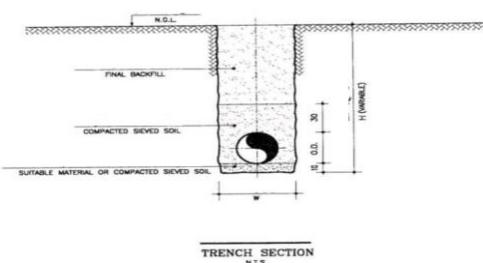
support system is also an important factor. When the intubation path crosses unfit country (eg mud, sand, etc.), in accordance with some guidelines, it is sometimes necessary to remove sub-quality materials and replace them with better alternatives. For establishing a stable foundation for the piping system, materials such as concrete, stone, mortar, granulated stone, riverbed materials, or selected soils will be employed for trench stabilization on site's specific locations. The trench bottom will be prepared to allow for the piping after the building foundation is completed. The minimum trench width will be affected by pipe type, pipe diameter, trench depth, and soil attributes. Suggested net width of the trench floor for soil compaction within and over the pipe for pipes outside diameter 500 mm the suggest net width of the trench floor for soil compaction around and above the pipe is 40 cm + outer diameter of pipe in centimeters. For the external diameter of the pipes more than 500 mm, the recommended trench floor width (soil compaction) is (60 cm + OD). For trenches of 1.5 m depth, an extra width of 60 cm is recommended, and if the trench exceeds 2 m depth, a minimum width of 80 cm should be maintained for the safety and installation purposes. [26]

Figure 2 A view of the trench section of metal intubation

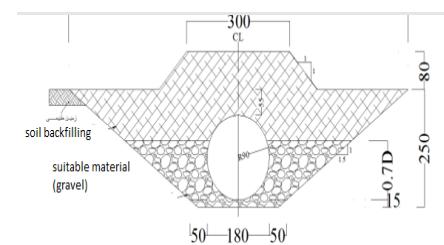
Figure 3: A view of piping in the cascading trenches

It should be noted that in this area, the level of groundwater level did not cause any administrative problems and its level was very low.

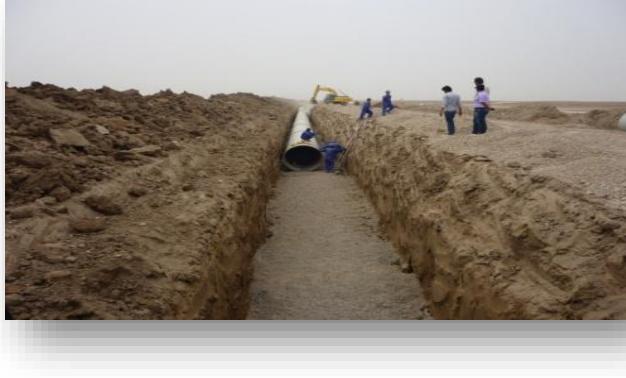
Figure (6) A view of GRP piping in vertical trench with appropriate substrate

The main substrate recommendations must be communicated with contractor and this will be discussed in the following sections. Water-consuming industrial and institutional customers must be identified. Analyzing table 1 (includes 13 owners of high water consumption) indicates that: One of the reasons behind water deficiency in Khuzestan province is leaking. Thus the periodic investigation and the reasons of leaking in the turbine pipes in Ghadir and other water pipes that transfers water in Khuzestan province must be identified. Informed by a large-scale in situ investigation, conducted on about 10 water distribution projects in Khuzestan Province, the factors causing the pipes to leak and fail can be listed out. [13]

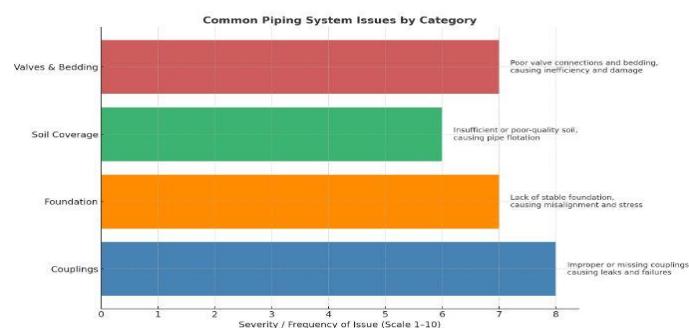
Graph(1) the common difficulties and issue in the pipe line

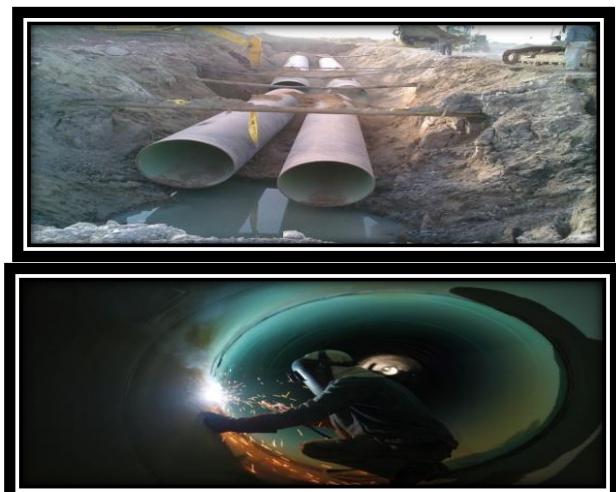
figure (7): Improper substrate of GRP pipes figure (8): Lack of proper welding of metal pipes and the presence of residual stress[11]

This displacement can disrupt the sealing of couplers, allowing contaminants to enter or fluids to escape. Such issues are frequently tied to a lack of attention to detail during backfilling or an attempt to cut corners by skipping soil

quality assessments, both of which undermine the system's long-term reliability. Finally, deficiencies in connecting valves and preparing proper bedding further contribute to these recurring challenges. Valves, which regulate flow and pressure, must be meticulously installed to function correctly; any misalignment or loose connection can lead to operational inefficiencies or catastrophic failures. Similarly, the bedding—the layer of material supporting the pipes—must be carefully selected and compacted to prevent settling or movement. When bedding is poorly executed, perhaps due to the use of unsuitable materials or inadequate compaction techniques, the pipes lack the necessary support, amplifying the risk of damage. These issues, though avoidable, persist due to a combination of human error, insufficient oversight, and a failure to prioritize quality at every stage of the process.

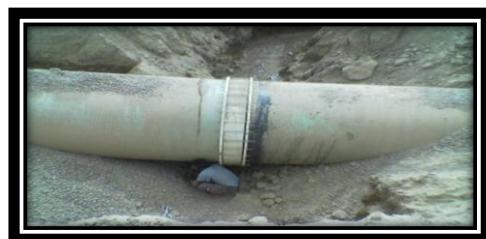
Figure (9): There is erosion under the GRP pipe bed
Image

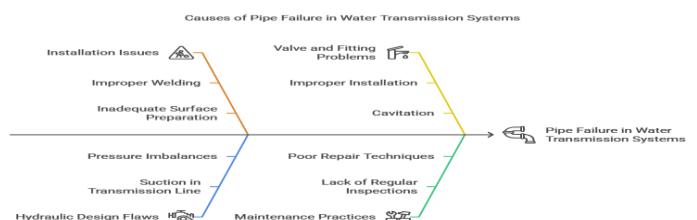
Picture (6): the nomogram of pipe failure in transmission system

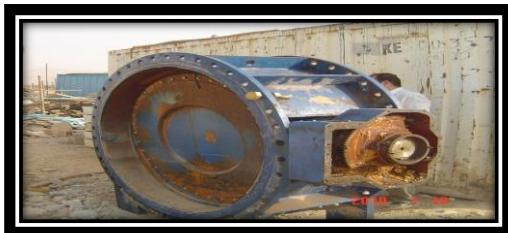
Figure (10) A view of the destruction of butterfly valve due to lack of proper connection

The leakage issue described above is primarily attributed to improper installation practices, particularly the misalignment of valve connections and the failure to establish a proper foundation under the valves before dewatering. Misalignment of the two sides of the valves and connections creates uneven stress distribution, leading to weak points where leaks are likely to occur. Additionally, the absence of a stable foundation under the valves exacerbates the problem, as the lack of support causes the valves to shift or settle unevenly during dewatering. These installation errors highlight the critical importance of precision and adherence to best practices during pipeline construction to ensure long-term system integrity.

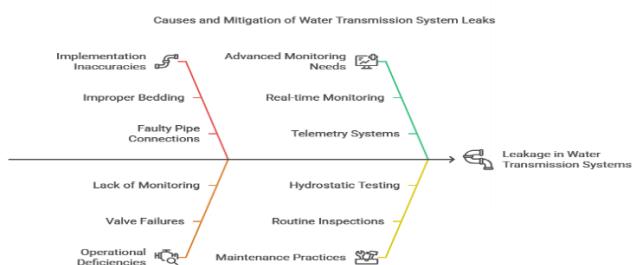
Picture (7): a review of leakage on the infrastructure water pipe line project

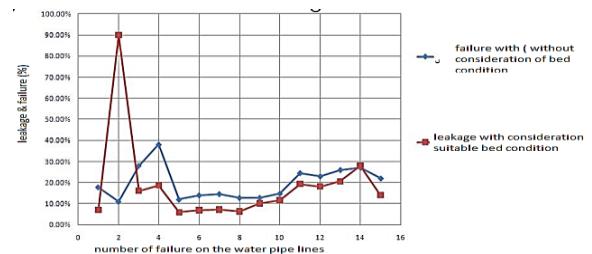
Diagram (1): Leakage rate in proper and inappropriate bedding mode

A key finding from the study is the critical role of proper bedding in reducing leakage rates. As illustrated in Diagram (1), the leakage rate in pipelines with proper bedding is approximately 6.2% lower than in those with inadequate bedding. This underscores the importance of ensuring that pipelines are installed on a stable and well-prepared foundation. Proper bedding not only prevents structural stress on the pipes but also minimizes the risk of fractures and misalignments, which are common causes of leaks.
