## Investigation of the causes and prevention of corrosion in the 11-megawatt electric motor of the Khatun Abad copper melt oxygen plant

Article info	Abstract
<p><b>Keywords:</b> Ozone, Nitric Acid, Partial Discharge, Corrosion, High Voltage, Ionization.</p> <p><b>Article history:</b> Received: 25 01 2025 Accepted: 01 10 2025</p>	<p>High-voltage electric motors are increasingly employed across industrial sectors due to rising energy demand and the expansion of energy-intensive processes. Given their high capital cost, complex operational conditions, and critical role in industrial continuity, improving efficiency and reliability is essential. Even minor degradation mechanisms can result in significant economic losses through unplanned downtime, reduced performance, and premature failure. One of the most critical degradation phenomena in high-voltage motors is partial discharge (PD), which occurs when localized electric fields exceed the dielectric strength of insulation systems, producing micro-scale electrical discharges. Partial discharge imposes combined thermal, chemical, and electrical stresses that progressively deteriorate insulation and surrounding components. In gas-coole

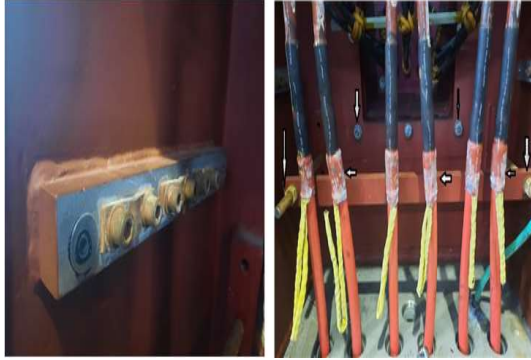
**Figure 2:** Corrosion in the electric motor power panels.

precision instruments installed within the electric motor panels after a short period, causing serious damage to this equipment. To analyze the current situation and gather more information, an inspection of the interior of the panels was conducted, and photographs of the corrosion on the electrical equipment were taken, as shown below. Figures (1 and 2)

As illustrated in Figures 1 and 2, corrosion is observed in various parts of the electric motor. Considering the critical importance of the motor in the oxygen production process, further investigation and resolution of this issue have been undertaken, as detailed below.

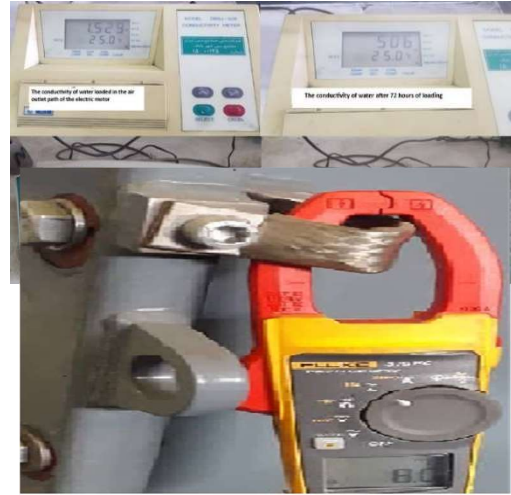
**Figure 4:** Examination of the electric motor grounding system and the presence of circulating currents

1. Considering that the grounding system of the oxygen plant is a rod-bonded configuration, and based on the measurements performed, the system's resistance does not meet the required standard, with the measured value being approximately 40 ohms. Moreover, due to the presence of circulating currents in the bonding loops—caused by the high resistance of the plant's grounding system—these currents are discharged through the outer casing of the electric motor.

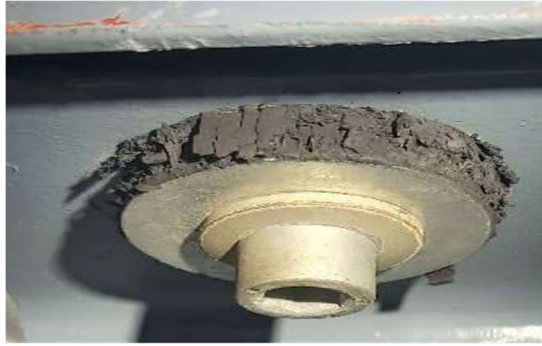
**Figure 6:** Presence of corrosion on the elastic rubber components

Ozone gas attacks any type of polymer that includes double bonds in its carbon chain. Rubber products such as latex, nitrile rubber (NBR), and styrene-butadiene rubber (SBR) are susceptible to ozone attacks. As a result of these attacks, cracks appear on the surface of these polymers, which increase in depth and width over time. The extent of this degradation depends on the concentration of ozone in the atmosphere and the load (weight) borne by the rubber. These types of rubber are protected against ozone degradation with the help of “antiozonant” materials, such as wax. Rubber gaskets and O-rings, which play

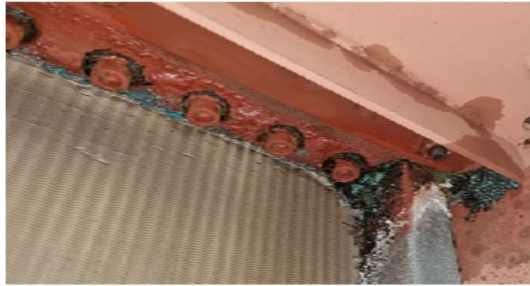
**Figure 7:** Corrosion of parts of the cooling cooler

3. Examination of Existing Samples of Component Corrosion (Figures 5, 6, and 7)
4. Disassembly of the Electric Motor Cooler, Cleaning, and Restoration of the Insulation Coating

- ✓ Opportunistic/overhaul maintenance, including:
    - ✓ Disassembly and servicing of the cooling unit.
    - ✓ Leakage testing of the cooler.
