Investigating the Reason for Compressor Gearbox Gear Failure in Arfa Iron and Steel Company using Analytical and Fracture Studies

Abstract: Given the application of gears in various industries including steel industries, studying the reasons for failure in gears before reaching the end of their lifetime is of great importance. In this study, a gearbox was investigated which included a gear and a pinion. After four years of use, the teeth of gear and pinion along with the shaft attached to the gear were fractured. The fracture had occurred suddenly and with a lot of noise. The fracture in gear and pinion were in the teeth while the fracture in shaft occurred in the keyway. At the beginning of the study, shaft and gear design equations were used to evaluate the suitability of each of the parts in the system using theoretical equations and then fracture type was determined using fracture studies and the accuracy of analytical results were determined. In the analytical study, the results showed that the fracture is due to improper design for the gear shaft leading to more than one million unites of load on the shaft leading to cracks in the keyway and misalignment between gears causin

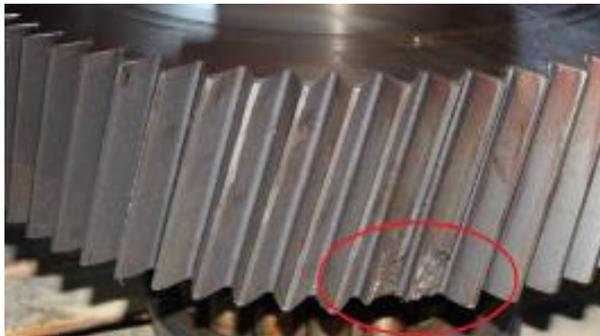
The damage in the gearbox is seen in two neighboring dents (Fig. 2) and another dent a distance away for the previous ones (Fig. 3). One dent on the pinion and two cracks on the shaft on the attachment point are shown in Figs (4 & 5).

Fig. 2 Two neighbouring damaged dents on the gear

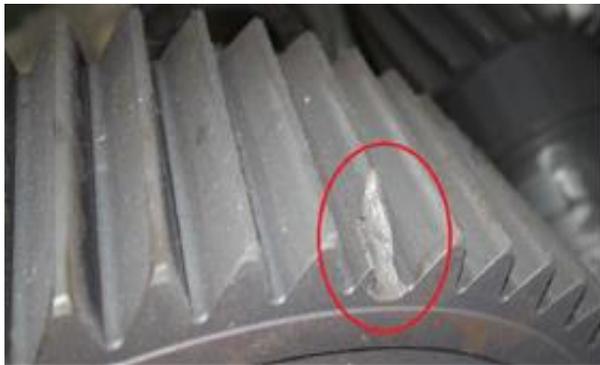
Fig. 3 The lone damaged dent on the gear

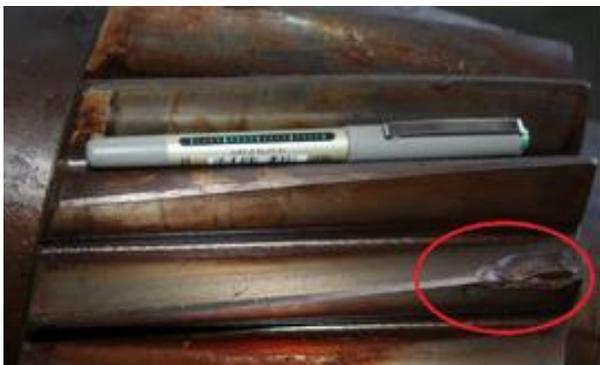
Fig. 4 The damaged dent on the pinion

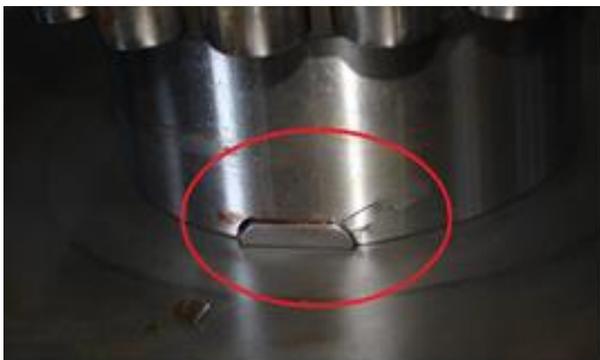
Fig. 5 Damaged location on the shaft

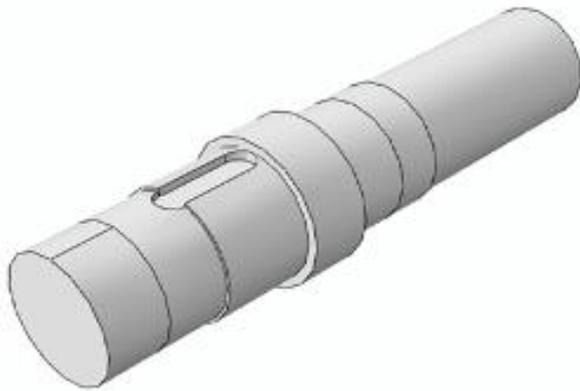
According to Fig. 6, the main diameter of the shaft is 200mm and the diameter in keyway is 210mm.

Fig. 6 Three-dimensional map of the gear shaft

Based on standard values and for improved safety, the diameter of 200mm selected for gear shaft is not suitable and the preferred diameter is 240mm.

Therefore, the shaft diameter at keyway should be 270mm instead of 210mm.

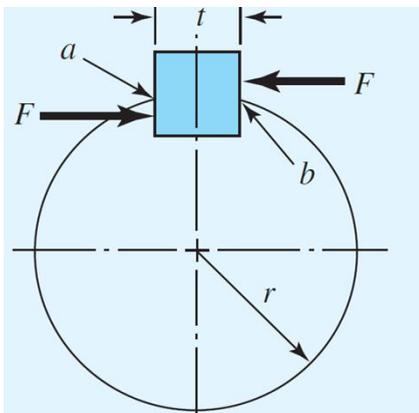
The length of the key should be designed based on compression and shear stress. Here, since the length of the key is known (110mm), the safety coefficients for these two conditions are controlled. Fig. 7 shows key parameters.

Fig. 7 Key parameters

The new key will have the dimensions of 63*32*110mm [14]. It is worth noting that the depth of keyway on the shaft is 20mm and 12mm of the key is inside of the keyway.

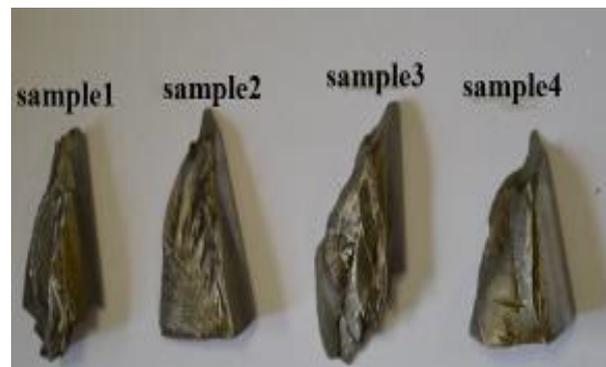
The fracture surfaces of the gear were investigated as shown in Fig. 8 in order to determine the reason for failure.

Fig. 8 Pictures of the failed parts

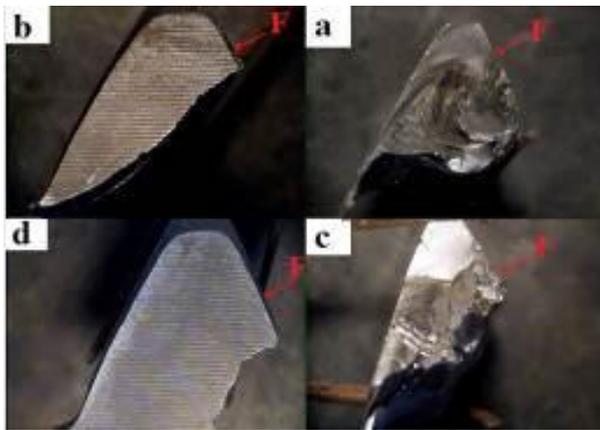
During the visual investigation of the fractured samples, it was determined that all samples were fractured at two-third of the height from dents' base (Fig. 9), which is the location with the highest shear stress.

The surfaces of the samples also show signs of overheating as changes in color which could have happened during operation due to insufficient lubrication or due to misalignment. Overheating can lead to creation of residual stress and changes in surface structure and facilitates the formation of cracks.

Fig. 9 Stereomicroscopy images from lateral surfaces of the samples and the direction of the forces on a-d gears for samples 1 to 4

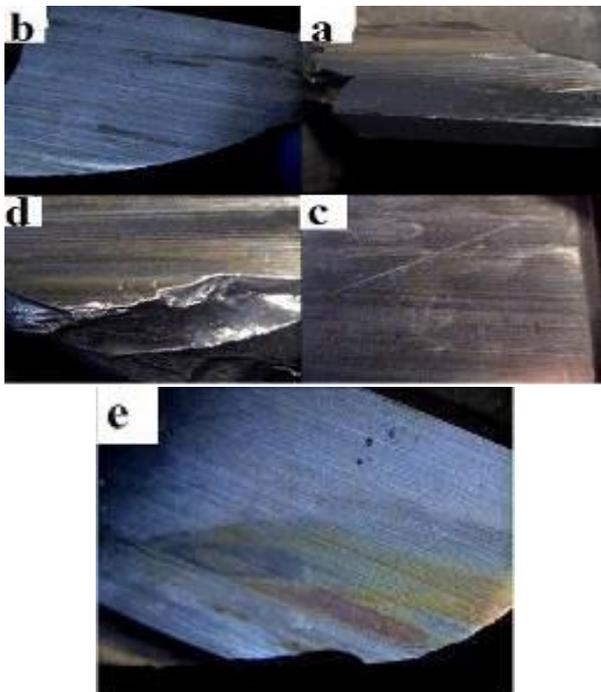
The signs of discoloration due to overheating on the samples' surfaces can be seen in Fig. 10. This discoloration was more intense and varied in sample 4 while it was less varied in sample 2. Only in samples 1 and 3, the signs of overheating are seen on the surface where the fracture has started.

Fig. 10 (a, b): The signs of overheating on the gears, (c): variety of signs in sample 1, (d): variety of signs in sample 2, (e): variety of signs in sample 4

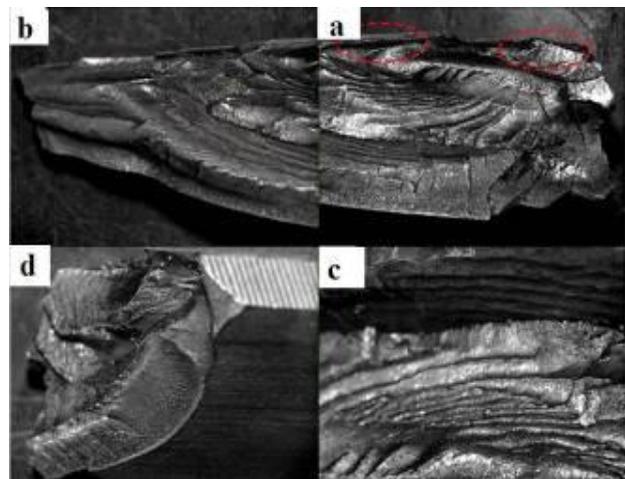
The study of the fracture surfaces showed that all samples except sample 3 have wave-like fracture surfaces which shows an unstable growth of cracks due to sudden impact force while the changes in the waves' directions shows the growth directions of the cracks. These lines show

significant plastic deformation. The stress concentration points and starting locations of the cracks are shown in figures with red circles. The images show that plastic deformation is higher in samples 1 and 2 and has happened since the start of the fracture which shows the presence of a high load. Stereomicroscopy image of sample 1 and sample 2 are shown in Figs. 11 and 12, respectively. Based on the fracture in samples 3 and 4 and comparing the surfaces of the gears, it can be said that samples 3 and 4 are the first to fail and samples 1 and 2 are the final fracture surfaces. For this reason, fracture surfaces in samples 3 and 4 were selected for further studies. Also the Stereomicroscopy image of sample 3 and sample 4 are shown in Figs. 13 and 14, respectively.

Fig. 11 Stereomicroscopy image of sample 1: (a), (b), and (c): wave-like fracture and (d): brittle fracture on the lateral surface of the gear

Based on the results of analysis of the fracture and based on the wave-like formations at fracture start points in samples 1, 2 and 4, there has been considerable plastic deformation due to high loads and these three gears have failed due to excessive load. In the gear 3, the presence of small cracks on the structure shows that high load has led to fracture and deformations of the gear. There is no plastic deformation resulting from high loads in this sample due to expansion of the cracks.

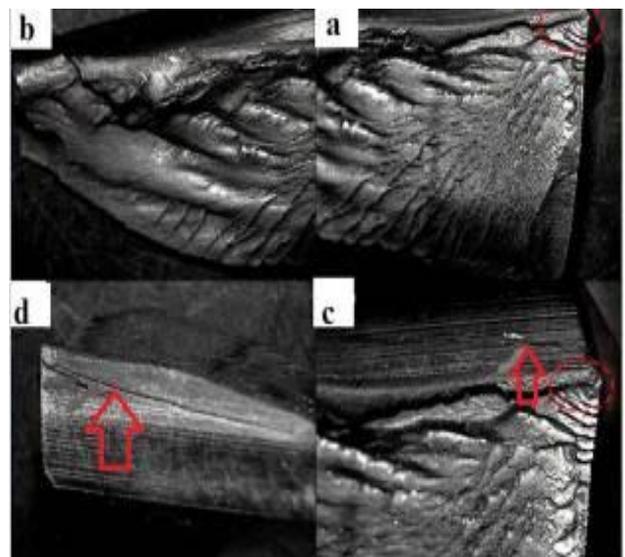
Fig. 12 (a, b): Stereomicroscopy image of wave-like fracture and (d, c): cracks in sample 2

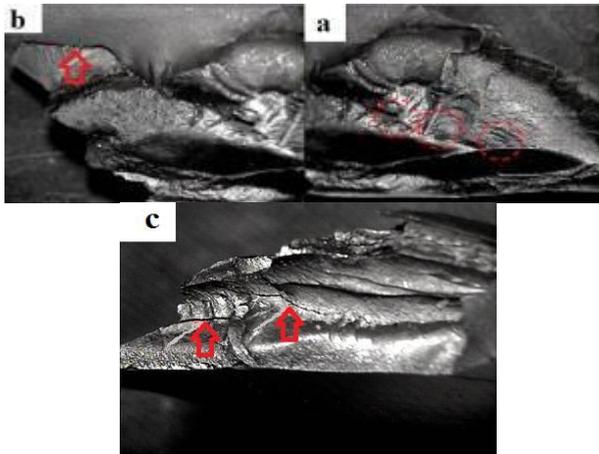
Fig. 13 Stereomicroscopy image of sample 3: (a): numerous points of stress concentration, (b) and (c): cracks under the surface and at the center of the sample

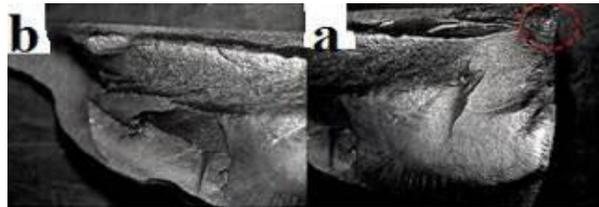
Fig. 14 (a, b): Stereomicroscopy image of wave-like fracture sample 4

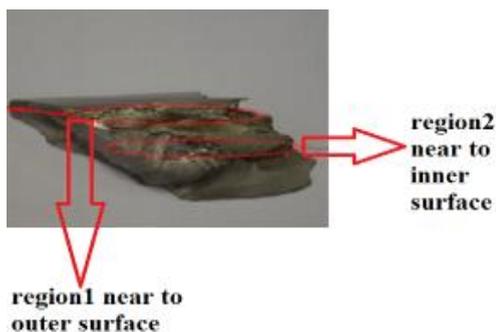
The supplementary fracture studies were carried out using SEM method. To this end, the surface of sample 3 was investigated at two locations of fracture's start and center of the gear and it was determined that all fractures are brittle and from grain boundary type. The fracture regions are shown in Fig. 15. A large part of the fracture at the center of the sample was damaged due to abrasion but investigating the intact parts showed that there are numerous cracks at the center and under the surface which might have structural sources. There were also traces of impact on the sample's surface which can be the reason for expansion of cracks and final fracture. SEM images of outside and center of the sample 3 are demonstrated in Figs. 16 and 17, respectively.

Fig. 15 Investigated locations using SEM in sample 3

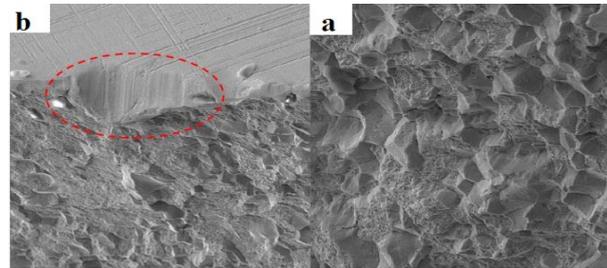
Fig. 16 SEM image of brittle grain boundary fracture near the surface of sample 3 and traces of impact on the outside surface

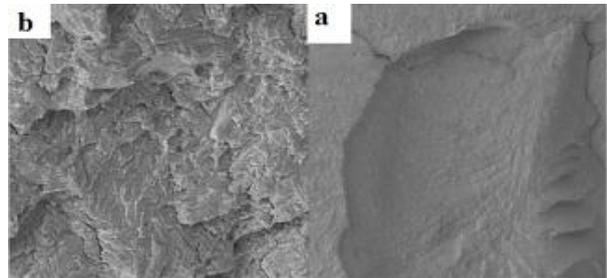
Fig. 17 SEM images of brittle fracture and cracks at the center of sample 3

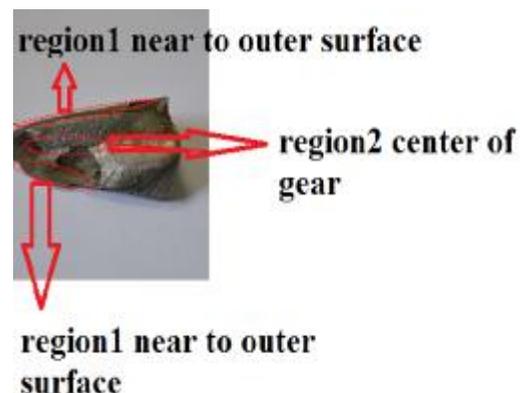
Investigating sample 4 at the start of the fracture and at the gear's center showed that the fracture surface is a mixture of soft and brittle fractures. Its fracture regions are shown in Fig. 18. The edges leading to the outside surface show brittle grain boundary fracture while the center of the sample showed soft fracture. It is worth noting that in fractures resulting from sudden application of force, it is possible to see a mixture of soft and brittle fractures simultaneously. SEM images of outside and center of the sample 4 are demonstrated in Figs. 19 and 20, respectively. This characteristic of fracture surface can also be due to microscopic differences between surface and center of the gear in which harder surfaces show increased brittle fracture while at the center fracture is often soft. A large part of the fracture surface at the center was unrecognizable due to abrasion.

Fig. 18 Investigated Locations using SEM in sample 4

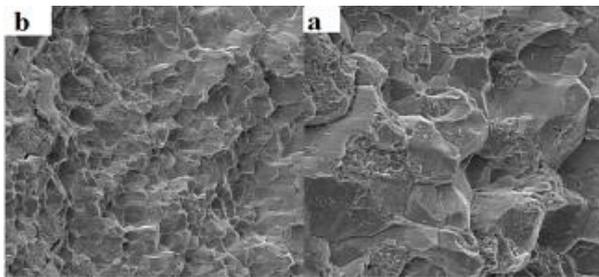
Fig. 19 SEM image of brittle fracture near the surface of sample 4

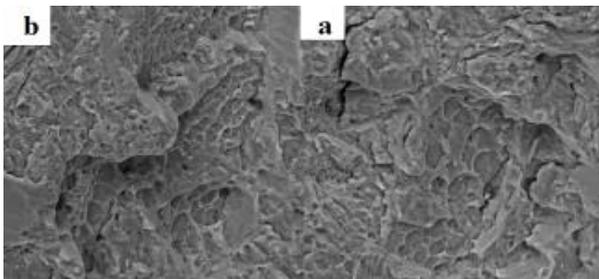
Fig. 20 SEM image of soft fracture at the center of sample

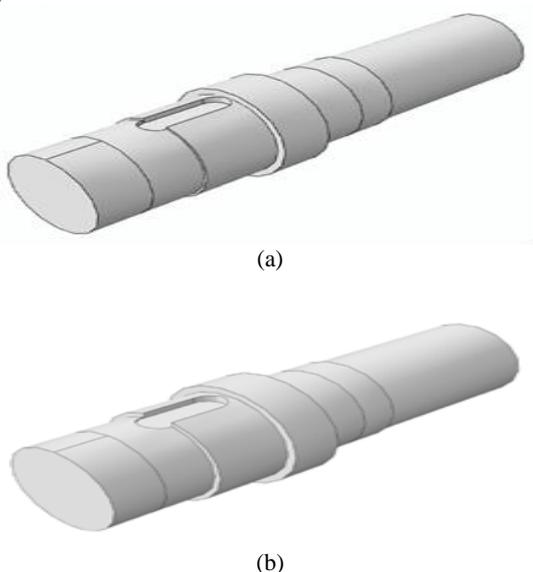
The results of the analysis were used to redesign a new shaft. The goal of stress analysis is to investigate the strength of the structure under maximum load and also to identify critical stress concentration points in the designed structure. These results are used to make the necessary corrections in the initial shaft design. 3d models of old shaft and redesigned shaft are shown in Fig. 21.

Fig. 21 3D model of (a) old shaft (shaft No. 1), (b) the redesigned shaft (Shaft No. 2)

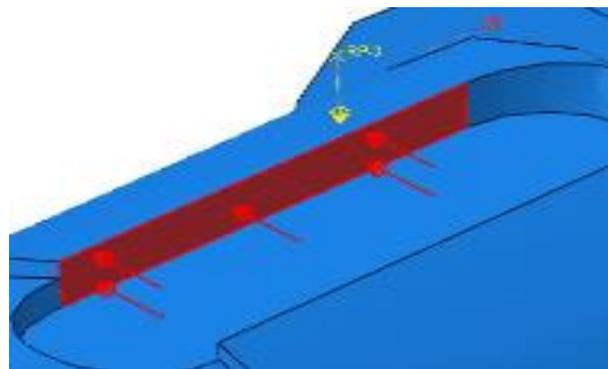
The shaft is tethered in the radial direction at the location of bearings, in the rotational direction (θ) at the compressor's location (loading location) and in the longitudinal direction at the bearing support in the middle of the shaft. The rotational torque applied to the shaft using gear's key is applied as expanded compression loading on the keyway. Therefore, the force w_t is distributed on the cross section of the keyway and is applied as a compression force on the keyway's wall in ABAQUS software (Fig. 22).

Fig. 22 Force applied at the keyway's wall in shaft 1 and 2

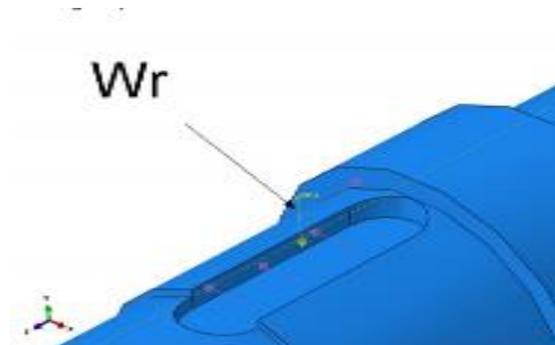
The lateral force applied from pinion to the shaft, W_r , is applied to the upper surface of the shaft at the location of the gear as a concentrated force (Fig. 23). Since solid elements are not capable of handling concentrated forces, a reference point is used for this force.

Fig. 23 Radial loading for shaft 1 and 2

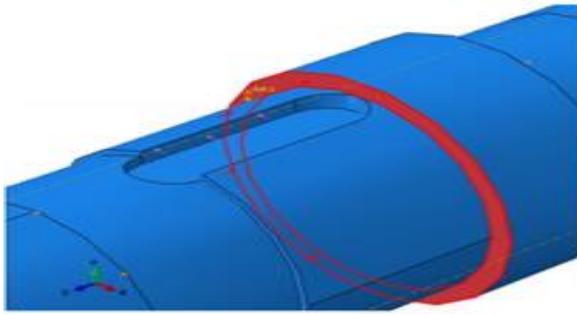
The longitudinal force applied by the pinion to the shaft, W_a , is tolerated by the outer ring of the middle bearing and is applied as a compression force similar to W_t on the support bridge of the hear (Fig. 24).

Fig. 24 The longitudinal force applied from pinion to shaft 1 and 2

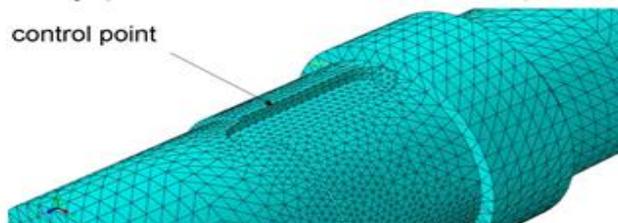
The proper size of elements is determined using meshing studies. To this end, the point shown in Fig. 26 is selected and the size of elements close to that point is changed and model's stress analysis is repeated after each change. By drawing the graph of stress that the selected point versus the size of elements, the dependence of results on meshing is determined. The selected point is located at the stress concentration location.

Fig. 26 The selected point for stress analysis

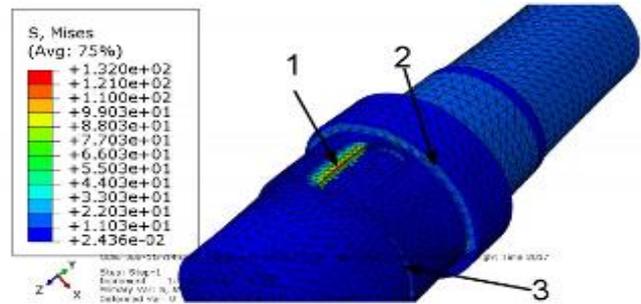
The results of meshing study are shown in table 4 and Fig. 27. Based on these results, the size of 14 millimeters is suitable for elements because using elements smaller than 14 mm leads to no significant changes in the results.

that after the edge of the keyway, maximum stress locations include the half-cycle near gear's support bridge (area 2) and the step near the bearing (area 3). It is necessary to mention that cracks in the shaft (Fig. 28) show the presence of maximum stress at these locations and therefore confirm the results of finite element analysis.

Fig. 27 Von Mises stress for shaft 1

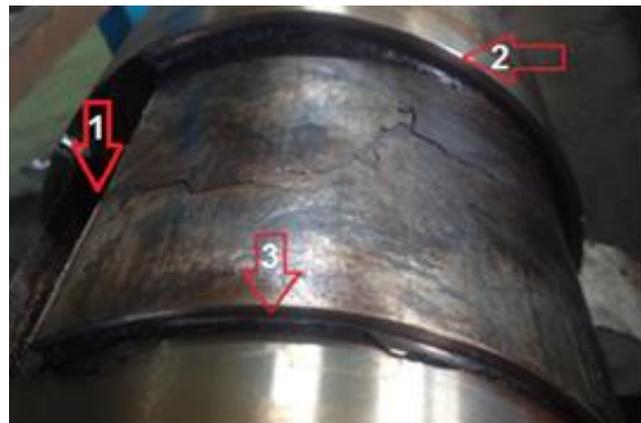
Fig. 28 The fractured gear shaft

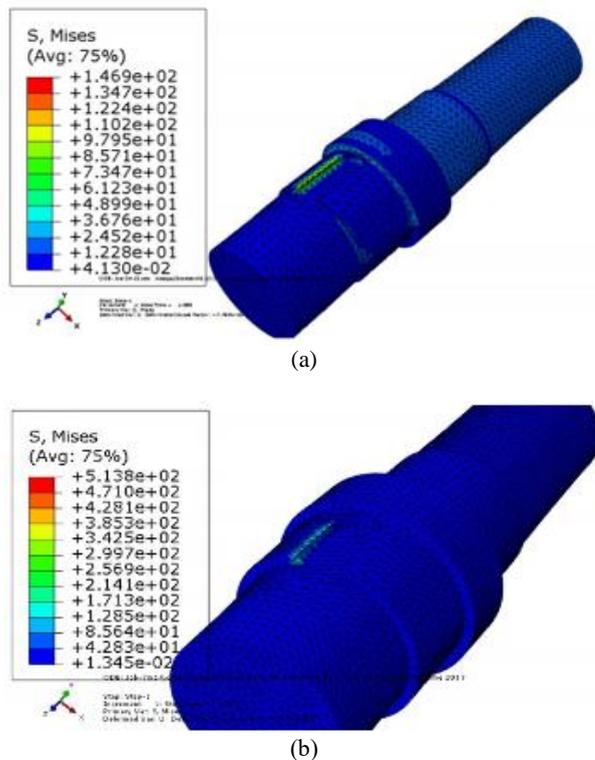
Afterwards, the redesigned shaft was analyzed using ABAQUS software. The results showed that despite improved stress distribution in the entire shaft and at locations near keyway (Figs. 29a and 29b), maximum stress has increased due to sudden change in area and creation of sharp edges at the location of the keyway.

Fig. 29 Stress distribution in (a) shaft 1 and (b) shaft 2

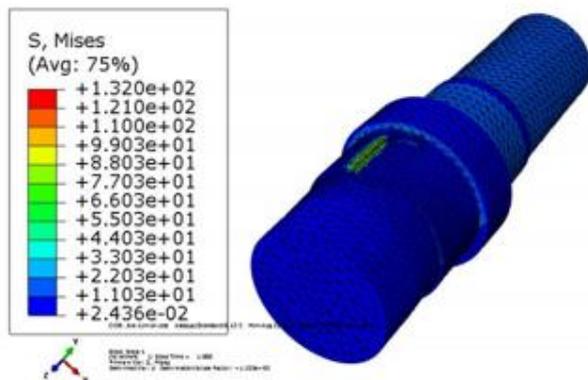
Therefore, based on these results and in the allowed range determined using design calculations, shaft diameter is modified in two stages until the problem is solved. The suitable diameter determined from repeated stress analyses is 251 mm. the results of the final shaft design is shown in Fig. 30. As can be seen, in this shaft, both the stress distribution and maximum stress are reduced.

Fig. 30 Stress distribution in redesigned shaft 2

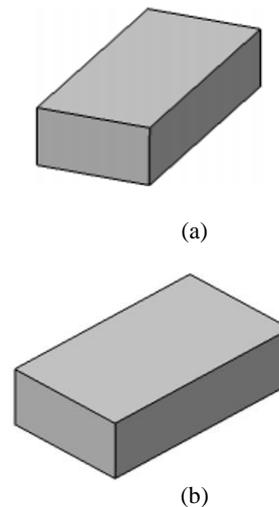
The three-dimensional models of old and redesigned keys are shown in Fig. 31.

Fig. 31 Three-dimensional model of (a) key 1 and (b) key 2

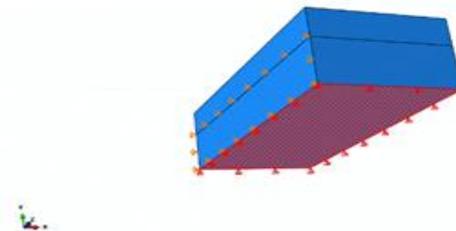
The border locations applied to the key is as follows: The side of the key that touches the keyway is tethered at the direction of shaft's radius (y axis, Fig. 32).

Fig. 32 Tethering of key's bottom for key 1 and 2

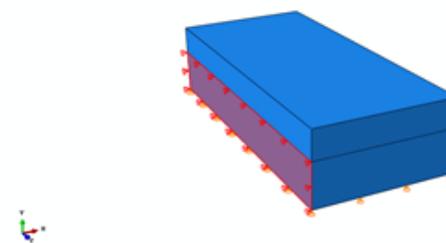
The part of key's side which transfers rotational torque to the shaft (Fig. 33) is tethered at the direction of x axis.

Fig. 33 The tether of side of key 1 and 2

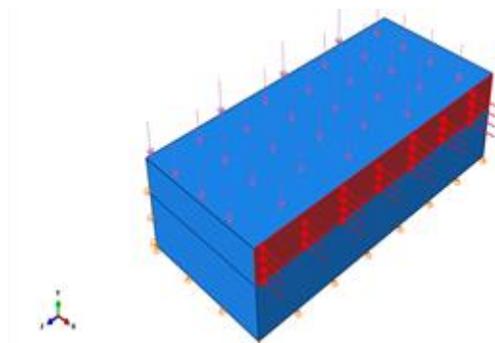
The loadings are as follows: The rotational torque applied to the shaft is applied as an expanded load to part of the key's wall from the wall of gear's keyway as a result of W_t force. This force is applied as a compression force due to being divided by the cross-section of keys 1 and 2 (Fig. 34).

Fig. 34 The force applied on the wall of key 1 and 2

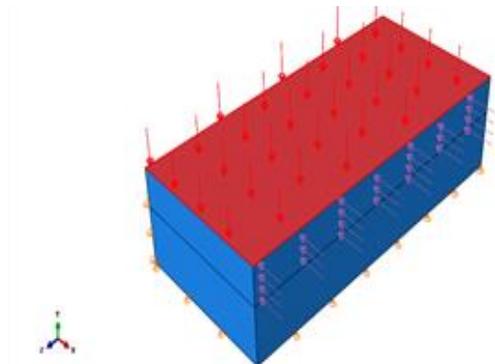
The force W_r is applied from gear to the key (Fig. 35). This force is directly applied to the cross-section of key 1 and 2 as a compression force.

Fig. 35 The radial force applied from gear to key 1 and 2

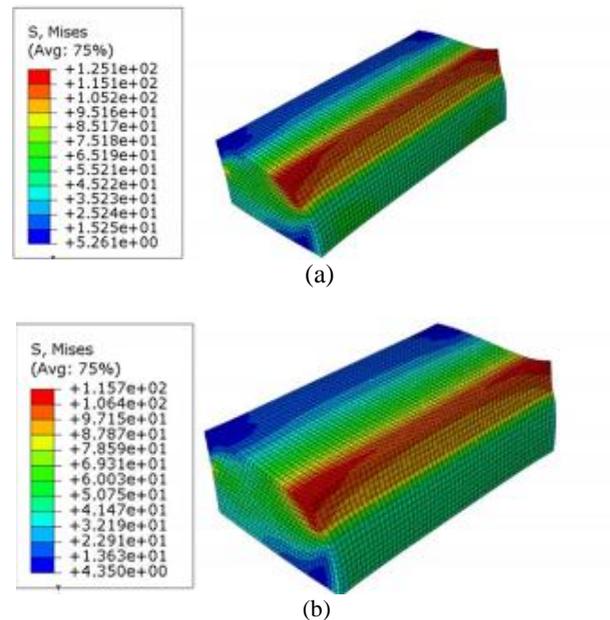
The results of stress analysis for key 1 and 2 are shown in Fig. 37.

Fig. 37 Stress distribution in: (a): key 1 and (b): key 2

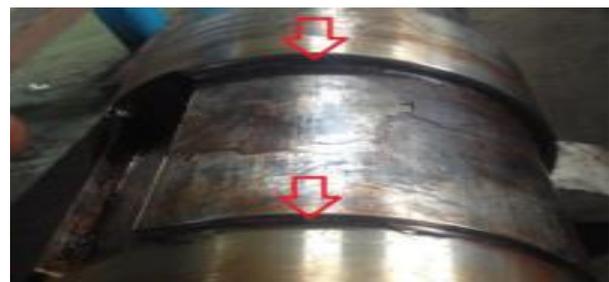
Based on these facts, it can be concluded that fatigue caused by more than one million cycles has led to creation and expansion of cracks on the stress concentration locations (keyway and the location with different shaft diameter, Figs. 38 and 39). Since the length of the key was longer than necessary, instead of damaging to the key, the shaft has been damaged which had led to the fracture. The creation and expansion of cracks on the shaft has led to misalignment of gears with each other, leading to abrasion and finally fracture.

Fig. 38 Cracks at stress concentration points of the diameter change location

Investigating the gearbox showed proper design in gears but intense stress concentration at the location of keyway, due to small diameter. In other words, the shaft diameter should be 270mm. while main shaft diameter was 240mm. Investigating the design of the key revealed its excessive length which led to a safety coefficient of 1.3 and lack of fracture.

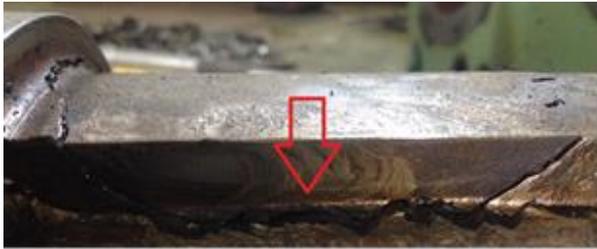
Fig. 39 Crack expansion from stress concentration points in the keyway
