## MONITORING PROCESS OF THE RE-CONSTRUCTION OF AN ANCIENT STRUCTURE: THE BALUARTE DO CAVALEIRO

Jorge Pinto<sup>1</sup>, Humberto Varum<sup>2</sup>, João Guedes<sup>3</sup> and Anibal Costa<sup>4</sup>

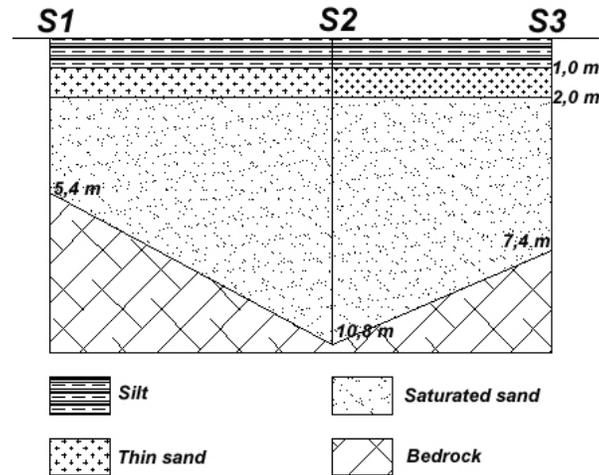
Figure 4(b) shows the soil that has been supported by the wall (December 2005). This soil has the following constitution: 1.0 m thick organic soil as the first layer; 11.5 m thick of embankment type of soil as the second layer. This soil is extremely consolidated because it allowed an almost vertical cut, Figure 4(b). Exploration drilling tests were done in the downstream side of the SE wall in order to identify the foundation soil. The results of these tests concluded that the foundation soil has the following typology (see Figure 5): the first layer is a 1.0 m thick of silt; the second layer is a 2.0 m thick of thin sand; the third layer goes down to until the bedrock and is formed by saturated sand which varies in terms of granulometry from thin to thick. The bedrock depth is around 5.4 m near the *cunhal* that connects the SE and SW walls (test S1), 10.8 m in the middle span of the SE wall (test S2) and 7.4 m near the *cunhal* that connects the SE and NE walls (test S3).

Figure 5. Results of the exploration drilling tests done in the downstream side of the SE wall (Tested by Material and Soils Laboratory of UTAD)

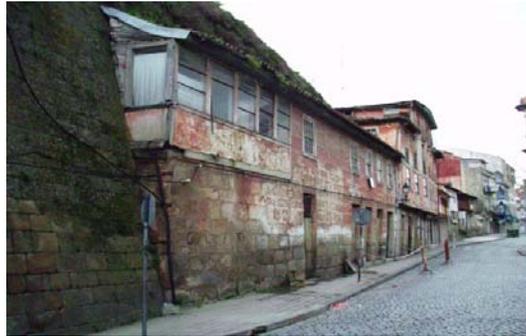
The SE wall has suffered two partial collapses recently. The first one occurred in March 2001 and the second one occurred in April 2002. Until March 2001, existed buildings attached to the SE wall all over its length, as can be seen in Figure 6.

Figure 6. SE wall of the Baluarte do Cavaleiro and the existing attached buildings before March 2001

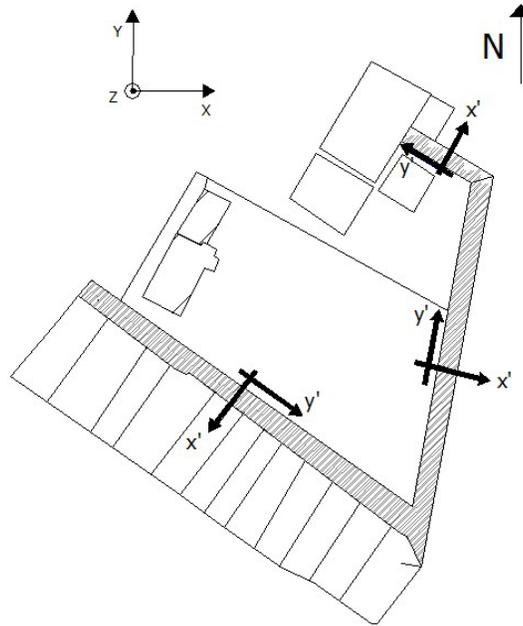
The location of the defined set of key-points (identified from 1 to 36) and the adopted notation for the controlled building (identified from A to L) can be seen in Figure 8. The coordinates of these points were measured using a pulse laser station NIKON-302 (Nikon 2007) and according to the traditional surveying techniques. Those coordinates were initially measured in a global coordinate system  $(x, y, z)$ . In order to simplify the analysis of the results those coordinates were then converted in a local referential ( $x'$ - direction perpendicular to the construction,  $y'$ - direction parallel to the construction,  $z'$ , vertical), as represented in Figure 9.

According to the technical specifications of the used surveying instrument (Nikon 2007), its accuracy can be measured using the expression  $\pm(3+3\text{ppm}\times D)$  mm, in which:  $D$  is the distance (in km) from the surveying instrument to the reflector. Thus, the key-points of the NE wall had no expressive displacements during the reconstruction process of the SE wall, these displacements were mainly related to the normal behaviour of the NE wall as being a stone masonry wall structure. We may conclude that the tasks related to the reconstruction process did not affect the stability of the NE wall. In fact, as it was stated before, the key-point 8 was the one that had shown a higher value of displacement and, at the same time, it was the most far away from the rebuilding area, Figure 8(b).

The key-points 12 and 13, Figure 8(c), were defined to monitor the cunhal that connects the SW and SE walls. Their displacement evolution is shown in Figure 13. In this case, there was not a generalised increasing trend on the component displacement of these key-points either; the average value of these components was less than 2.0 mm. These facts indicate that this structural element was not affected by the reconstruction process of the SE wall.

A similar situation had happened for the cunhal that connects the SE and NE walls for which the related key points were 4 and 5, Figure 8(b). The displacement component evolution of these key points is described in Figure 15 where we can notice that until the 116<sup>th</sup> measurement (June 2006) there were not expressive value of displacement. However, from this measurement, the vertical component of displacement of both key points had increased which indicates that these key points went up. This evolution had inverted from the 158<sup>th</sup> measurement (November 2006) and the vertical component of displacement evolution converged to 0 mm, Figure 15.
