Analysis of the Fracture of a Turbine Blade

A.R. Shourangiz Haghighi¹, S.Rahmanian¹, A. Shamsabadi^{2,*}, A. zare³, I. Zare²

Received 18 February 2016; accepted 5 April 2016

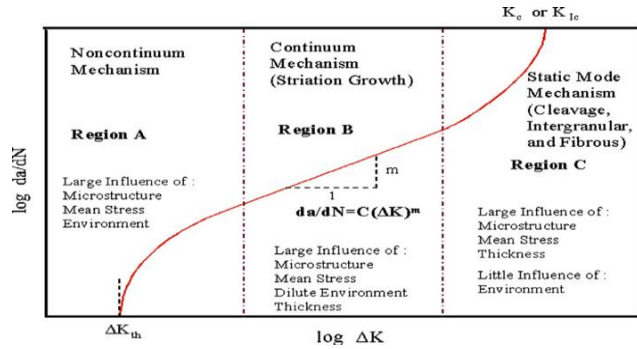
The schematic plot of fatigue crack propagation rate is shown in Fig. 9. It shows, in detail, that region A is mostly influenced by environment, microstructure and mean stress. It was shown by Mercer for Ni-based superalloys that the mechanisms of fatigue crack growth had a different range of DK for the crack-tip intensity factor [33, 43]. At higher portion of the Paris regime, fracture mechanism transfers to a striated mode. It was similarly reported by Luo and Bowen that the fracture surface is faceted at the lower DK levels while striated at higher DK levels [12, 34]. The phenomena of fractured blade, which have cleavage-like fracture (region A), striations (region B), and dimples (region C) in stages, are fitted with above theory and it is a good sign for us.

Fig.9 Schematic plot of fatigue crack propagation rate [1, 12].

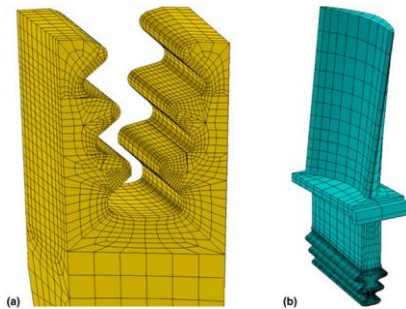
Parametric geometry models of disc and blade were made, using the MSC-Patran 2009 program. The FE model of disc is shown in Fig. 12(a) which consists of 11,220 nodes and 10,360 first-order HEX-8 elements.

Note that the discretized model of the blade, is shown in Fig. 12(b) consists of 11,430 nodes, 22,248 first-order HEX-8 elements.

Fig.12 Finite element models of the disc segment (a) and blade (b).

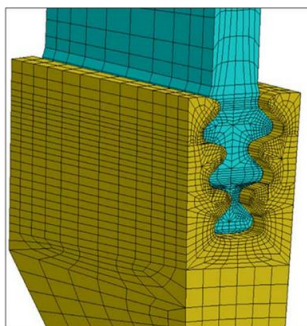
Fig.13 Assembled model of the disc/blade segment in the vicinity of fir-tree slots.

In order to model the mechanical interface of nearby surfaces of the disc or blade, the “master-slave” type of contact with friction coefficient of 0.15 was well-defined for analysis [38,39]. As it can be seen, Fig.13 clarifies the assembled model of the disc or blade section.

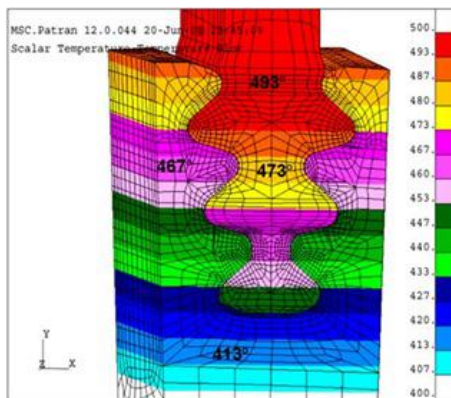
A rotating hot section component in a turbine engine is in general subjected to a combination of aerodynamic loads, thermal loads, and centrifugal loads. The surface loads are associated with aerodynamic forces [40]. The centrifugal loads arising from the mass of the rotated disc and blades which are generally the most critical loads acting on a turbine disc. Then, this load was easily determined through finite element calculation (after defining the axis of symmetry). In this work, the operational turbine speed of 12,500 rpm was applied. Furthermore, the computation for the rotational speed range of 0–23,000 rpm were made so as to analyze the phenomena which occurring in the turbine during extreme speed. Fig.14 clearly shows the simplified thermal load in Celsius scale.

Fig.14
Thermal field defined for models of disc and blade in the dovetail-rim region.

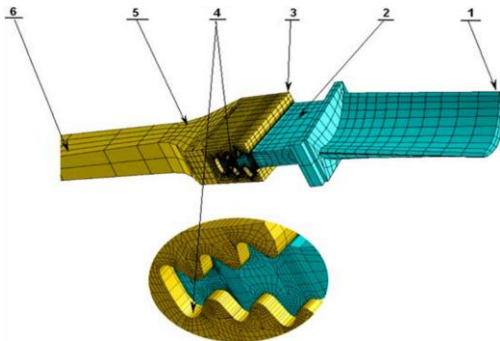
For all results, Mega Pascal (MPa) units is used in order to describe the stress. The additional aim of this work was to indicate the critical areas with excessive rotational speed. For this purpose, in the numerical model the following characteristic points, shown in Fig. 15 as follows:

- (1) Top part of the blade,
- (2) Bottom part of the blade (connection between fir-tree slots and blade),
- (3) Outside corner of the disc,
- (4) Corner of 3rd lower slot of the dovetail-rim region of disc,
- (5) Central part of disc,
- (6) Bottom part of disc.

Fig.15
Specified control points of turbine blade.

The specified points were too useful to control the stresses and plastic strains of the turbine blade during its acceleration from 0 to 23,000 rpm.
