Evaluation of Acoustic Emission Inspection of Oil Tank Floor via Tank Bottom Plates Thickness Measurement

Abstract: This paper deals with an inspection of defects including corrosion and leakage by Acoustic Emission (AE) in an oil tank floor. 5 AE sensors have been attached to an oil tank and the sensors were calibrated by pencil lead break test. The emissions have been recorded within an oil tank. The oil tank was not emptied and had an amount of oil for the test unlike other test methods like magnetic flux leakage, eddy current or ultrasonic. The test method and formulas of AE investigation and AE source location are presented in detail. The result of AE test in the studied oil tank verifies the presence of corrosion in some areas of the tank floor. After AE test, the tank was emptied and inspected using ultrasonic thickness meter. The result of thickness measurement reconciles in an acceptable manner with AE test.

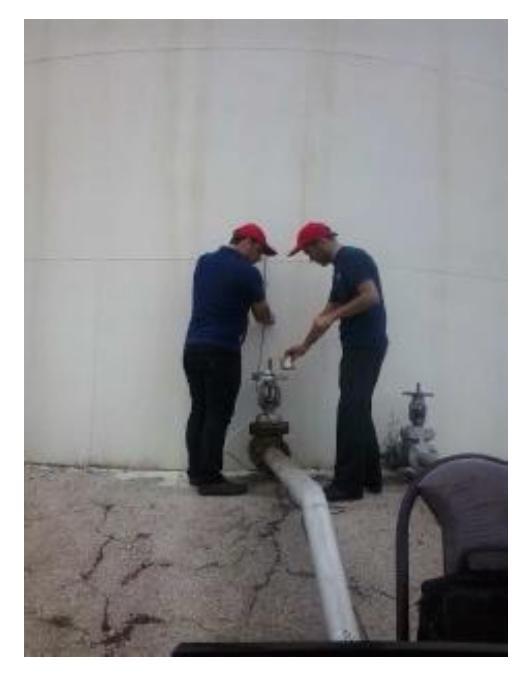
Fig. 2. AE sensor installation (TETA Co.).

To meet the standard sensor arrangement, five AE sensors were mounted along the circumference of the tank wall by 6 m space at the level of 1.5 m above the tank bottom (Fig. 2). All sensors were 24 kHz resonant frequency with integral preamplifier and 10 kHz high pass filtering which matches well with the bottom plates defect (Fig .3). The sensitivity of sensors was calibrated using pencil lead break. The calibration testing was carried out by threshold level of 70 dB. A MICRO-II SAMOS-32 from PAC (Physical Acoustic Corporation) which is a 32 channel acoustic emission system used to acquire the AE data which was equipped with a keyboard, a mouse and a monitor. AE data collection was performed with a threshold level of 40 dB.
