Physical and Numerical Investigations of Gas Turbine Blades Failure**H.R. Faridi¹, A. Momeni¹, M. Mohammadpour¹, V. Sarfarazi^{2,*}**¹*Department of Materials Science and Engineering, Hamadan University of Technology, Hamadan, Iran.*²*Department of Mining Engineering, Hamadan University of Technology, Hamadan, Iran.**Received: 15 July 2017 - Accepted: 27 August 2017***Abstract**

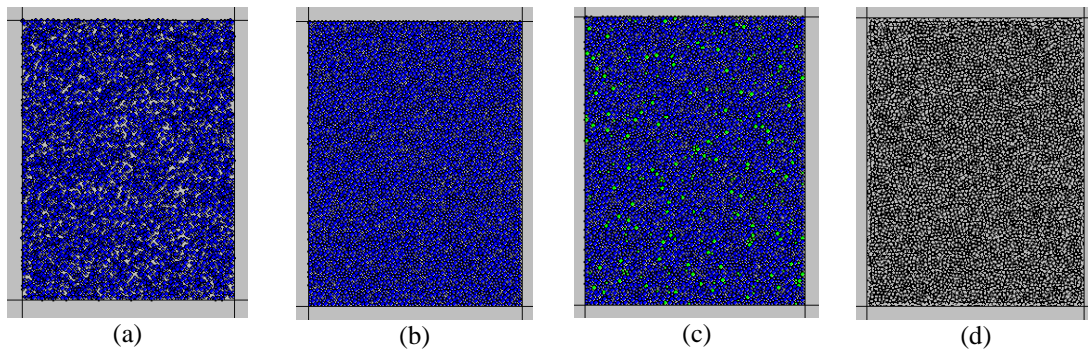
Fig. 6. The standard process of generation of a PFC₂D assembly to represent a test model involves four steps: (a) particle generation and packing the particles, (b) isotropic stress installation, (c) floating particle elimination, and (d) bond installation.

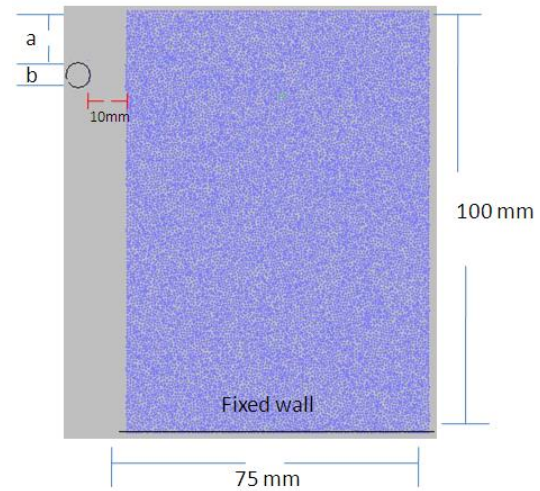
After calibration of PFC_{2D}, numerical simulation of blade and particle was simulated by creating a box model in the PFC_{2D} (Fig. 8a). The PFC specimen had the dimensions of 75×100 mm. A total of 11,179 disks with a minimum radius of 0.27 cm were used to make up initial model condition. After model generations, a particle was created in the right edge of the model (Fig. 8b). Round particle were considered to locate vertically at a distance of 5mm from the blade's internal wall (Fig. 8.). The particles diameters (b in Fig. 8.) for modeling were set at 1, 2, 4, and 6 mm, vertically located in front of the wall (a in Fig. 8.) at 0, 5, 10, and 30 mm from the blade tip. The particles hit the blades with the speed of 2 m/s and diffused into 0.2 mm in dept. In all simulations, blades were taken to be static and struck by the moving particle. Totally, twenty simulating performances for different modeling arrangements were executed to investigate the effects of particle diameter and its distance from the blade tip on any possible fracture patterns.

Fig. 8. Numerical simulation of blade and particle.
