# **Design Enhancement of EGR System for Improved Vibration Performance on Truck Diesel Engine**

**Abstract:** In the diesel engine Exhaust Gas Recirculation (EGR) components, valve and connecting pipes are the critical components and often fail during new engine development. These components are important for meeting NO<sub>x</sub> emission norms. Thus design of these components should remain robust. The compact packaging of complete EGR components on the engine, however, is counted as a designing challenge in which the consequent vibration-related failure plays a major role. Normally in pneumatic EGR valve, shaft spring stiffness is considered important for shaft opening and closing. But during emission testing in this layout, shaft is self-opened without feedback signal from sensor; this is due to resonance where the problem is solved by increasing the spring stiffness. The next key components are the EGR pipes; the flexible bellows on these pipes are useful for thermal expansion during hot conditions. In this case the bellow crack failure is observed due to vibration. Therefore, design improvements due to proper design of bellow geometry and bracket support for these pipes fac

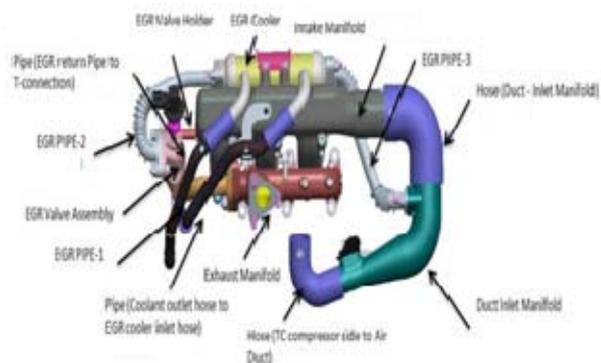
Fig. 1 EGR Valve Location on Engine

EGR valve installation on the engine is shown in Fig. 1. The EGR valve is connected by rigid casting pipe (1) at the bottom valve inlet side and by flexible pipe (2) at the top outlet side. The hot gas flows from bottom side and exits from the top side. Exhaust gas flow is controlled by means of shaft motion. This shaft is compressed by spring and actuated with the help of vacuum regulator.

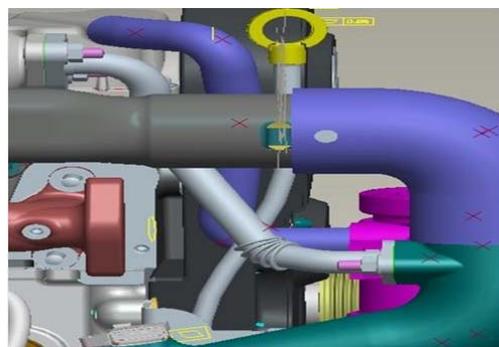
Fig. 2 EGR pipe-RH arrangement on engine

Normally EGR pipe thickness ranges from 0.4 mm to 0.8 mm. The design of this pipe, thus, is critical. In this case study of EGR pipe failures, vibration from the air-duct (connecting component of EGR pipe) is forced to act on the pipes causing vibration failure. In forced vibration, the frequency of vibration is defined by the frequency of force, with order of magnitude being dependent on the actual mechanical system. EGR pipe-3 (RH) arrangement on the engine is shown in Fig. 2. Therefore, packaging constraint highly affects the vibration-related problems.

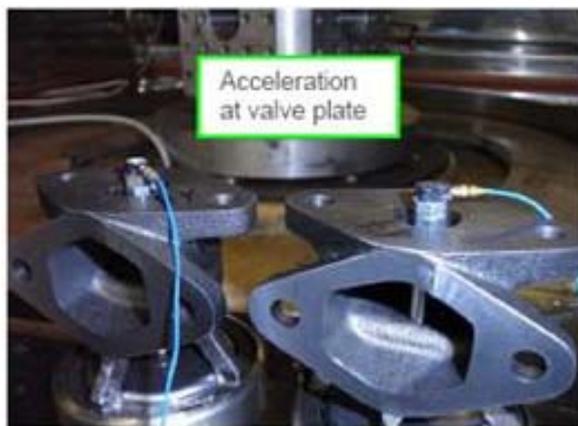
Fig. 3 Accelerometer Sensor arrangement on shaft

To identify the resonance on EGR valve, accelerometer sensor is placed on the valve in different locations before and after spring stiffness modifications. Fig. 3 shows the sensor arrangement on the EGR valve for acceleration measurement towards the direction of the shaft for both springs' stiffness. This arrangement is for valve open condition.

As Fig. 4 indicates, during valve open condition, valve resonance occurs at 113 Hz with maximum acceleration of 416m/s<sup>2</sup> for 2N/mm spring stiffness (red line). By increasing the stiffness, the resonance (green line in Fig. 4) did not occur and there is no self-opening of the valve.

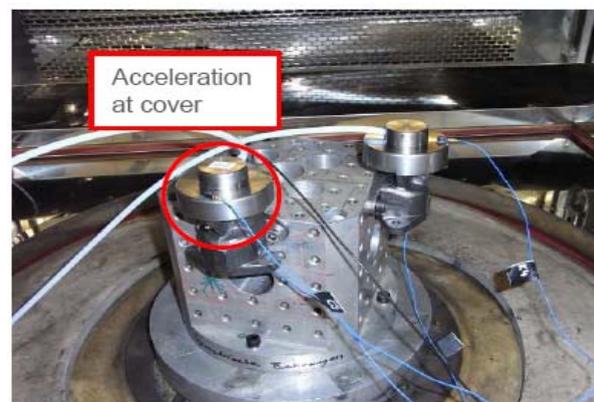
Fig. 5 Accelerometer sensor arrangement on the cover

Fig. 5 shows acceleration measurement taken on the cover during valve operating condition. Based on Fig. 6 during valve open condition, valve resonance occurs at 123Hz with maximum acceleration of 362m/s<sup>2</sup> for 2N/mm spring stiffness. By increasing the stiffness, the resonance did not occur concerning the fact that there is no self-opening of the valve.

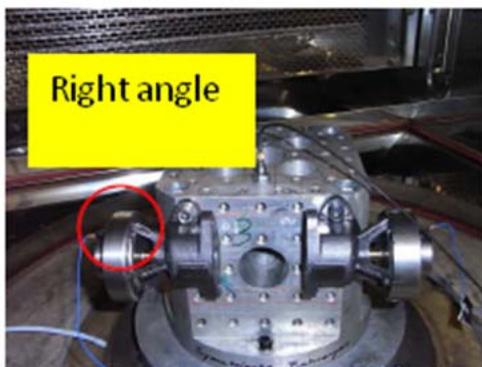
Fig. 9 Accelerometer sensor kept on the cover

As figures 7 & 8 show, during valve closed condition, valve resonance did not occur within 130Hz, which is an appropriate condition for self-opening of valve. Fig. 9 shows EGR valve with both springs' stiffness mounted at right angle for acceleration measurement.

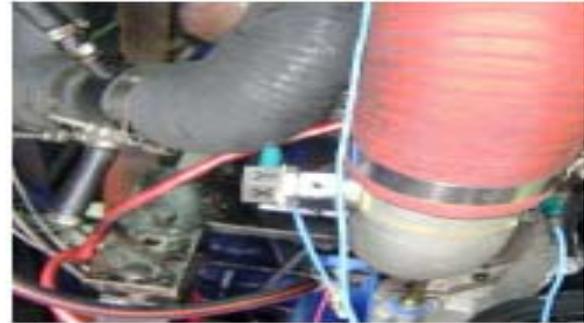
Fig. 20 Sensor arrangement on the air duct

Figures 18, 19 and 20 show the sensor (Tri-axial accelerometer) arrangement on air duct bracket, EGR cooler and air duct to study the vibration level in the
