## **Failure Evaluation of Cupronickel Alloy Used in the Condenser of the Desalination Unit**

This study looks into the various forms of corrosion that affect various elements of the South Pars Gas Company's first refinery's desalination plant, such as water compartments, tubular plates, support tubes, and the self-tube. To investigate the corrosion variables, a thorough analysis of the device's structure and process, as well as the material, was conducted. During repairs, damaged tubes were sampled and subjected to scanning electron microscopy, X-ray diffraction, and X-ray fluorescence testing. Evaluating scanning electron microscopy pictures from the inner surface of the tube reveals deformation and a rise in the tube's inner diameter. The X-ray diffraction patterns and elemental analysis by X-ray fluorescence show that the inner surface is corroded. The external surface of the tube and analysis of the diffraction patterns in this region reveal the formation of copper oxides on the outer surface of the tubes, which, when compared to electron microscopic images, distinguishes pitting corrosion caused by acid condensation collision on the outer surface of the tube. Finally, the ma

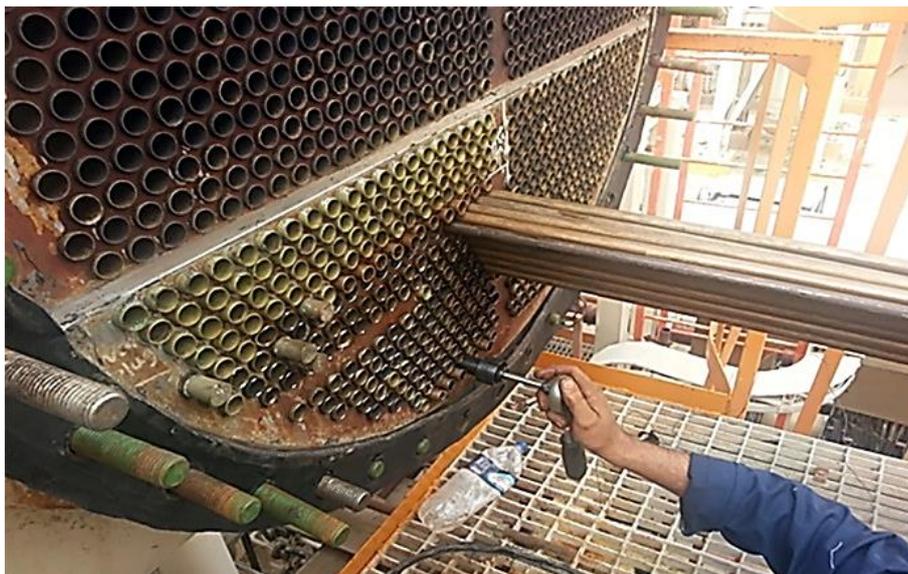
Figure 1. Pulling the tubes out of the apparatus

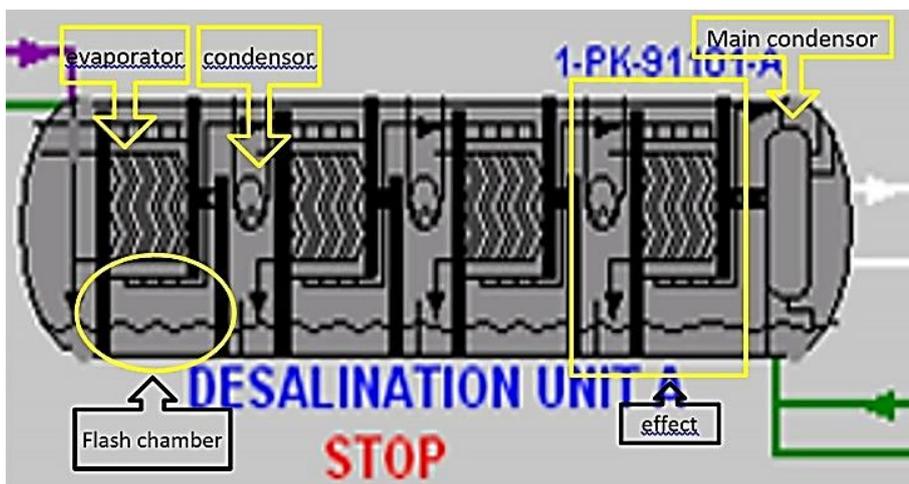
Figure 14. Schematic image of different parts of desalination unit

The effect's entrance is made up of seawater and steam. The steam is heated by the saltwater in the evaporator and becomes distilled water in the first effect. It then flows into the enclosure through the channel embedded in it and based on the pressure difference in the package, it moves to the last effect, which eventually delivers the device's product. In all impacts, this cycle is repeated. Each effect has its seawater input, although the second effect flushes steam from the flash unit's concentrated saline water. Non-condensable gases such as CO<sub>2</sub>, N<sub>2</sub>, O<sub>2</sub>, and others can be found in saltwater. When polluted with water, hydrogen sulfur (H<sub>2</sub>S) and ammonia (NH<sub>3</sub>) might be present, causing severe corrosion. To control them, chlorine is pumped into saltwater. As illustrated in Figure 15, gases in seawater, including CO<sub>2</sub>, are released from the saltwater in the flash chamber [21]. Carbonic acid is formed when carbon dioxide reacts with existing water (Eq. 1).

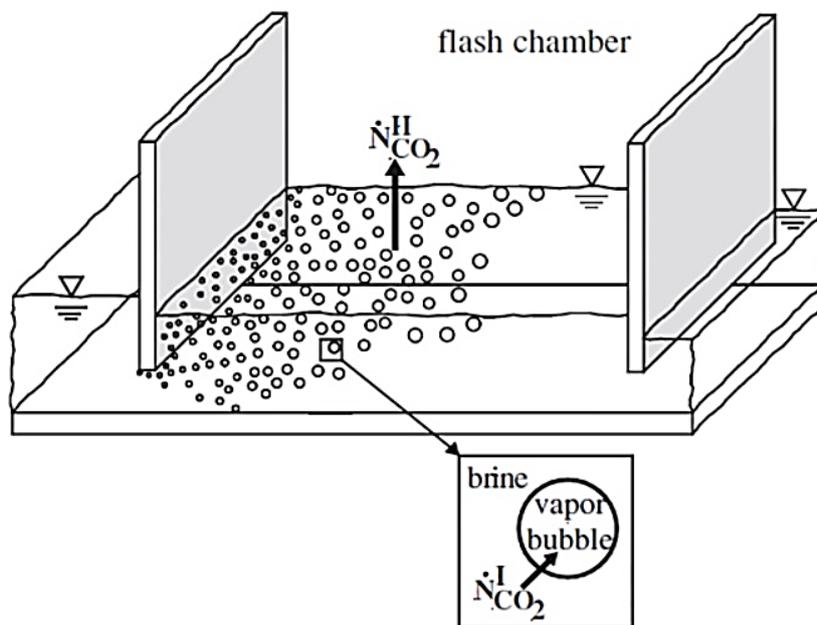
Figure 15. Condensate flow in desalination flash chamber

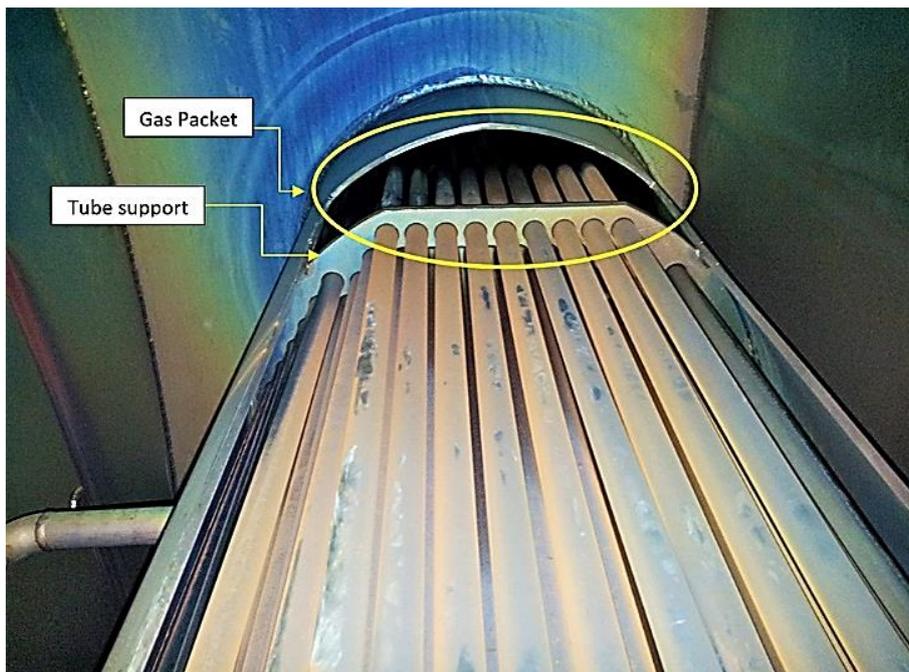
The heat source (steam) for the following phase is generated by the steam trapped in the flash unit with corrosive gases. Of course, before proceeding to the next stage, they must pass through a condenser, which produces distilled water by condensation and separates non-condensable gases. There is also an outgoing channel for non-condensable gases that do not condense into the main condenser and transforms it into a condenser under the same circumstances at a certain temperature. Finally, non-condensable gases that have not been converted to liquid in either of these zones are separated by the system's two-stage output. Existing condensers have compartments with a gas trap, and the fluid remains in them (Figure 16).

Figure 16. Heat exchanger interior

Gas traps typically form between the support tubes and the tubular plate on the device's side. Corrosion conditions are comfortable due to the corrosive gas environment and the ideal time in this location. As seen in Figure 17, there is substantial corrosion in this area.
