An Investigation of the Fatigue Corrosion Behavior of Al 6063-T6 Alloy under Seawater Influence

Abstract

Keywords: Corrosion Fatigue, Al 6063-T6 Alloys, Seawater, Crack Initiation, Striation lines.

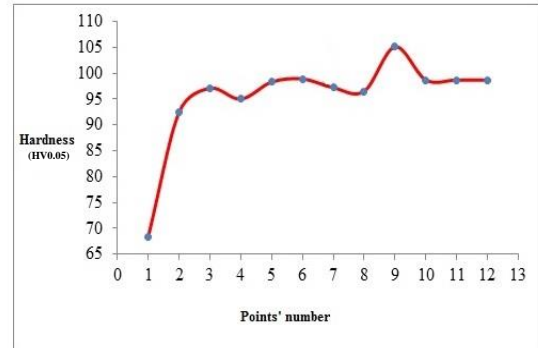
As determined in Table 3., the magnitude of Mg is almost twice greater than Si magnitude in the phase. The hardness of the phase β is probably higher than phase α . To obtain the hardness level of the alloy employed in the tests, micro hardness test was performed on the fatigued sample (Fig. 3.). Given

Fig. 3. Micro hardness profile of the fatigued surface.

the approximate evenness of the hardness level in line with the diameter, this fact can be a reason for the evenness dispersion of phase β in field phase α . The recorded optical microscopic images of the sample surface before fatigue test (Fig. 1.) evidently suggest this fact.

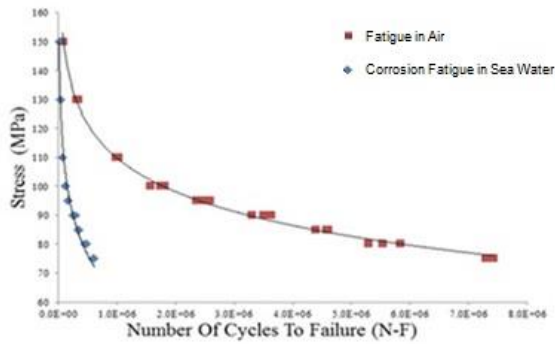
Fig. 4. depicts the S-N curve (stress-the number of cycles to failure) related to the Al-6063 alloy in the air and inside seawater. As the figure shows, the alloy's fatigue strength at the room temperature is 75 MPa and its fatigue life is 7.3×10^6 . As it can be seen, the last stress level (in which the piece has suffered from a failure) is 75 MPa and after 7.3×10^6 , it has been suffered failure. However, performing fatigue test on another sample of the alloy, the cycle has suffered failure in 70 MPa stress level and after 13×10^6 , indicating the ultra-life of the alloy. Furthermore, comparing the two curves reveals that this alloy shows a different behavior in the seawater. In other words, subjecting the samples to corrosion-fatigue test, fatigue strength and fatigue life decrease at corresponding stress levels. Corrosion fatigue in aqueous media is an electrochemical behavior. The presence of a corrosive environment during loading fatigue leads to corrosion pits. Fractures are initiated either by pitting or persistent slip bands. In this alloy, pitting will often be the most damaging type of corrosion, degrading performance by increasing the crack initiation and crack-growth rate more than any other kind of corrosion. Notably, to compare fatigue and corrosion-fatigue tests, the selected stress levels and applied stress levels have been considered identical in the fatigue test.

Fig. 4. S-N curves of aluminum samples in the presence of air and in Seawater.

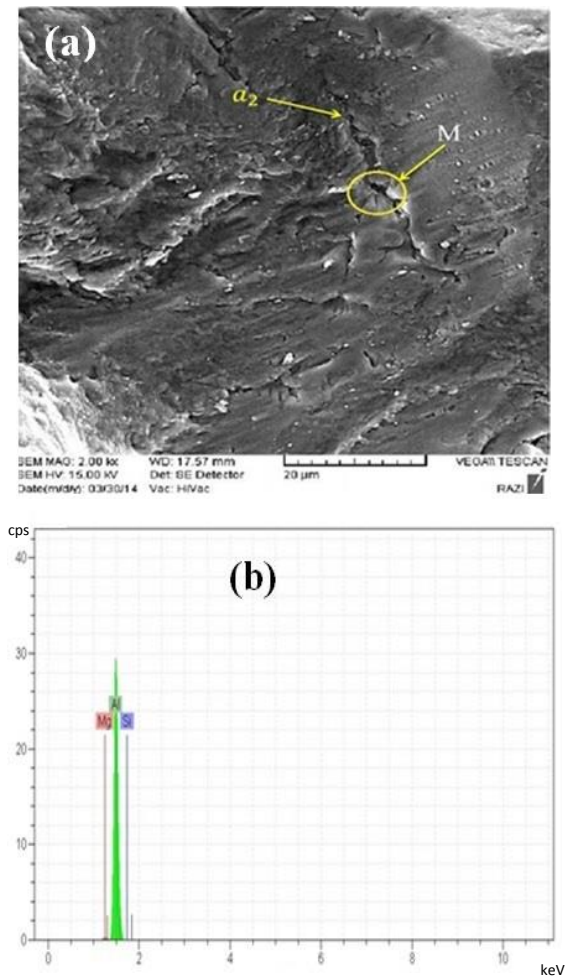
Fig. 12a shows that the crack a_2 is an internal crack, i.e. its initiation occurs within the sample (point M) and its propagation continues within the sample in a limited way. Similar to the crack a_1 , this crack experiences splits and branches in its propagation path when encountering the second phase. As shown, in the Al-6063 alloy, an internal crack has been observed at the failure level of a sample, which endured 4572917 stress cycles. These cracks can be due to the presence of hard phase of β at the crack place. Fig. 12b shows the chemical combination analysis of the crack initiation place (point M). More investigation that is precise reveals that the crack initiates from the hard phase of β . The chemical analysis from point M is determined in Table 5.

Fig. 12. (a) SEM image of initiation and propagation path of crack a_2 , (b) EDS of point M.

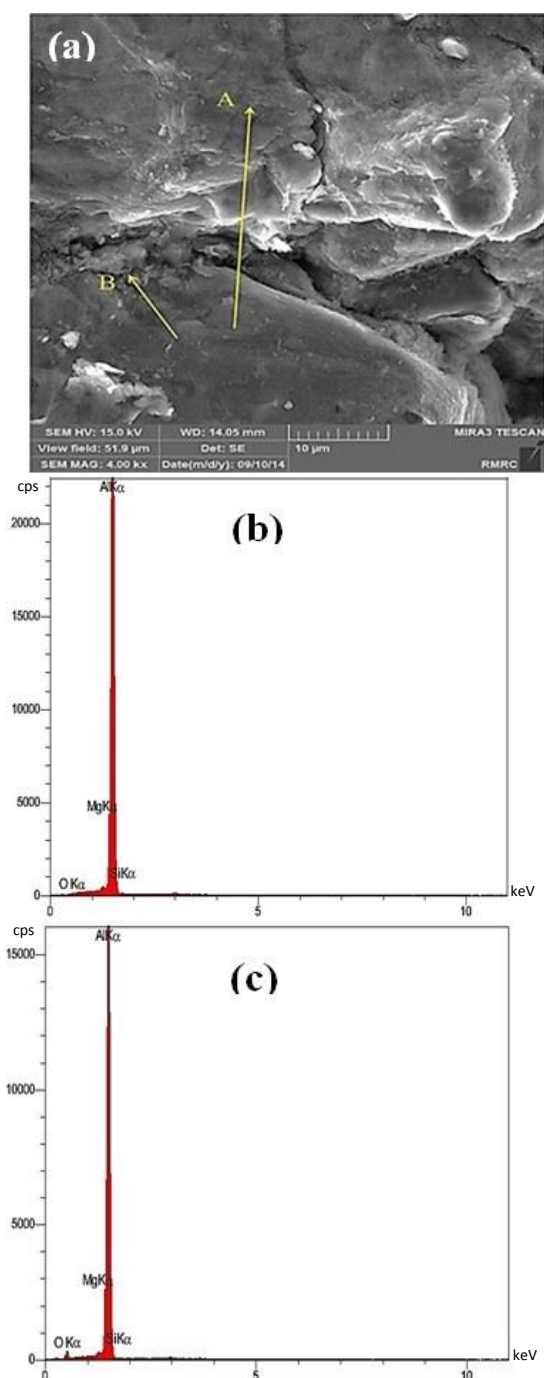
SEM studies of the fractured surfaces indicated the contribution of corrosion on the occurring of fracture, i.e. presence of corrosive products on the fracture surfaces illustrated this contribution (Fig. 16.).

According to the Fig. 16. and the results obtained from chemical composition determination test (Table 6 and 7), these materials can be considered as corrosion products.

Fig. 16. (a) SEM images of the corrosion fatigued fracture surface, (b) EDS of point A, (c) EDS of point B.

Table 6. Chemical composition test results related to point A (Fig. 16a)

Table 7. Chemical composition test results related to point B (Fig. 16a)
