# Evaluation of Mixed-Mode Center Crack SIF in a Curved Plate Repaired by Stop Holes, Composite Patch, and Hybrid Methods

**Abstract:** In this research, using the 3D finite element method and considering different materials for a composite patch, the effect of separate and simultaneous use of stop holes and composite patch (one-sided and two-sided) on reduction of SIF in a curved plate including mixed-mode crack is investigated. Glass-epoxy, graphite-epoxy, carbon-epoxy, and boron-epoxy are used for repair patches. For the one-sided patch, the effects of different geometric parameters on the efficiency of the repair are investigated. For all four composite patches, as the thickness of the patches increases, KI and KII decrease, but with increasing the patch length, KI and KII increase. The research results also show that with increasing the width of the glass-epoxy patch, KI and KII almost do not change, but for other patches, as the patch width increases, the SIF increases. The effect of the radius of curvature of the plate on the efficiency of various repair methods is also investigated. In all repair methods studied, SIF decreases with increasing radius of curvature of the cur

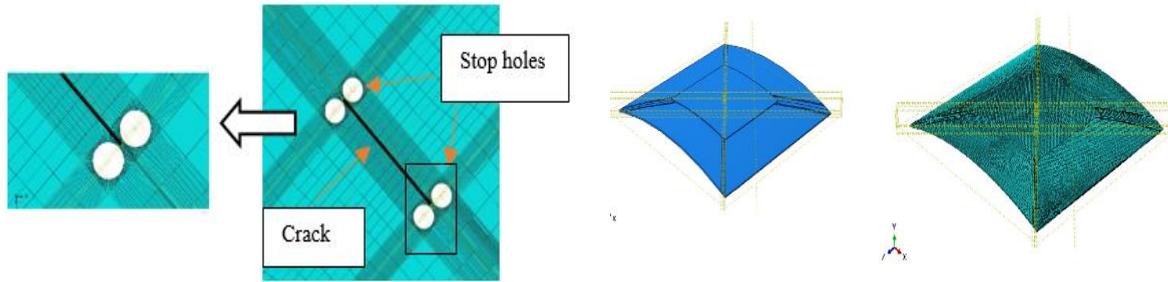
Fig. 1 Model and meshing around crack tip and crack stop holes in Abaqus software.

In this study, to investigate the effect of stop holes on both sides of the crack and composite patches on the reduction of SIF in the mixed-mode crack, a curved plate (a sectional cut at an angle of 30 degrees from a cylinder with a radius of 1 meter) containing a 30 mm long crack with an angle of 45 degrees is considered. The length of the circumferential side and the thickness of the model are 0.5 m and 4 mm, respectively. The plate is made of an aluminum alloy with an elastic modulus of 74 GPa and a Poisson's ratio of 0.33. The top and bottom edges of the plate are bounded in a radial direction and a tensile load of 1 MPa is applied to it. For repair with stop holes, holes with a diameter of 5 mm were drilled at a distance of 3 mm from the crack tip. Also, for patch repair, composite patches are cut segmentally with a 15-degree angle from a cylinder with a radius of 1 m. The length of the peripheral side of the patch is 250 mm and the width of the patch is 260 mm. In this study, composite patches of different materials of boron, carbon, graphite, and glass epoxy are used. To connect the composite patches, a thin layer of FM73 adhesive with a thickness of 0.1 mm is used, and because in this research the goal is not to investigate the separation and damage of the adhesive, so in modeling, the adhesive is considered as a solid layer. The properties of composite patches and adhesive are presented in "Table 1". XFEM is used to calculate the stress intensity factor (SIF) at the crack tip and 20-node hexagonal elements (C3D20R) are used in the modeling. The model of cracked curved plate has meshed with 71620 elements. The model of the cracked curved plate repaired with stop holes and a composite patch in Abaqus software is shown in "Fig. 1".

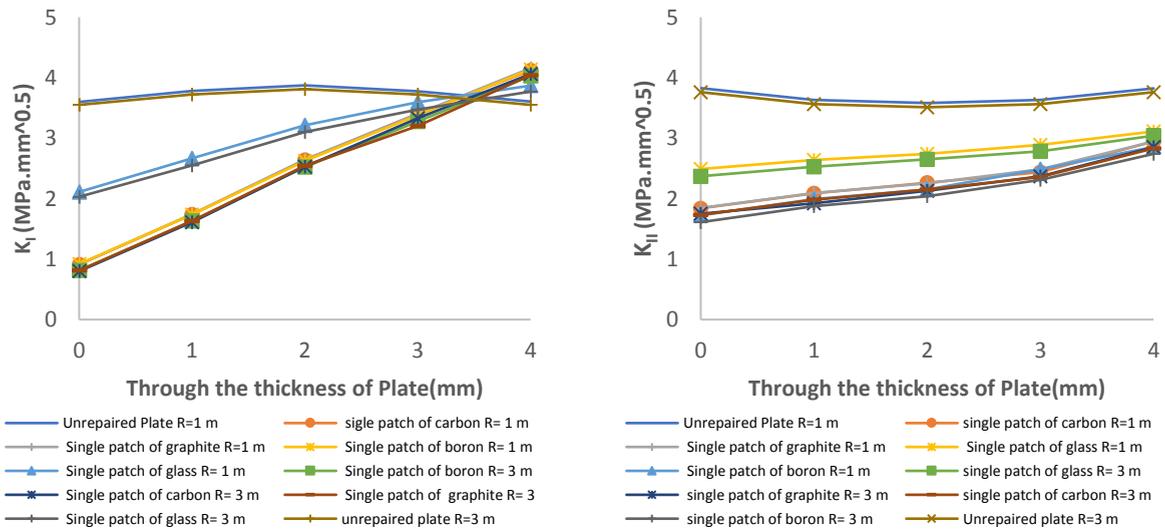
Figure 2 shows the changes in  $K_I$  and  $K_{II}$  along the plate thickness for curved plates with a radius of curvature of 1 and 3 meters repaired with one-sided composite patches of carbon, graphite, boron, and glass-epoxy. As can be seen, the  $K_I$  decreased on the repaired side but increased on the unrepaired side. In addition, the  $K_{II}$  of the repaired side differs from the unrepaired side, but this difference is less than the first mode.

Fig. 2 Variations of  $K_I$  and  $K_{II}$  along with the plate thickness for the curved plate repaired with single patches.

According to “Fig. 2”, boron, graphite, and carbon epoxy patches have reduced the SIF further than the glass epoxy patch. The greatest reduction in SIF is

caused by the use of the boron-epoxy patch, which reduces SIF slightly more than carbon and graphite patches. For the second mode, the percentage of SIF

reduction for all three patches of boron, carbon, and graphite is close to each other. The use of a one-sided boron-epoxy patch in modes I and II reduced the SIF by 31.40 and 39.27%, respectively ( $R = 1$  m). In general, in the one-sided repair, composite patches reduce  $K_{II}$  more than  $K_I$  (“Fig. 2”).

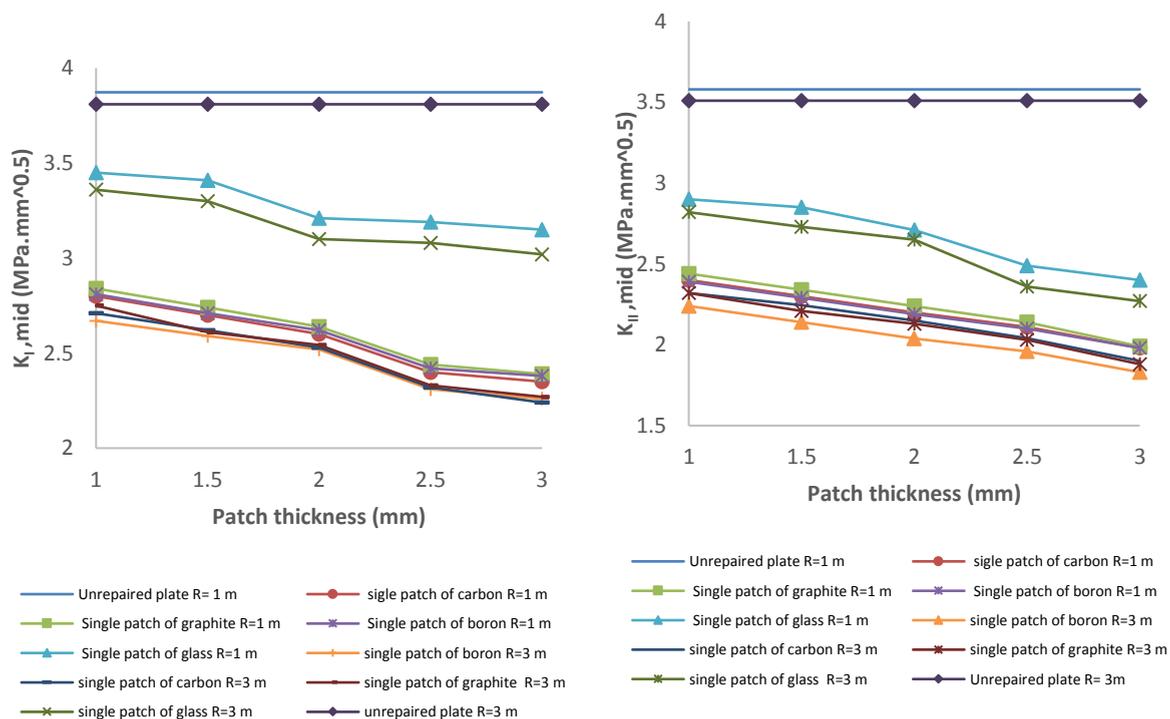
To investigate the effect of the patch thickness on repair efficiency, patch thicknesses of 1, 1.5, 2, 2.5, and 3 mm are considered for all four composite patches of boron, carbon, graphite, and glass-epoxy. Figure 3 shows the changes in  $K_I$  and  $K_{II}$  in terms of patch thickness for both radii of curvature of the plate 1 and 3 meters.

Fig. 3 Variations of  $K_I$  and  $K_{II}$  in terms of the patch thickness.

According to “Fig. 3”, for all four composite patches of boron, graphite, glass, and carbon-epoxy, as the thickness of the patches increases,  $K_I$  and  $K_{II}$  decrease, and the patch efficiency increases. For both 1 and 3-meter radii of the curved plate, the amount of SIF reduction is greater in the second mode. For example, for the glass-epoxy patch, increasing the patch thickness from 1.5 to 2.5 mm reduced the  $K_{II}$  by 12.63%, while the  $K_I$  decreased by only 6.45% ( $R=1$  m). The results of research [19] also show that in general, increasing the patch thickness reduces the SIF. Another point is that compared to a curved plate with a radius of 1 meter,  $K_I$  and  $K_{II}$  are less for a plate with a radius of 3 meters. As the radius of curvature increases, for the glass-epoxy patch,  $K_{II}$  decreases more than  $K_I$ , but for the three boron, carbon, and graphite-epoxy patches,  $K_I$  and  $K_{II}$  decrease almost equally. For the glass-epoxy patch,  $K_{II}$  and  $K_I$  decreased by 5.22% and 3.44%, respectively, by increasing the radius of curvature by 2 m at a thickness of 2.5 mm.

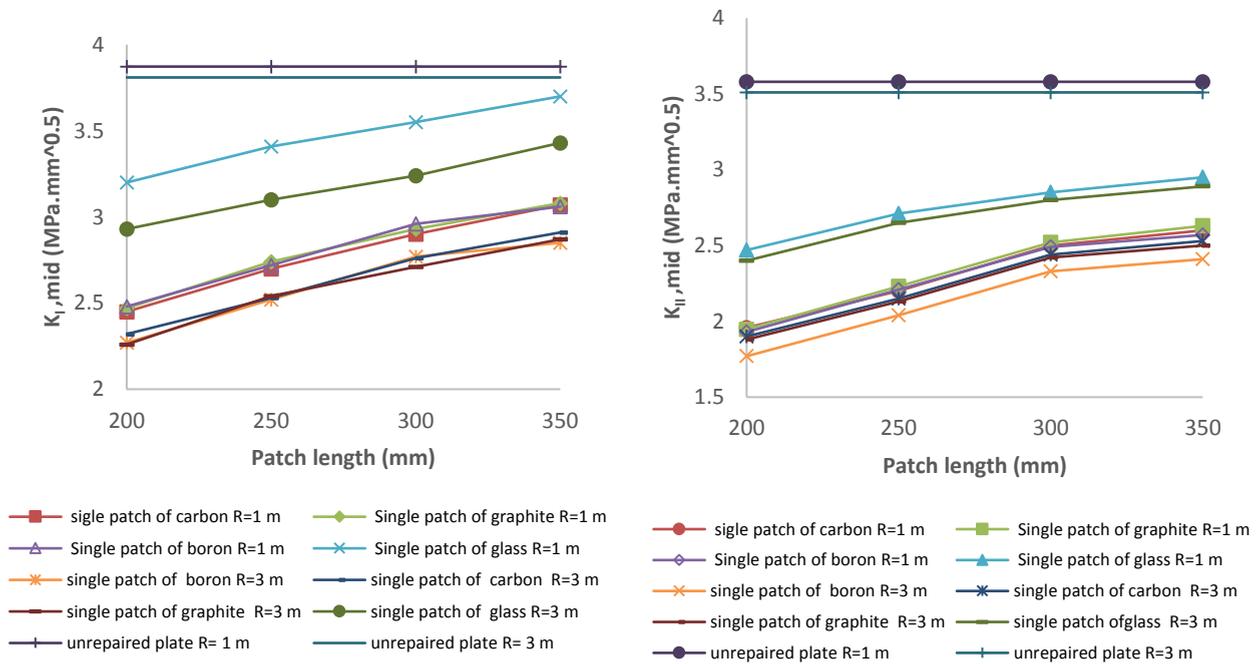
In this section, for the two radii of curvature of 1 and 3 meters of the curved plate, the effect of patch length on  $K_I$  and  $K_{II}$  is investigated (“Fig. 4”). According to “Fig. 4”, with increasing the patch length,  $K_I$  and  $K_{II}$  increase and the amount of  $K_{II}$  increase is greater than  $K_I$ . For example, increasing the length of the carbon-epoxy patch from 250 to 300 mm increases the  $K_I$  and  $K_{II}$  by

Fig. 4 Variations of  $K_I$  and  $K_{II}$  in terms of the patch length.

7.40% and 13.63%, respectively ( $R = 1$ m). Therefore, increasing the patch length is not a good way to increase repair efficiency. The results of the study [22] also confirm that increasing the patch length increases the SIF on the cracked flat plate. Increasing the graphite-epoxy patch length from 250 to 350 mm has increased  $K_I$  and  $K_{II}$  almost equally.

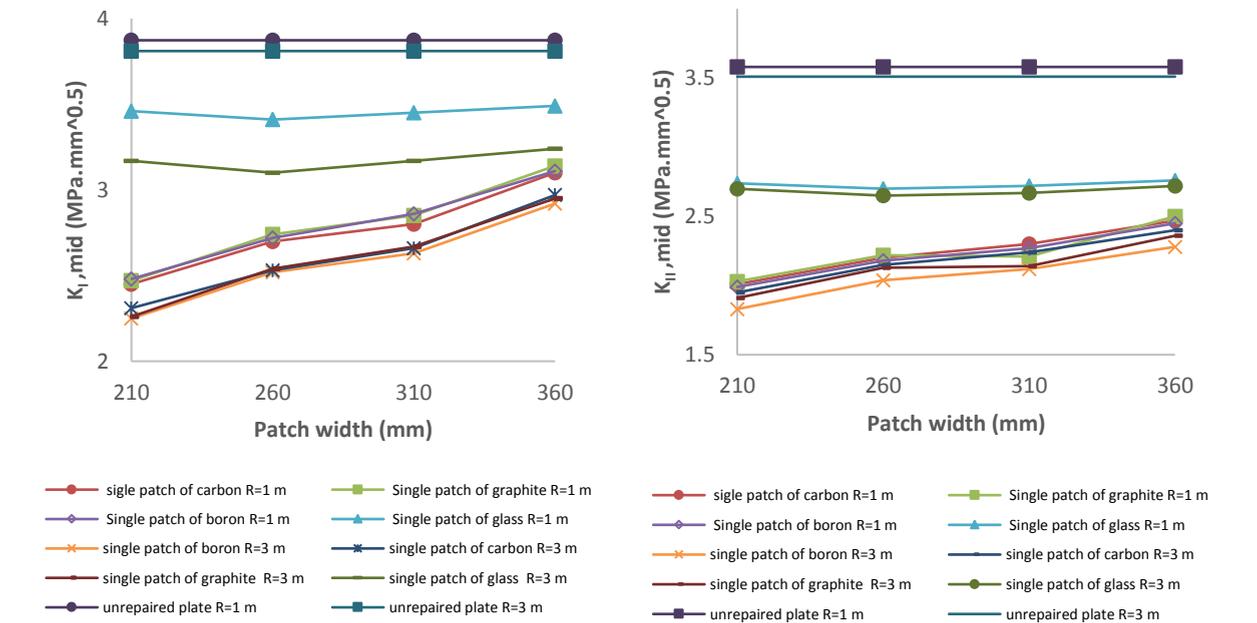
In this section, the effect of the patch width on  $K_I$  and  $K_{II}$  for a curved plate with a radius of curvature of 1 and 3 m is investigated (“Fig. 5”). According to “Fig. 5”, with increasing the width of the glass-epoxy patch,  $K_I$  and  $K_{II}$  almost do not change, but for other patches, as the patch width increases, the SIF increases and the amount of  $K_I$  increase is slightly greater than  $K_{II}$ . Increasing the width of the graphite-epoxy patch from

Fig. 5 Variations of  $K_I$  and  $K_{II}$  in terms of patch width.

210 to 260 mm increases the  $K_I$  and  $K_{II}$  by 10.93% and 9.35%, respectively (R = 1 m). As the radius of curvature increased, the  $K_I$  of the glass-epoxy patch decreased more than the other patches, but the  $K_{II}$  of all patches decreased almost equally. In repair with 310 mm wide glass-epoxy patch, increasing the radius of curvature from 1 to 3 m reduced  $K_I$  and  $K_{II}$  by 8.83% and 1.84%, respectively.

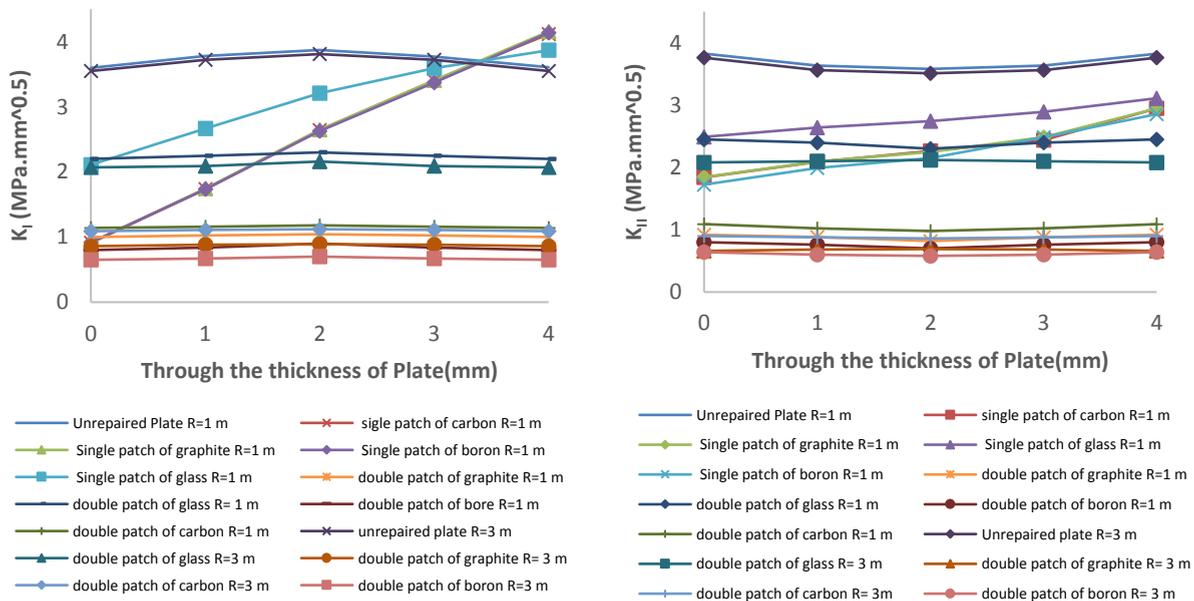
In this section, the repair of the cracked curved plate with a two-sided composite patch for two curvature radii of 1 and 3 meters of the curved plate is investigated and compared with the one-sided repair mode (“Fig. 6”). The length, width, and thickness of the patches used are the same in one-sided and two-sided modes.

**Fig. 6**  $K_I$  and  $K_{II}$  along with the plate thickness for the curved plate repaired with one and two-sided composite patches.

According to “Fig. 6”, the use of double-sided composite patches has further reduced the SIF compared to one-sided patches. For example, in one-sided repair mode, graphite patch reduces  $K_I$  and  $K_{II}$  by 30.84 and 37.17%, respectively, while in two-sided repair, the corresponding numbers are 73.06 and 77.14%, respectively ( $R = 1\text{ m}$ ). In the case of double-sided repair, in both curvature radii of 1 and 3 m of the curved plate, the highest SIF reduction belongs to the boron-epoxy patch, which reduces  $K_I$  and  $K_{II}$  by 76.76% and 80.44%, respectively ( $R = 1\text{ m}$ ). The use of the double-sided composite patch, unlike the one-sided patch, reduces  $K_I$  and  $K_{II}$  almost equally. The lowest SIF reduction is for the glass-epoxy patch.

According to “Fig. 6”, the use of double-sided composite patches has further reduced the SIF compared to one-sided patches. For example, in one-sided repair mode, graphite patch reduces  $K_I$  and  $K_{II}$  by 30.84 and 37.17%, respectively, while in two-sided repair, the corresponding numbers are 73.06 and 77.14%, respectively ( $R = 1\text{ m}$ ). In the case of double-sided repair, in both curvature radii of 1 and 3 m of the curved plate, the highest SIF reduction belongs to the boron-epoxy

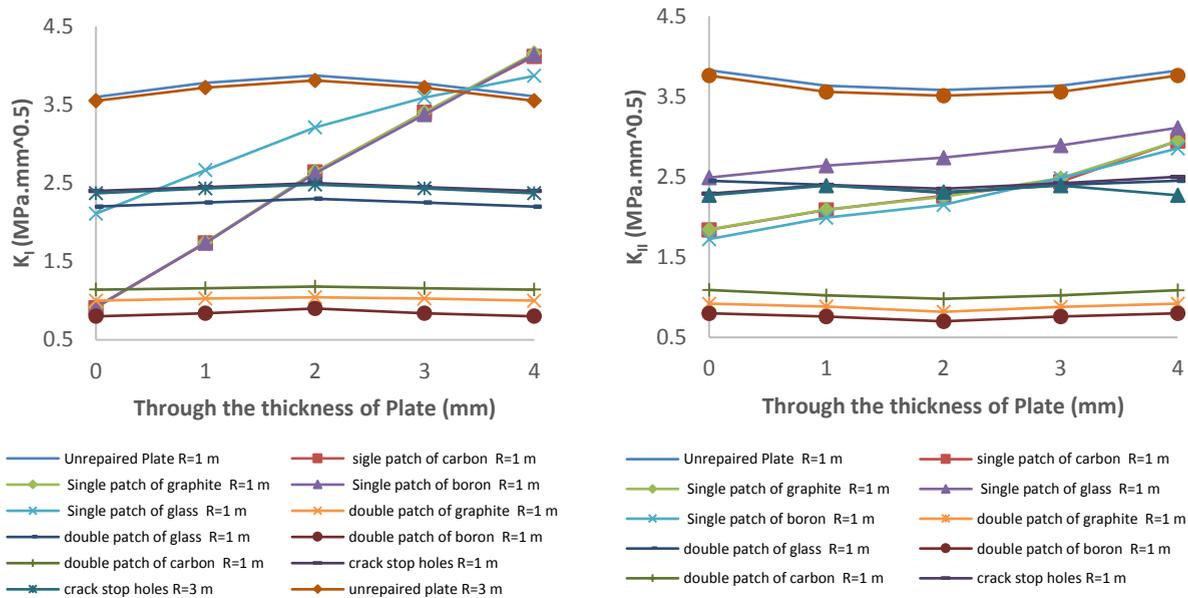
**Fig. 7** Variations of SIF along with the plate thickness, for the curved plate repaired with composite patch and stop holes.

In this section, the repair of the curved plate by stop holes method is investigated, and its efficiency is compared with the method of composite patches (“Fig. 7”).

According to “Fig. 7”, the use of stop holes on both sides of the crack further reduces the  $K_I$  compared to repair with all four one-sided composite patches, and for the second mode only reduces the  $K_{II}$  more than the glass-epoxy patch. Double-sided patches resulted in more reduction in  $K_I$  and  $K_{II}$  than the stop holes. The double-sided boron-epoxy patch (highest efficiency among patches) reduced  $K_I$  and  $K_{II}$  by 41.31 and 45.30%, respectively, more than the stop holes method. In the first and second modes, for plates with two different radii of curvature of 1 and 3 meters, the stop-hole method is applied, and the results obtained for both curvatures are very slightly different. Therefore, the radius of curvature does not have much effect on the efficiency of the stop holes method. As shown in “Table 4”, in this method, by increasing the radius of curvature from 1 to 7 m,  $K_I$  and  $K_{II}$  decreased by only 1.6 and 2.5%, respectively.

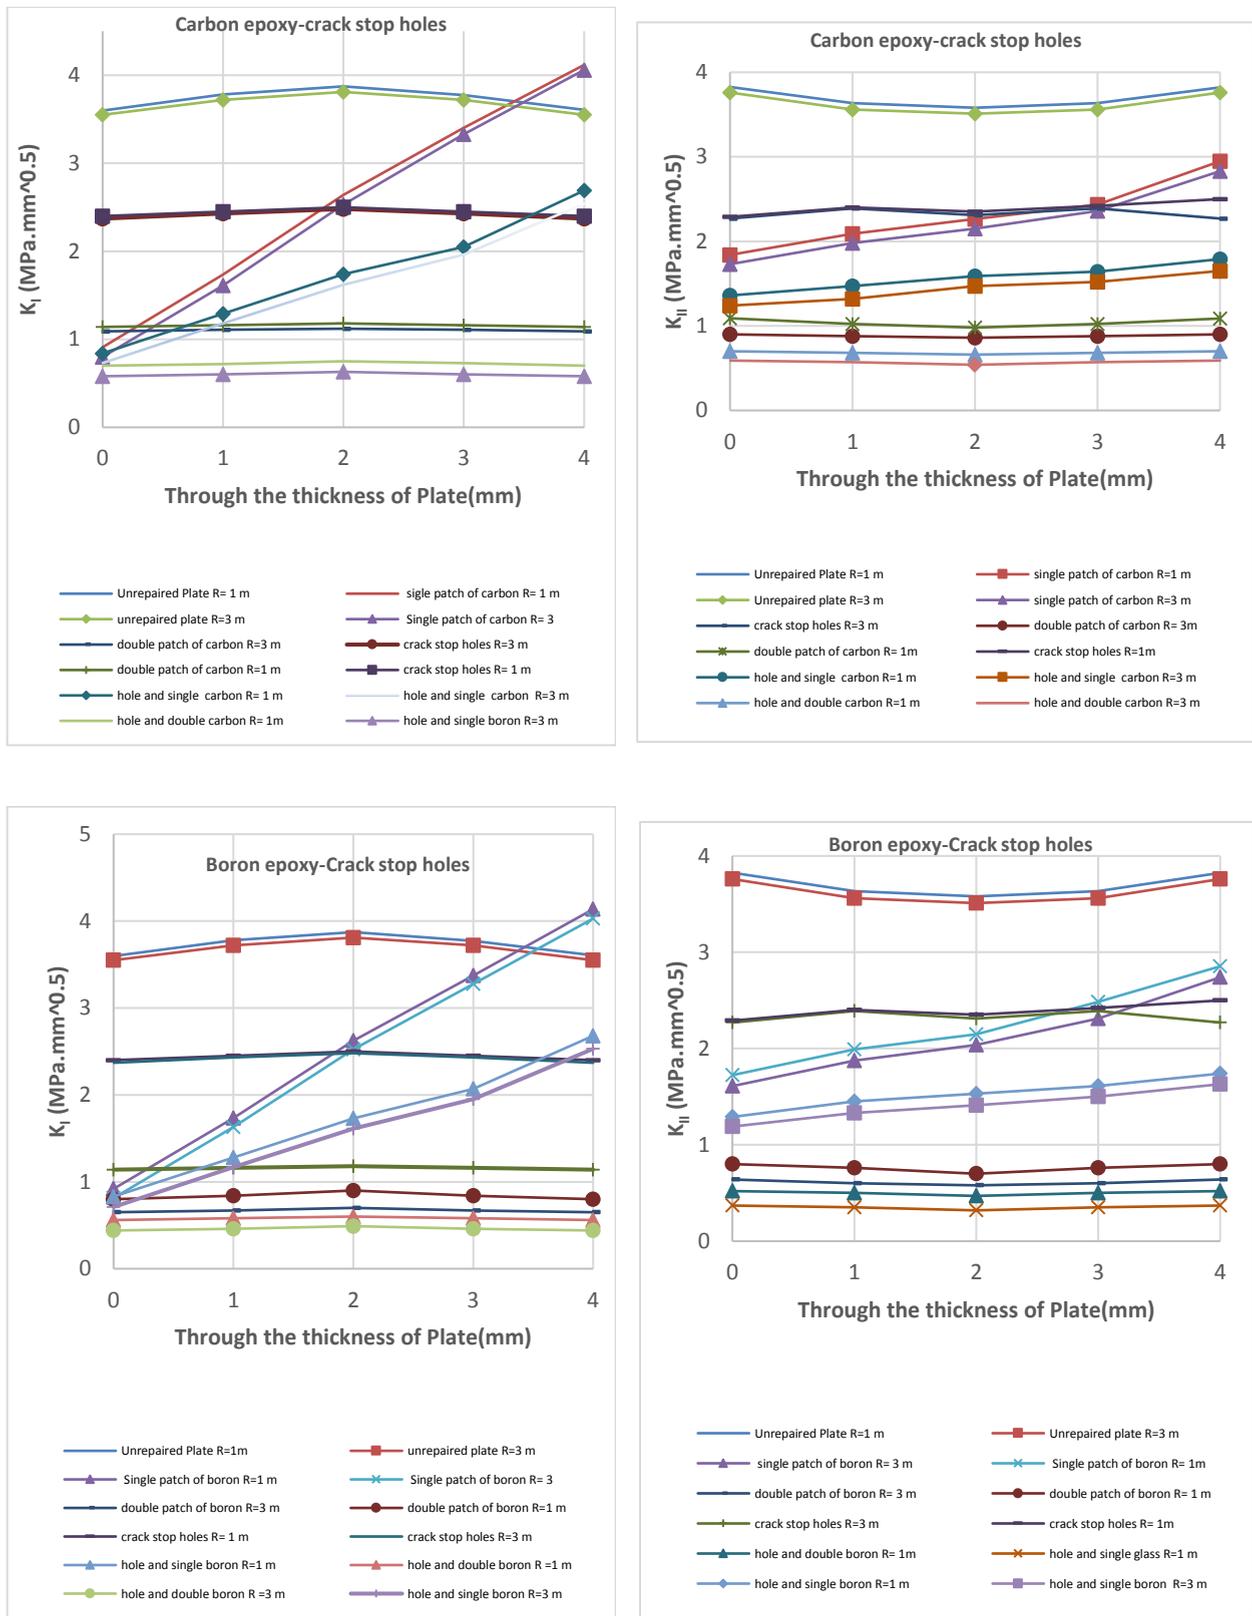
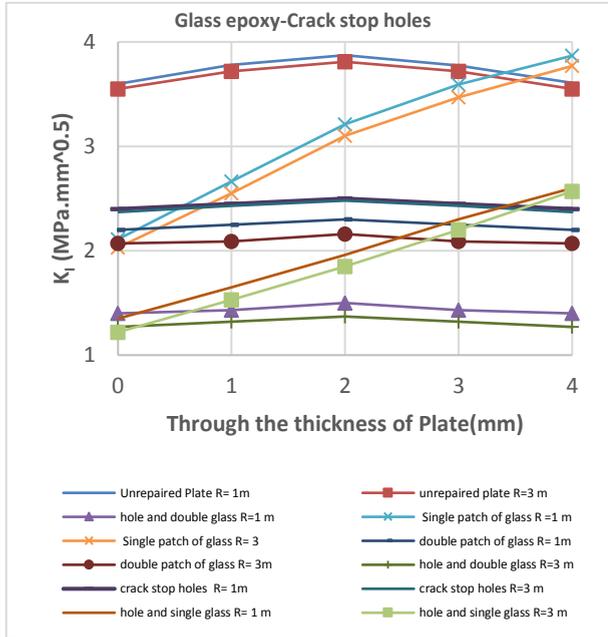
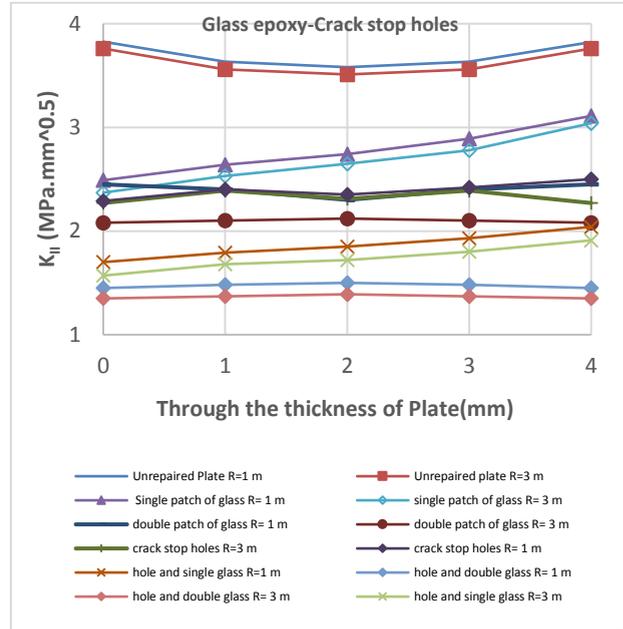
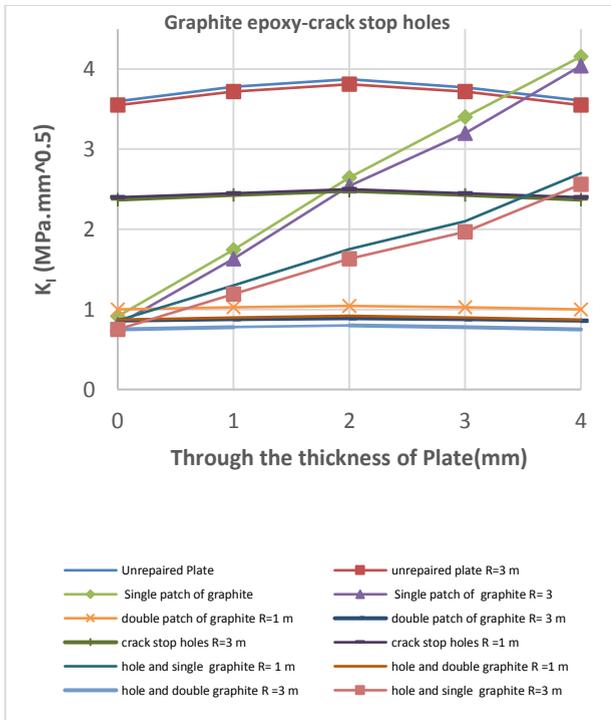
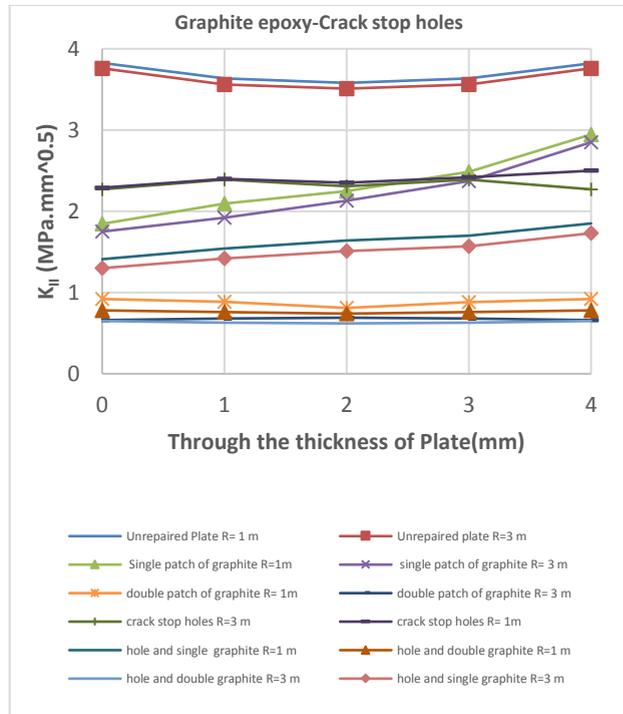
In this section, the combined repair method of composite patches and stop holes are investigated and compared with other methods (“Fig. 8”). As can be seen, the use of a combination of stop hole-composite patch methods further reduces  $K_I$  and  $K_{II}$  compared to the separate use of these methods. For example, a combination of stop-holes and one-sided graphite patch reduces  $K_I$  and  $K_{II}$  by 54.81 and 54.18%, respectively, while stop-holes and one-sided graphite patch methods reduce  $K_I$  by 35.45 and 30.84%, respectively. Applying the combined method reduces  $K_I$  and  $K_{II}$  almost equally. The best repair mode in this study is a combination repair with stop-holes and a two-sided boron-epoxy patch, which reduces  $K_I$  and  $K_{II}$  by 84.50 and 86.6%, respectively.

Fig. 8 SIF along with the thickness of the plate repaired with the patch, stop holes, and hybrid.

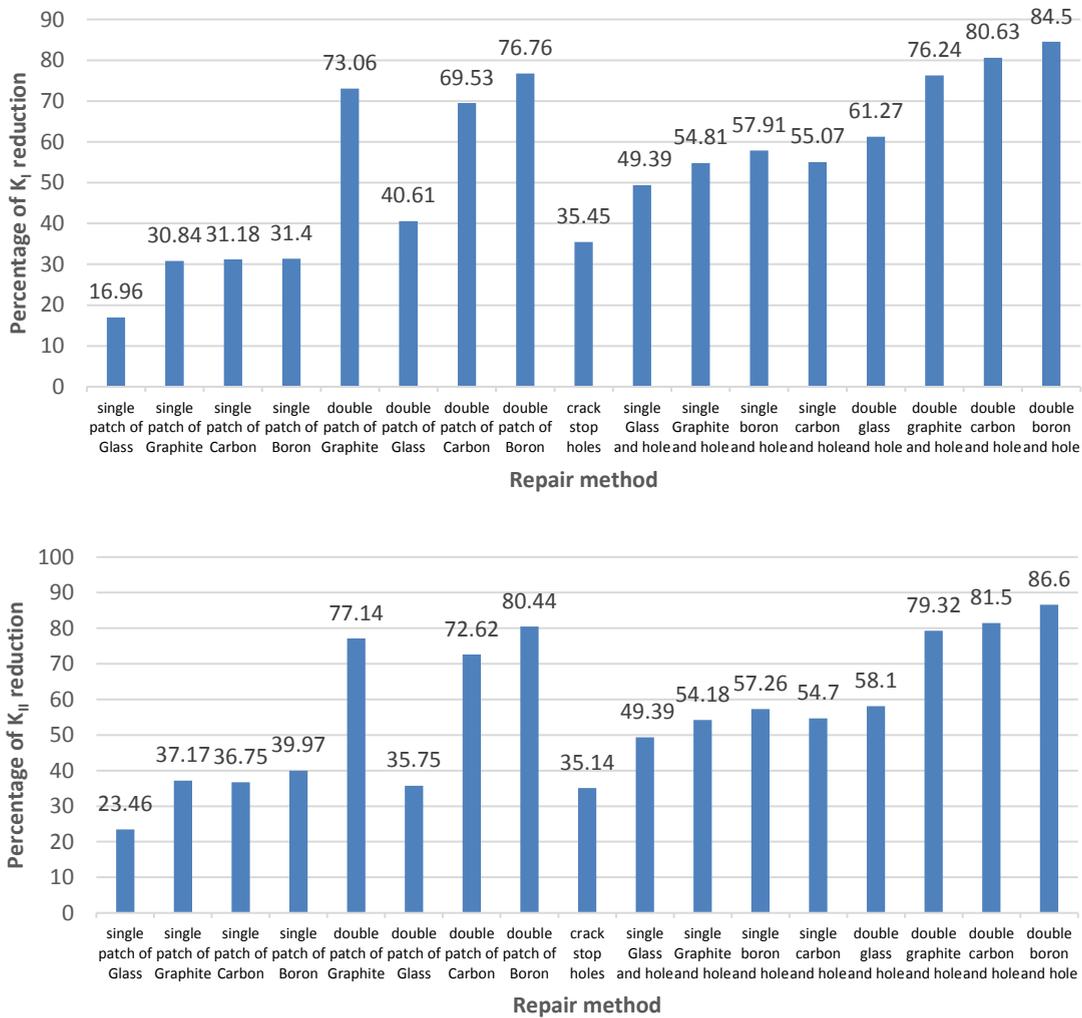
Figure 9 shows the  $K_I$  and  $K_{II}$  percentage reduction for cracked curved plate repaired by various repair methods for different patch materials of boron, carbon, graphite, and epoxy glass (R = 1m).

**Fig. 9** Percentage reduction of  $K_I$  and  $K_{II}$  of cracked curved plate repaired by different methods.

According to “Fig. 9”, in the one- and two-sided composite patch repair methods, the highest reduction of  $K_I$  and  $K_{II}$  belongs to boron-epoxy and the lowest efficiency belongs to the glass-epoxy patch. In addition, the percentage of  $K_{II}$  reduction in the composite patch repair method is higher than  $K_I$ . Another point is that the use of double-sided composite patches reduces  $K_I$  and  $K_{II}$  more than one-sided mode. For example, the use of

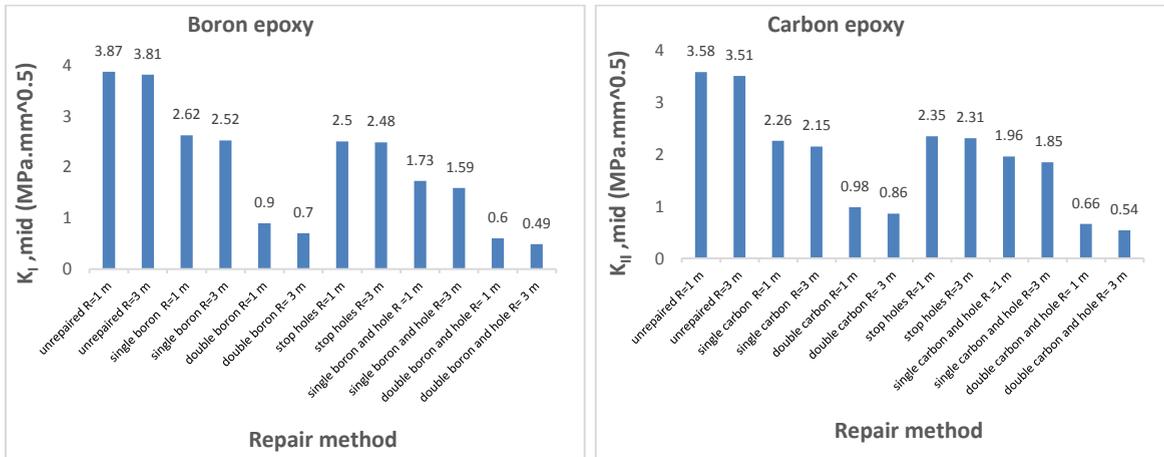
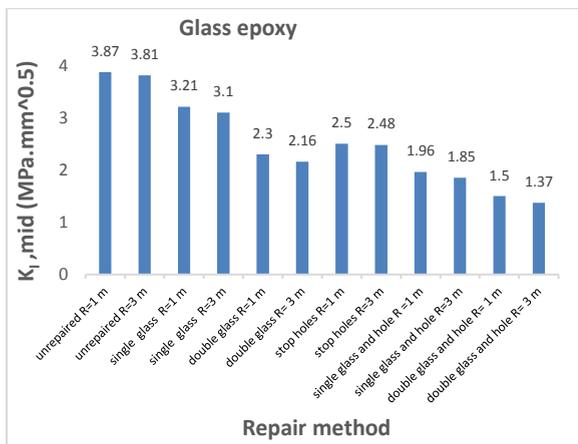
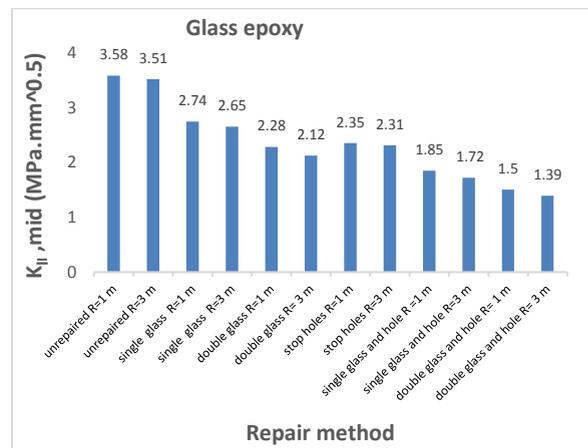
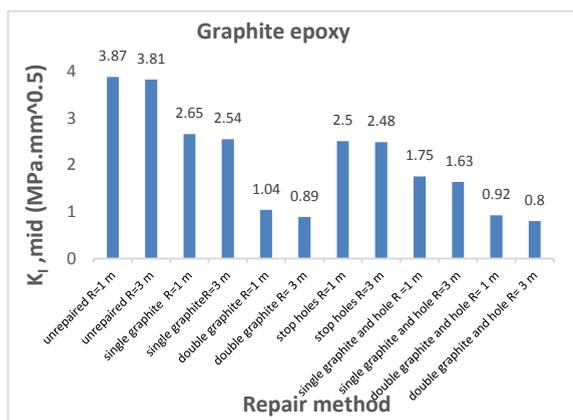
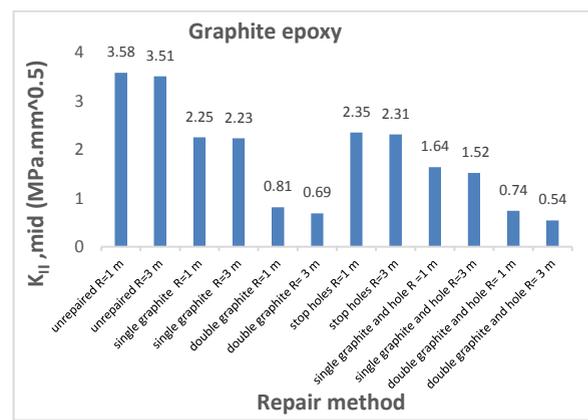
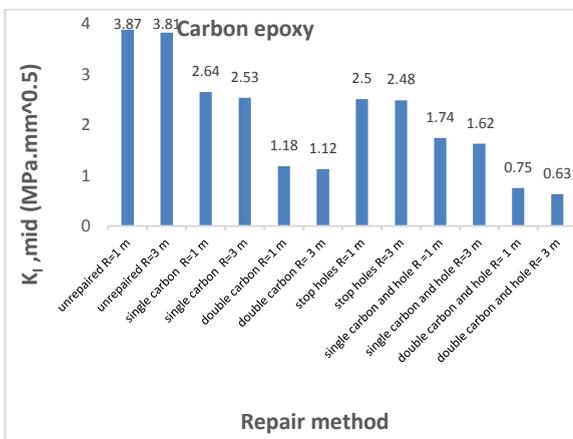
Figure 10 shows the average values of  $K_I$  and  $K_{II}$  in different repair methods and for different materials of composite patches. It is clear that in the repair method

Fig. 10 The average value of SIF of different repair methods for the radius of curvature of 1 and 3 meters.

with one- and two-sided composite patches, for all materials used in this research, the average value of KII has decreased more than KI. In addition, in stop-holes

and combined methods, in two different radii of curvatures of 1 and 3 meters, the average KI and KII are reduced almost equally.

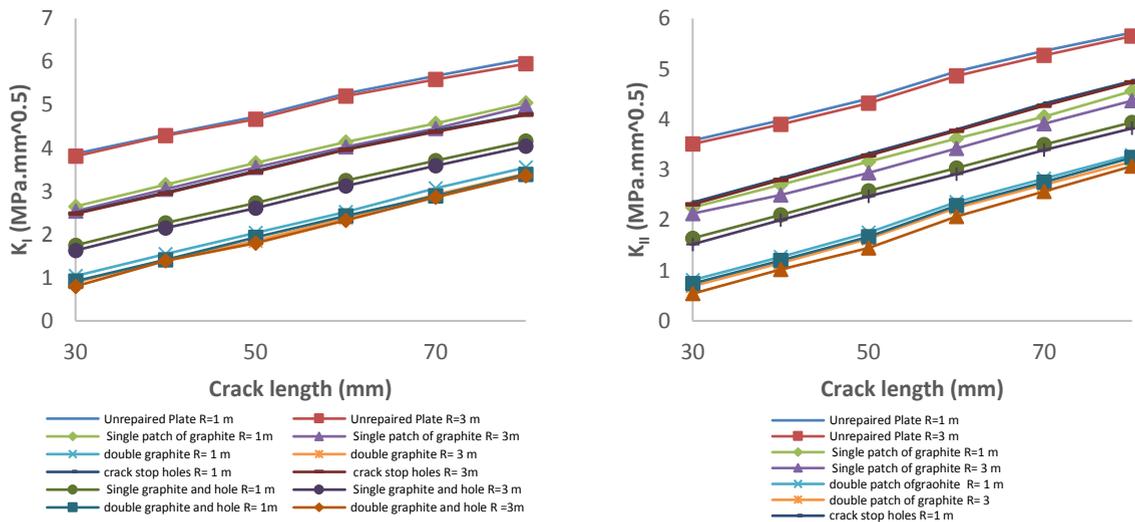
In this section, the effect of increasing the crack length on  $K_I$  and  $K_{II}$  in different repair methods is investigated. In this analysis, the graphite-epoxy patch is used. According to “Fig. 11”, with increasing crack length, for both plate radii of curvature of 1 and 3 m,  $K_{II}$  increases

Fig. 11 Effect of the crack length on KI and KII of the curved plate repaired with different repair methods

more than  $K_I$ . For example, in the one-sided repair of the graphite-epoxy patch, with a 50% increase in crack length from 30 to 45 mm,  $K_I$  and  $K_{II}$  increase by 28.49 and 30.22%, respectively ( $R = 1m$ ). In the stop-holes repair method, with increasing crack length from 30 to 60 mm in radii of curvatures of 1 and 3 m,  $K_I$  increased by 59.20 and 59.67% and  $K_{II}$  by 61.7 and 63.20%, respectively.

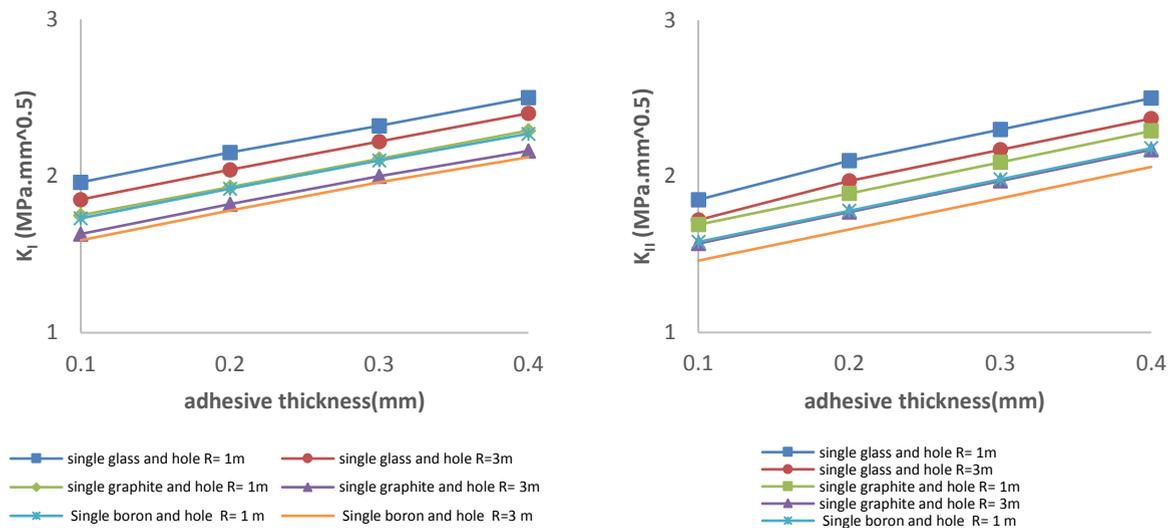
In this section, the effect of adhesive thickness on the efficiency of the combined repair method for the two radii of curvature of 1 and 3 meters of the curved plate is investigated (“Fig. 12”). For this purpose, adhesives

Fig. 12 The effect of adhesive thickness on SIF of the curved plate repaired with the hybrid method.

with different thicknesses of 0.1, 0.2, 0.3, and 0.4 mm are used. According to “Fig. 12”, as the thickness of the adhesive increases,  $K_I$  and  $K_{II}$  increase, and the amount of  $K_{II}$  increase is slightly greater than  $K_I$ . For example, in the case of the glass-stop holes hybrid repair method, the  $K_I$  and  $K_{II}$  increase by 54 and 65%, respectively, with a 0.3 mm increase in adhesive thickness ( $R = 1m$ ). In the case of combined repair of boron-stop holes, with a 0.3

mm increase in adhesive thickness,  $K_I$  and  $K_{II}$  increase by 52 and 61%, respectively ( $R = 3m$ ). Another point is that, for all the patches used and in both radii of curvature of 1 and 3 meters, with increasing the thickness of the adhesive, the stress created in the

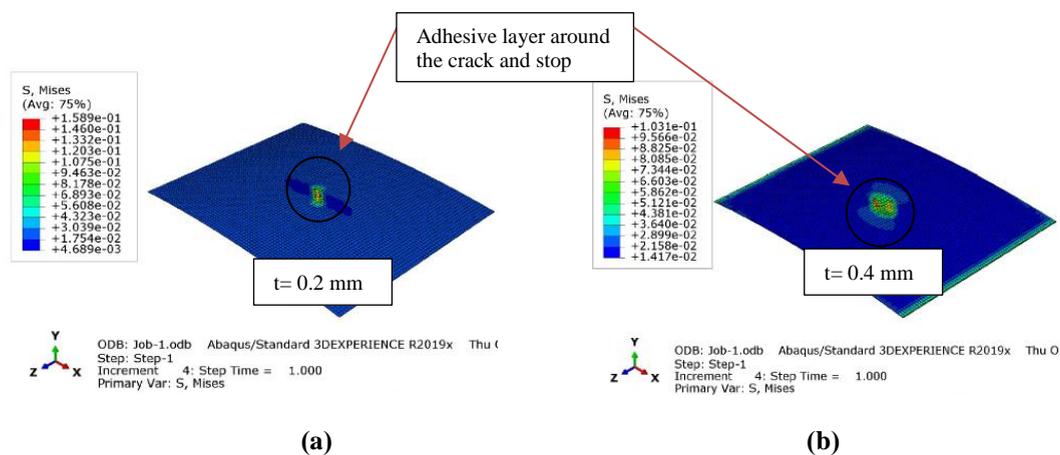
Fig. 13 (a): Von Mises stress in the adhesive layer ( $t_a = 0.2mm$ ), and (b): ( $t_a = 0.4mm$ ).

adhesive decreases. For example, by increasing the thickness of the adhesive from 0.2 to 0.4 mm, in the graphite-stop holes hybrid repair method and for curvature radius of 1 m, the maximum Von Mises stress decreases from 0.16 to 0.1 MPa (“Fig. 13”).
