# Measuring The Quality Of Natural Lighting In A Building With Double Skin Façade (DSF)

**ABSTRACT:** Lately a double skin façade (DSF) has been increasingly popular as an aesthetic and shading device. A façade with a secondary skin is employed in buildings to let natural light flow into the building without glare and heat. The purpose of this study is to examine the performance of secondary skin in buildings and to investigate the level of natural lighting in buildings that meets visual comfort standards according to the function of space in buildings. The object of this research is the Henricus Constant building of Soegijapranata Catholic University Semarang Indonesia. The research method used is descriptive quantitative. The authors assessed the level of natural lighting in the building by analyzing the results of field measurement data with luxmeter measuring devices and model simulations regarding natural shadows and lighting levels with Sketchup software and dialux. The results of this study suggest that secondary skins in the Henricus Constant building manages to create shade in the building's interior, but the natural lighting level is only 30 lux, less than the standard l

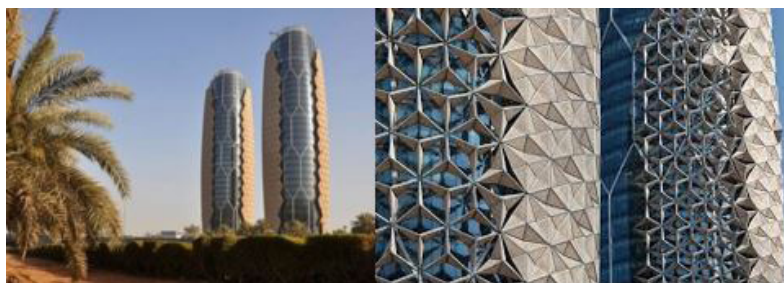
Fig. 2: The Building of Al Bahar Tower di Abudabi, Dubai

In a film about a building with a secondary skin façade in Abu Dhabi, Dubai, as shown in Figure 2, the secondary skin façade of the building can be opened and closed as needed to provide comfort (Elwazer, 2012). The Al Bahar Tower's secondary skin façade can be opened kinetically in response to the temperature to decrease glare and provide more comfort.

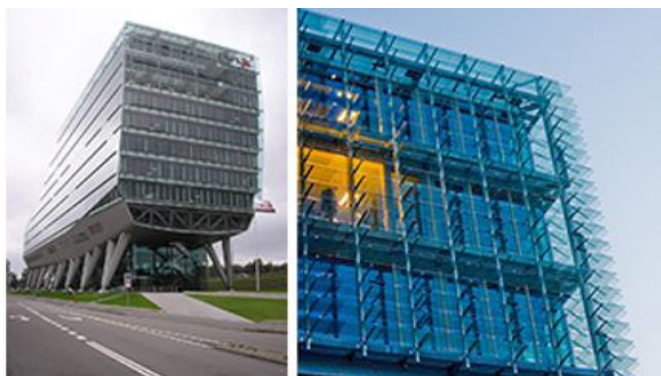
Fig. 3: Building with Double Skin Façade

A façade having a secondary skin is also called the Double Skin Façade (DSF). In DSF, the building has an outer façade placed in front of the building wall within a certain distance to create a cavity that allows natural ventilation. In Figure 3, the air moves, entering from below and exiting through the hole above (chimney effect or stack effect). This DSF is utilized to heat buildings in cold climates and to cool buildings in tropical climates (Poursani, 2018).

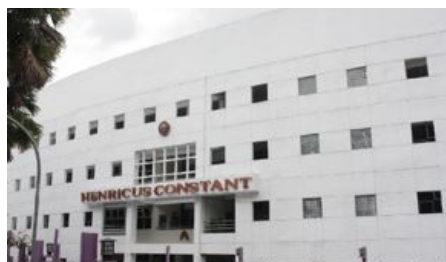
Fig. 4: The Building of Henricus Constant of Soegijapranata Catholic University, Semarang

In Semarang, several buildings are designed with secondary skins; for example the Henricus Constant Building in Soegijapranata Catholic University, located in Bendan Ngisor, Semarang area (Fig. 4). This building has a secondary skin made of reinforced concrete frame and brick walls with square holes-pattern. The secondary skin in this building functions as a vertical interior shelf. The secondary skin that covers most of the building façade makes the building look distinctive and unique compared to other nearby buildings.

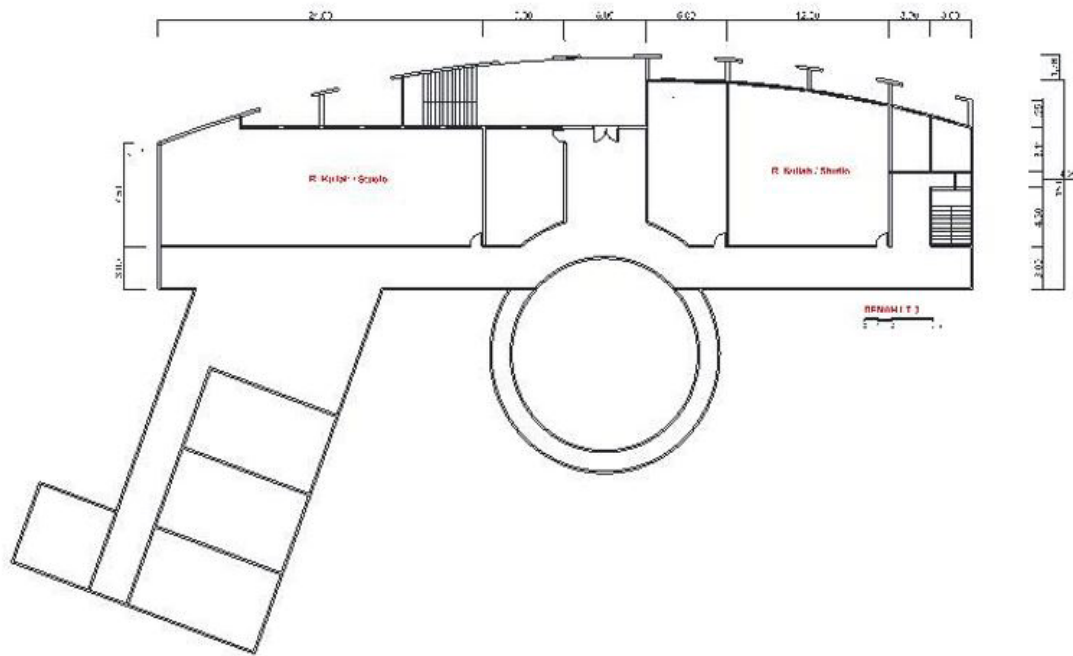
Fig. 5: Position of Measurement Point of the Level of Room Illumination (3rd Floor)

The measurement on the 3rd floor was done for 5 points in one room (Fig. 5). On the 3rd floor, the level of natural lighting was

between 2 lux - 10 lux, which was low because the exposure to light was blocked by the seven-meter retaining wall in front of the building. On the 4th floor, the level of natural lighting was not evenly distributed at the point near the glass wall, with a total value of 500 lux. However, in the south, the value was smaller because the sunlight was still blocked by the retaining wall (Fig. 6). On the 5th floor, the natural lighting level was between 10 lux and 15 lux. The quality of natural lighting increased from the 5th floor upward because the floors were not blocked by the retaining wall (Fig.7).

The measurement in the field suggests that the level of natural illumination was still below the visual comfort standard for the classroom, which is 350 lux (Tureková et al., 2018). (Table 1)

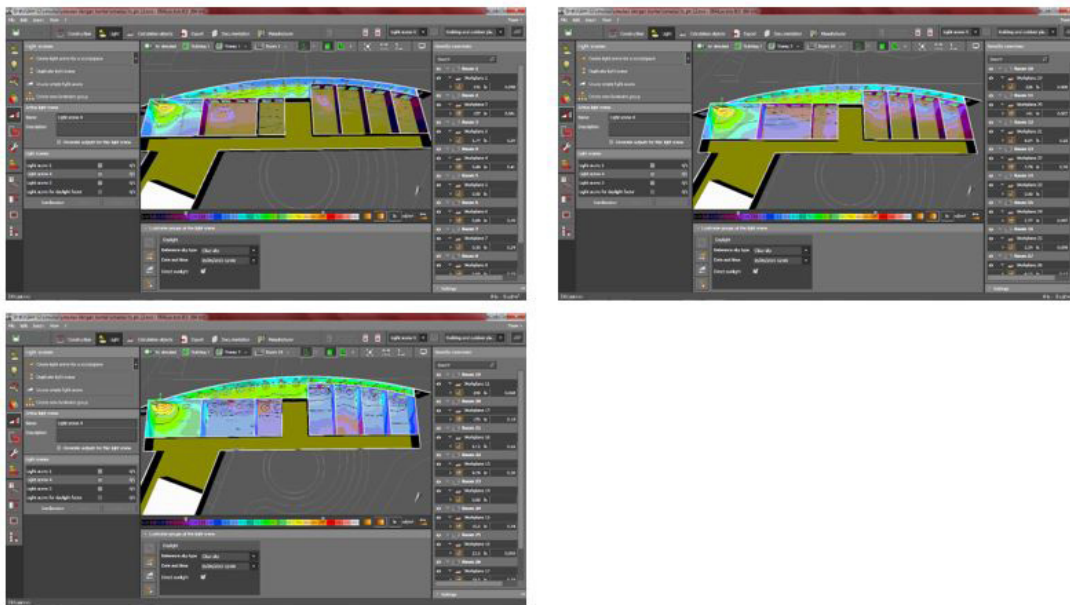
Fig 8: Dialux Simulation Results on Level 3, 4 & 5 at 12:00 noon

of illumination in room 1 (The cavity between walls and secondary skin) was 145 lux - 298 lux. In-room 2, which was not protected by secondary skin, the level of illumination in the form of the curtain wall was 107 lux - 185 lux, and in spaces 3,4,6,7,8, and 9, it was 0,49 lux - 31,4 lux. The average of simulation carried out at 12:00 noon. shows the decrease in natural illumination level compared to that of at 9:00 a.m. (for example: in room 3 from the 3rd to 8th floor, the level

of natural illumination is at 1.74 lux, 8.02 lux, 19.4 lux, 19.3 lux, 19.1 lux, and 19.6 lux at 12.00; meanwhile, at 09.00 the level of illumination is at 18.1 lux, 16, 3 lux, 30.1 lux, 30.1 lux, 30.3 lux and 30.6 lux). This happens because the angle of direct exposure to the sunlight at 12 o'clock was 69°. The secondary skin covered the main walls so that the walls of the building were completely covered by shadows. Whereas at 9:00 a.m., exposure to the sunlight can still enter the walls and openings

of the Henricus Constant Building.(Table 3) (Fig. 8)  
 At 3:00 pm, the sun's exposure reaches 140° and is already on the west side of the building. In the glass-walled room the illumination level is 250°, but on the part where the secondary skin is located, the natural lighting level drops to 10 lux - 30

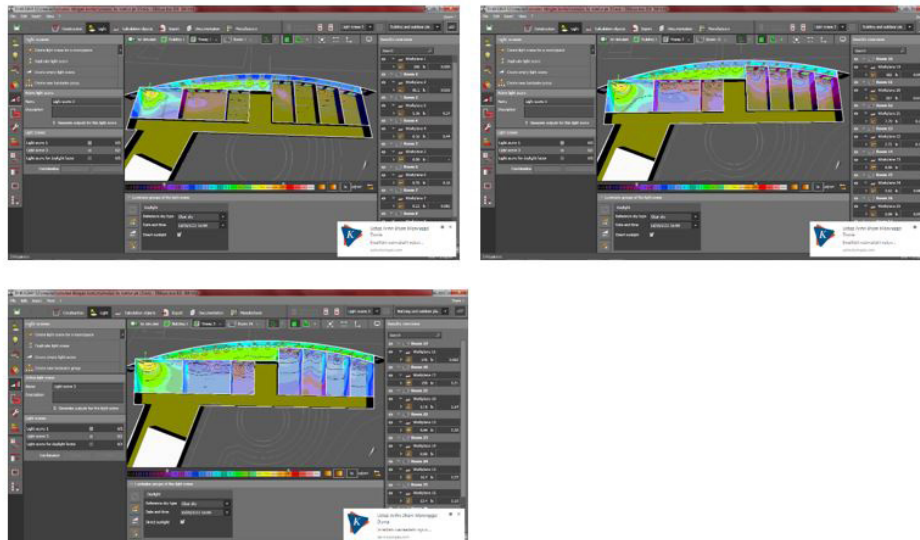
Fig. 9: Dialux Simulation Results on Level 3, 4 & 5 at 3:00 p.m.

lux. Only on the 3rd and 4th-floor exposure to natural light is blocked by the talud, so the value ranges from 0.8 lux - with 7 lux. Therefore, at 3:00 p.m., the space in the building becomes less bright and requires lighting support (Jafari et al., 2018) (Table 4) (Fig. 9).
